Load test to failure of VariEze N11EJ

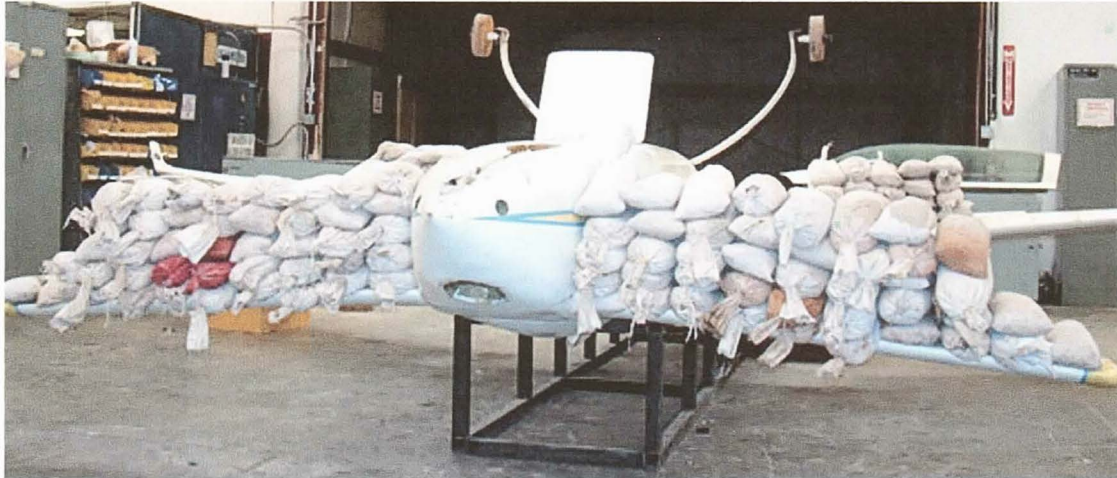
The canard shown here prior to adding another row on top of the first 8 stacks on each side. We missed getting a photo fully loaded due to an early failure! It failed at 8.3 'Gs'

We decided to load the canard first, but in order to do that we had to stack a bunch of shot bags on each wing root, to prevent the whole plane from nosing over! As you can see from the enclosed photos, we stacked 6 shot bags vertically starting at the side of the fuselage, and working outboard. We ended up with 8 vertical stacks of six 25 lb. shot bags, one stack of two shot-bags, and finally just one shot-bag at each canard tip. After a few seconds, the canard failed symmetrically starting at the right root, but both sides broke flush with the sides of the fuselage. Based on the maximum gross weight of a VariEze of 1050 lbs., this particular canard failed at an 8.3 'G' load factor.

This is lower than we expected. We have failed several canards over the years, none as old as this one, so age may be playing a part here, and we who fly these types of aircraft, should bear this fact in mind! The symmetrical failure and the failure mode were unusual though, and had not been seen before. The top spar cap, loaded in compression, popped loose from the 'C' shaped shear web lay-up beneath it, tearing the top skin loose, and then the shear web and lower spar cap failed catastrophically on both sides at almost the same instant. Typically we have seen one side of the canard fail all at once, at a load factor of 12 'G's, or more. We have never seen the top spar cap separate at the secondary bond line between the shear web and the top cap. This may have been due simply to the age of the materials and/or the hot/wet semi-marine type environment in which this aircraft spent most of its 21 years of life. It could also possibly be a workmanship issue, an incorrectly prepared shear web surface for example, or a combination of both.

Conclusion: Based on just this one test-to-failure of what appears to be a well-built VariEze, we must insist that all VariEze flyers, as well as Long-EZ flyers with GU canards, should never exceed 3.5 'G' in flight. If you do, particularly at heavier gross weights, you are possibly in danger of an in-flight structural failure! Do not take this lightly!

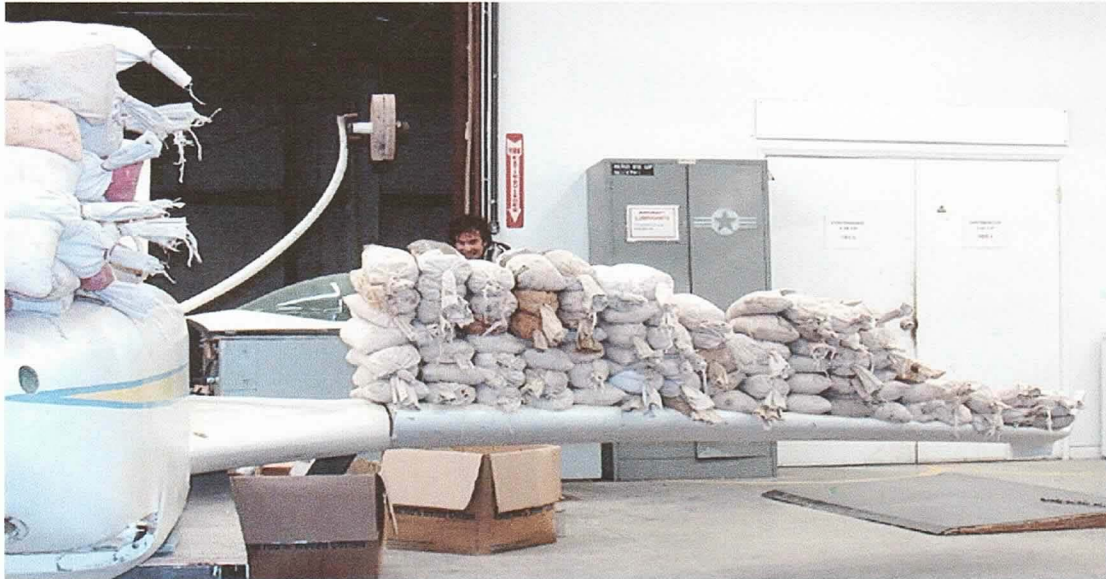
The left wing shown one instant before it failed catastrophically at 7 'Gs' Note the leading edge of the wing mismatched with the fuel strake as it fails!

The main wing was then carefully loaded, see photo. Because the normal failure of a VariEze wing would almost certainly be near the end of the wing spar box, around mid-span of the wing itself, we deliberately loaded this set of wings biased to the inboard to ensure a failure at or very near the wing fitting itself. In this we were successful. The failure occurred right at the wing attach fitting in the centersection spar. Just prior to this failure, the additional torsion that was applied, due to our desired load schedule, caused the centersection spar to tear away from the lower fuel tank skin, then the centersection spar box failed cleanly at the inboard edge of the wing fitting. The load factor at the moment of failure was 7 'G's. This failure also occurred at a lower load than expected. Some of this was due to our desire to fail the wing at the wing fitting. Some of it may be due to old age, and the hot/wet semi-marine environment in which it was stored. It is difficult to quantify exactly why the wings and the canard on this particular aircraft failed at a lower than expected 'G' load factor.

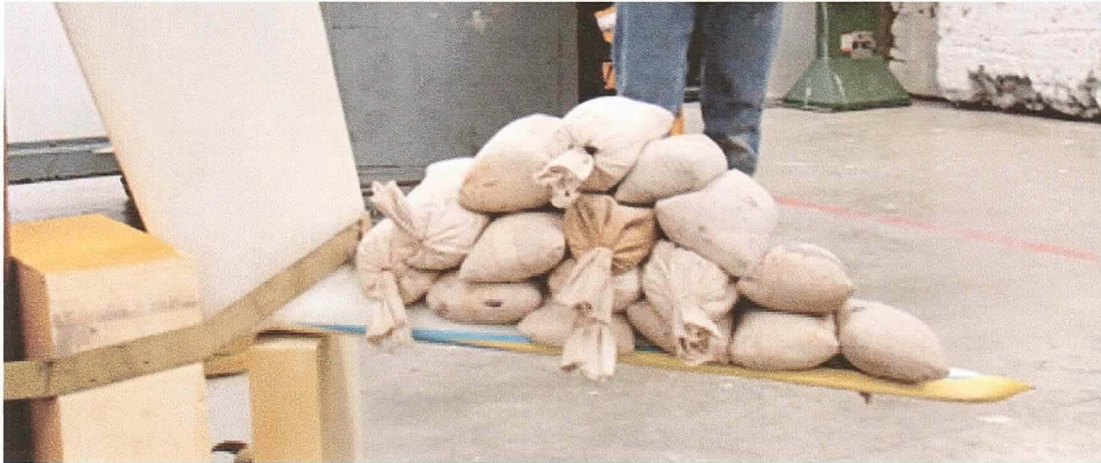
The wingtip is supported at the winglet root, and the shot-bags shown here represent design limit load. The winglet failed right at ultimate load.

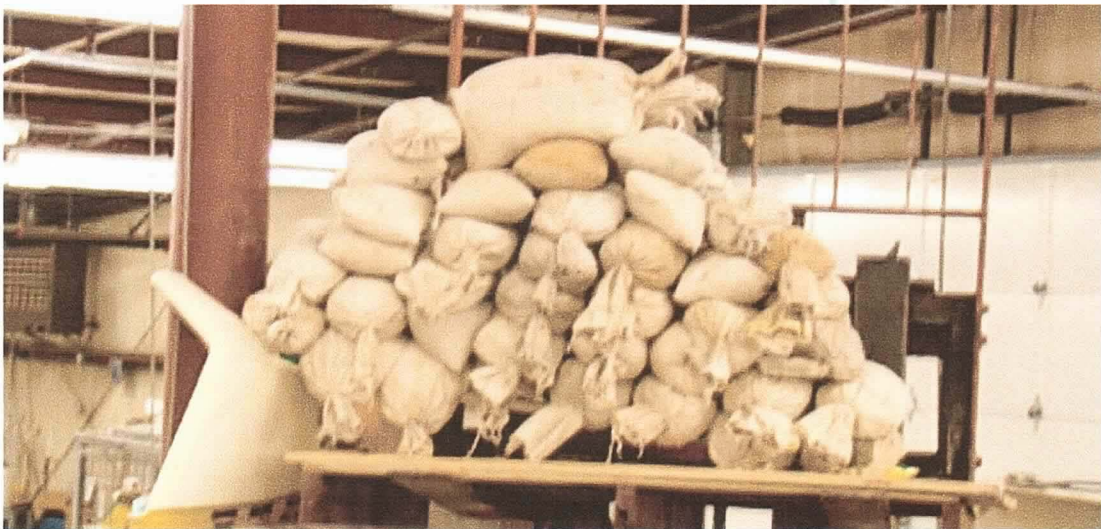
The steel support post & top of the wing can be seen. There are 42 shot-bags on the outboard side of the winglet, and a forklift with a pallet on its forks, is positioned just under, but not touching in case of a failure. It did NOT fail, although this load was more than two times the required strength!

The winglet tip-to-outboard test on the right wing resulted in a failure right at the prediction for such a failure. When we tested the left wing, we ultimately loaded 42 shot bags onto this winglet! This was all that it was possible to physically fit on to the winglet, however, we heard no noise, and could not fail this wing/winglet joint. Indeed, it way exceeded our expectations! Does this mean that age may not play much of a part? If so, maybe workmanship perhaps plays a much larger part?
