A Report from MATCO Mfg.

INSPECTION REPORT

Part Number: WHLD6 Brake Disc

Aircraft: Velocity

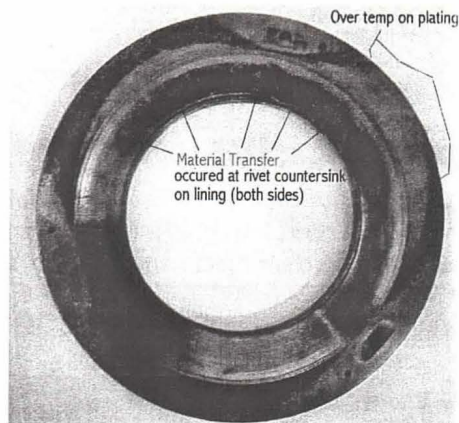
The blemishes did not appear to be disc material. An attempt was made to remove the blemishes and proved quite easy with a sharp edged knife. The blemish material was brittle and tended to come off in flakes. There was very slight deformation of the disc material under the blemishes that were visible but not measurable in height.

The brake disc had been severely over heated. Temperature estimates required to blister the plating are 650-700 F. The blemishes on the disc were wear material that had bonded to the disc. The wear material collects in the rivet holes during operation. The severe overheating of the brake caused the wear material trapped there to bond to the disc when the aircraft was parked. The linings on both sides of the disc exhibited these phenomena and caused the blemish pattern to be the same on both sides of the disc. After the aircraft cooled and was later moved, the wear material 'buttons' that had fused to the disc were snapped off. With the linings in a conditioned state, the fused material was not scraped off on subsequent passes with the lining but instead formed a hard barrier that caused the lining to 'skate' over the deposits. Additional wear debris was infused into the blemishes making them appear very smooth edged. The blistering of the disc edge occurred in the arc segment where the caliper stopped on the disc. This would be the hottest portion of the disc. A more severe overheat would cause blistering around the entire surface.

The following photo shows one of the discs with the material transfer areas highlighted. Both sides of the disc exhibited transfer in the same areas. The blistered area of the plating on the disc OD is also highlighted.

Second, the material deposits on the surface of the disc may cause some torque oscillation from the brake. The impact to the gear stability will vary with aircraft but a torsionally sensitive gear may suffer some loss of stability for the oscillation. The deposits can be easily removed with a metal edge and should be so removed if found. Both sides of the disc should be cleaned. Care should be taken so as not to gouge the sur-

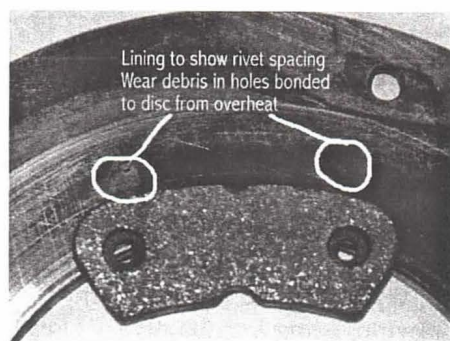
The next photo (below) shows the material transfer areas with a lin-

ing to clarify the spacing. In operation, the counter sunk area of the lining that is visible in the photo would be against the disc surface and serves as the collecting point for the debris.

The ramifications of this over heat condition are several. First, the linings can be overstressed at the rivet holes as the bonded material is sheared off on the initial rotation after the material transfer occurs. If the material transfer is evidenced on

the disc, the linings should be inspected for cracking at the rivet holes. It has been reported by other brake manufacturers that in severe conditions, entire sections of the lining surface can be transferred from a severe overheat requiring immediate lining replacement.
