Mandatory Ground ELEVATORS

ELEVATOR Inspection continued

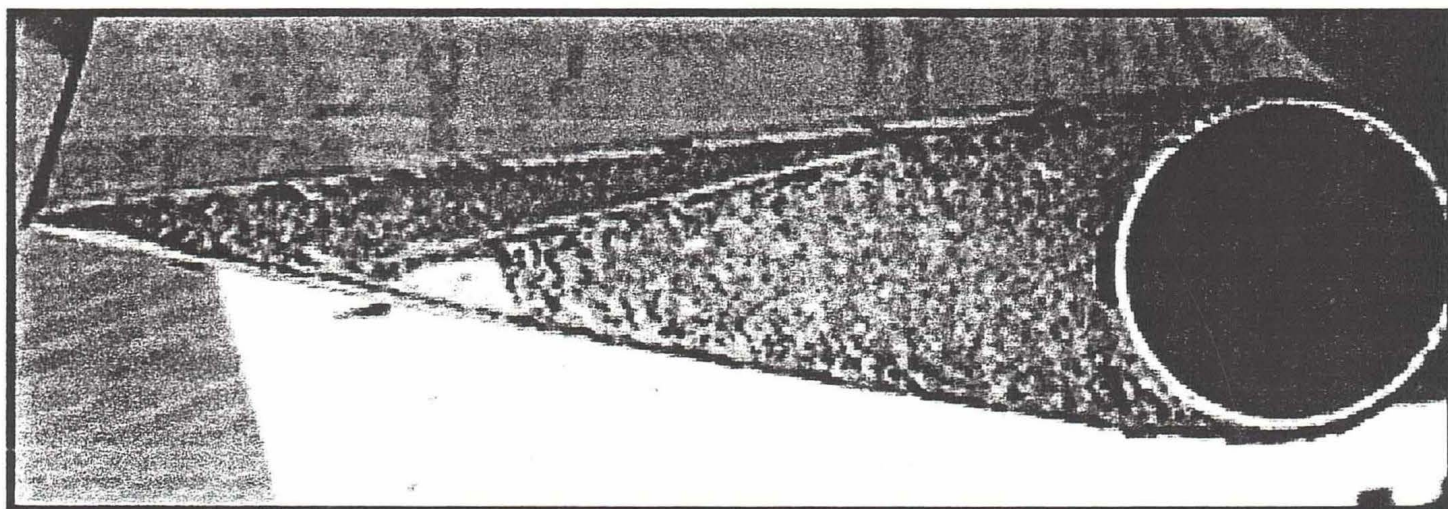
If you own an older Varieze, built with the original short chord elevator that has been modified to the "new" longer chord, in other words, an elevator within an elevator, (see photo).

Ground your aircraft; do not fly it again until you have fabricated new elevators with the correct shape, size and balance.
