Vari-Eze Spar Cap Failure

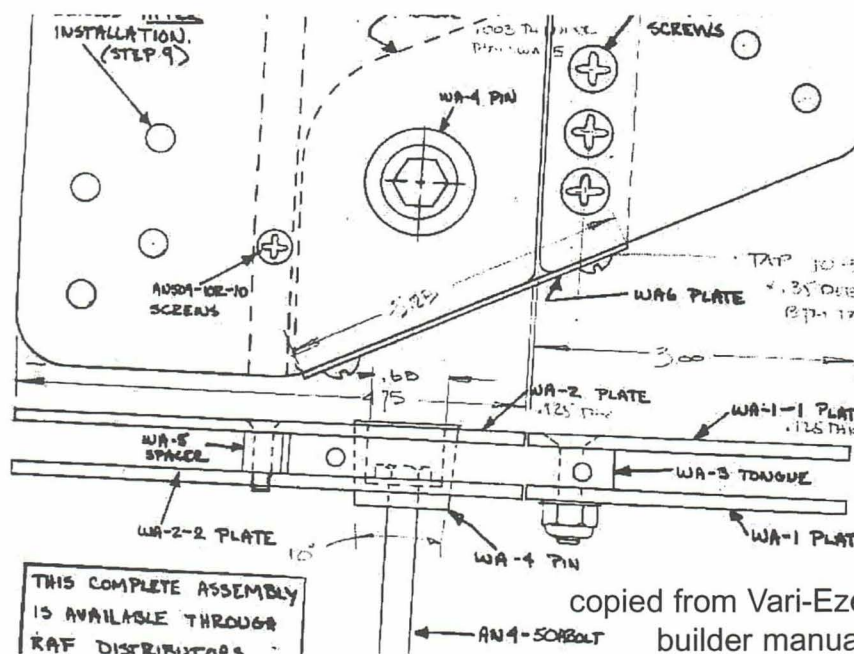
The bottom surface of WA-2 was severely corroded. About half the metal had been converted to a gray/white chalky material. The spar cap had failed exactly on the inboard edge of WA-2 plate. The shear web had failed along the top front and top rear edge of WA-2. The bottom surface of WA-2-2 plate was also badly corroded as were all

four faces of WA-5 spacer.

There was NOTHING holding the upper wing attach fitting to the center section spar, except a snug fit, and positive G.

My guess is that progressive movement and failure of the spar cap followed corrosion.

I had no external corrosion indication. Most corrosion was buried inside the structure. The failure of the upper center section spar cap was **TOTAL**.

MY PLEA TO ALL OF YOU IS PLEASE!! CHECK your wing fittings thoroughly before next flight.
