A Tale of Two Voltage Regulators

Solid-state automotive replacement units are cheaper, but not better.

by Dan Stogdill

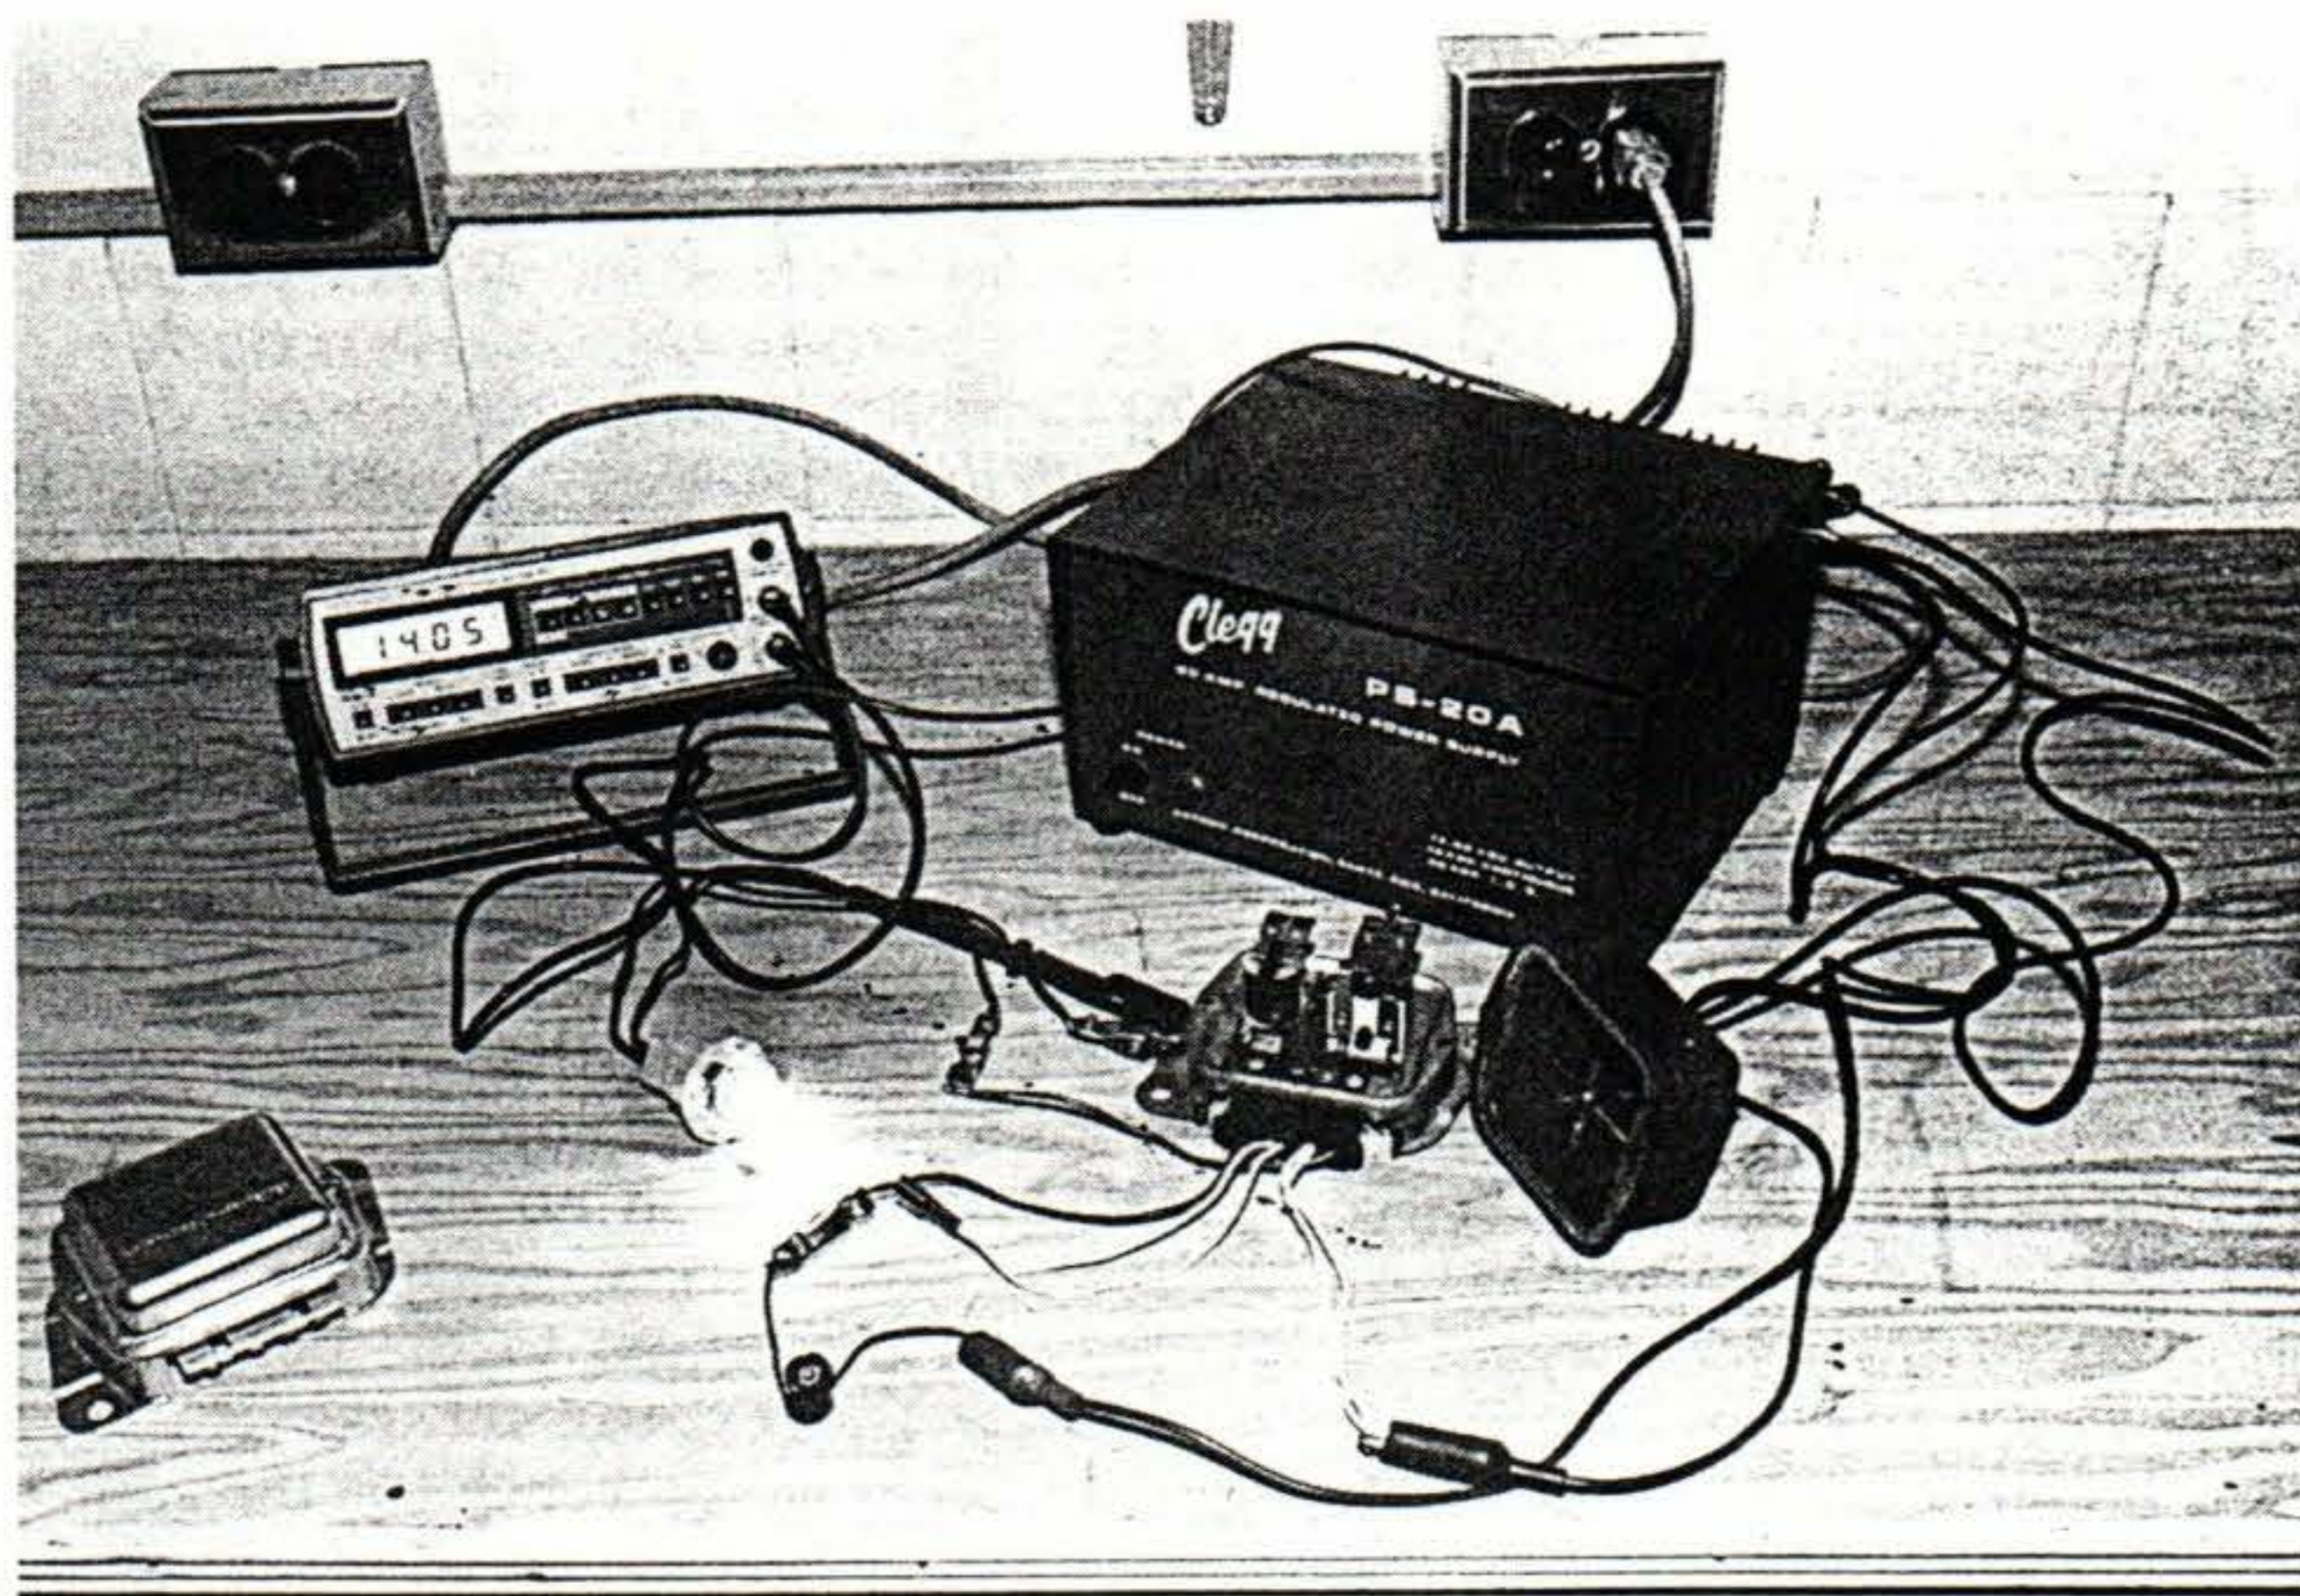
The author's bench-test setup included a Micronta meter and Clegg power supply. Automotive regulator can be seen at lower left.

When the solid-state automotive regulator was tested, it too functioned normally when both halves of the split master were closed; more importantly, field excitation disappeared at 14.4 volts. But when the ALT half of the master was opened, the 'F' terminal of the regulator remained hot: It continued to supply excitation, even though the illumination of the high-voltage lamp indicated (or seemed to) that the charging circuitry was not functioning. What's more, when the voltage was cranked up (to simulate increasing alternator output at higher engine rpms), this regulator continued to provide field excitation. At 17.9 volts, the 12-volt lamp I was using to monitor the field output glowed its last glow. Cranking the voltage back down and removing the high-voltage indicator eliminated the backfeed (as it did on the aircraft) and caused the 'F' terminal's output to drop to zero, as it should with the ALT half of the master open.

To ensure that I didn't have one "flaky" regulator that was not representative of the whole batch, two more identical solid-state automotive regulators were purchased from different outlets and tested. All three behaved similarly. The units in question (in case you're wondering) carry no name, although their packaging indicates offshore manufacture. They are approximately half the height of the older electromechanical and Cessna regulators and are a shiny

Is there a moral in all this? I think so. If your aircraft has a Cessna-type charging system with an over-voltage light on the panel, be very careful if you decide to try a non-approved voltage regulator. At idle rpm, if the high-voltage light comes on *and* the ammeter shows a charge with the ALT half of the master-switch rocker open, you're in trouble. Shut both halves of the master off immediately and investigate further as soon as possible. *Don't* just turn the ALT switch back on and promise yourself

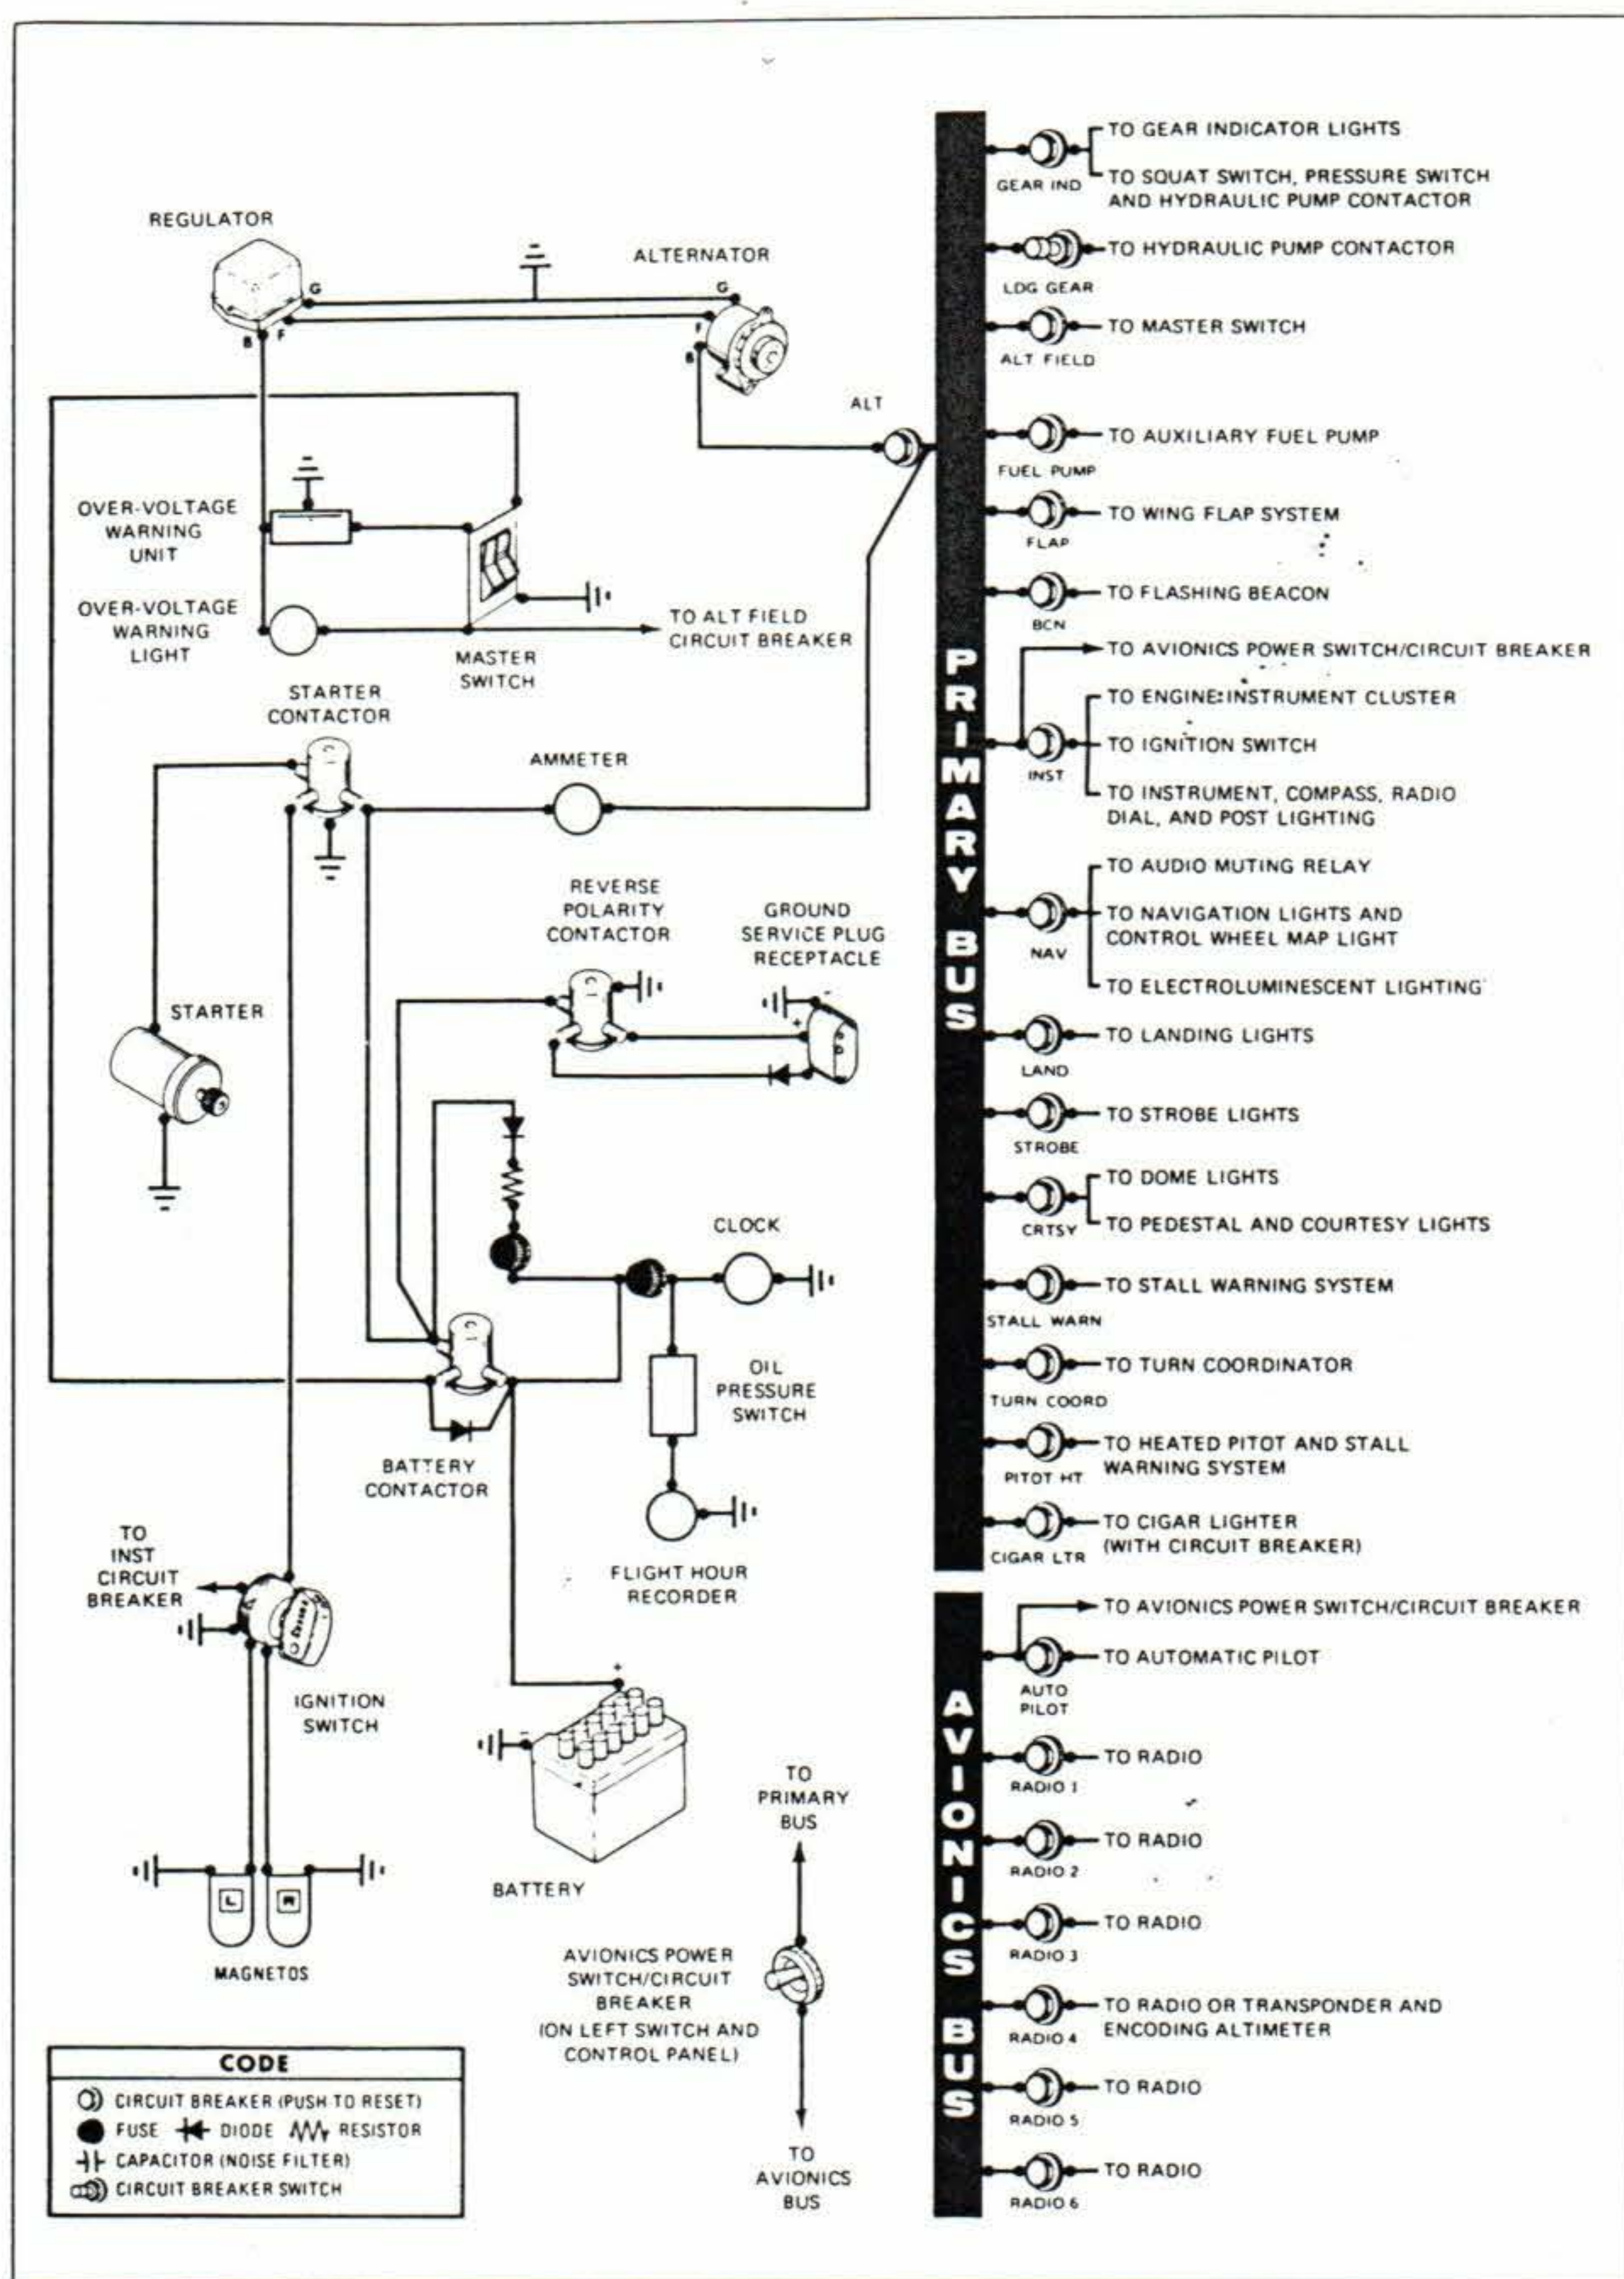
If everything were working according to Hoyle, these last two symptoms should not exist simultaneously. (See accompanying diagram.) The electrical system is set up in such a manner that if the ALT half of the split master is open, or the over-voltage sensor trips (i.e., opens), the +12 volts is removed from the 'S' terminal

of the voltage regulator and the regulator's field relay drops out, causing the 'F' terminal to go cold, cutting the alternator's output to zero. At the same time, the regulator's 'I' terminal goes to ground potential, completing the high-voltage indicator circuit.

I studied the charging system schematic again. It indicated an alternate path for the +12 volts to the regulator with the ALT half of the master open; namely, through the *high-voltage indicator*. When this lamp was disconnected, normal operation of the regulator was restored. With the ALT half of the switch closed, charging rates were normal; with the ALT switch open, the ammeter no longer showed a charge and the 'F' terminal read zero volts when checked with the voltmeter. In addition, system voltage as measured at the bus indicated 13.6

Cessna electrical systems differ in subtle ways from model to model, but the above schematic (from the 1978 Cardinal RG) replicates the author's setup.

VDC (i.e., battery voltage). There was obviously some type of backfeed through the high-voltage lamp which allowed the regulator to excite the alternator field even with the ALT portion of the master switch open.
