# Anatomy of a Lightning Strike

## And then everything went quiet.....

Paul McAllister  
September 2004

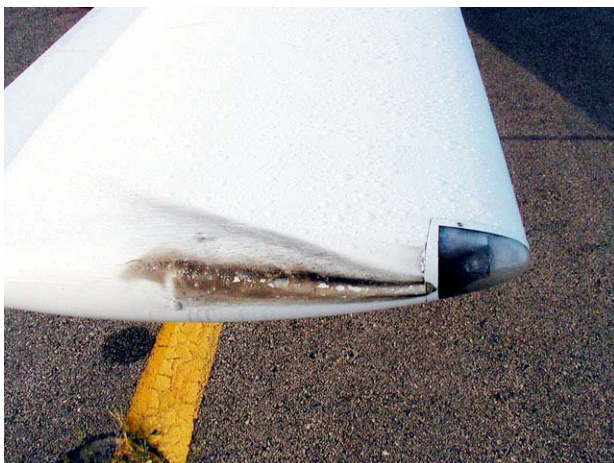
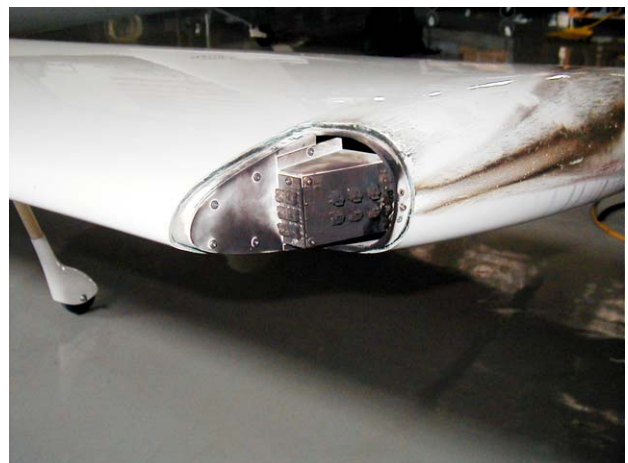
The panel went blank, and apart from the engine running things were quite. I looked out at both wings and saw long black training streaks on the tips. My first reaction was to check my 4 axis of control to ensure the aircraft was still flyable, which it was. I then surveyed the exterior for any other signs of damage, and none was evident. My next concern was electric fuel pumps continuing to run. I have my aircraft wired up with an E-Bus setup as described by Bob Nuckolls in the AeroElectric Connection. In addition, one fuel pump is connected directly to the alternator so I turned on the E-Bus and GPS / Radio along with the transponder sprang into life but nothing much else. I press the "Nearest" function but the GPS seemed pretty confused so I dug out my hand held. As luck would have it I was only a few miles away from an airport and with over 8000' beneath me I knew I even with the engine out I was fine.

The next day I unpacked the aircraft and started to survey the damage. The first thing I looked for was welding of the control mechanisms and I couldn't see any evidence of this. I pulled off the tip lights and looked inside the wings and I could not see any internal damage, nor was any evident in the inspection ports. It appeared that the conduction path was only along the navigation lights wiring. Surprisingly the wires seemed intact.

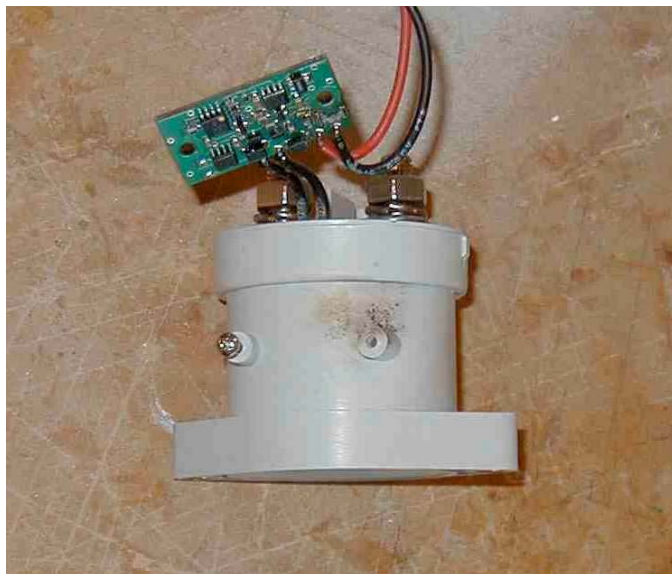
I have a fuel gauge system designed by Tony Krzyzewski. It has a zero to one inch pressure transducer at the lowest point in the tank and it sends via a microprocessor a signal to a panel display. I expected that the microprocessors had failed, however it turned out that one of the 4 RS232 drivers on the MAX232 had failed. Why one and not the others I don't know, but it sure made fault diagnosis difficult.

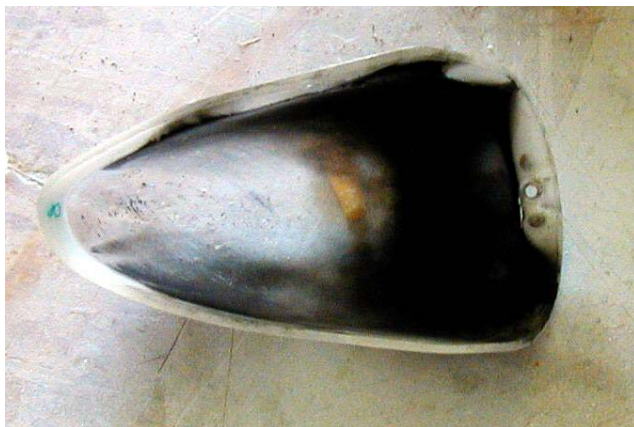
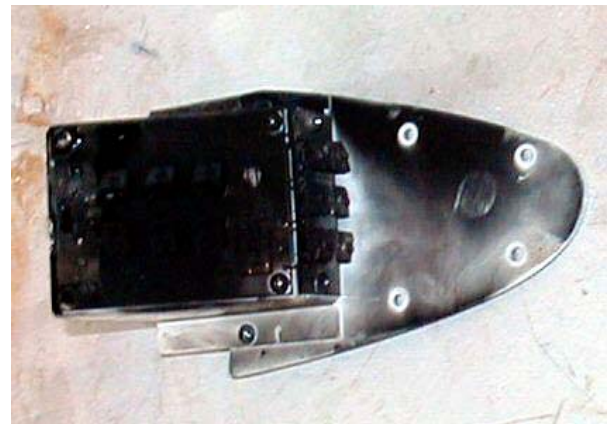
I won't get hit by lightning again. You can see in the photograph where the parts had vaporized and left burn marks on the casing.

Its hard to be sure, but it looks like the lightning entered the starboard wing and exited the port side. The strangest thing about this was that on the starboard side I had clear blue sky as far as I could see, and on the port side any evidence of storm activity was 20 miles away. At no time did I see any typical thunder clouds forming and the main storm front didn't pass through for three more hours. It had tracked through the wing tip wiring, though the panel and out the other side. I have a single potentiometer that both dims the lights and turns on a relay to turn on the nav lights. The lightning jumped the relay and though the dimmer board. From there it tracked in to the VOR light circuit and I think down the left / right signal into the Nav aids. The intercom is connected to the Nav aids to disable it when the PTT button is pressed, so I can only assume that how it got into the XCOM. As for the

The main contactor was beyond repair so I replaced it with a prototype solid state unit from Eric Jones of <http://www.periheliondesign.com/> It also will be susceptible to large voltage spikes, but I am hoping that
