### More Landing Gear Shake

### Crankshaft Seal Retainer

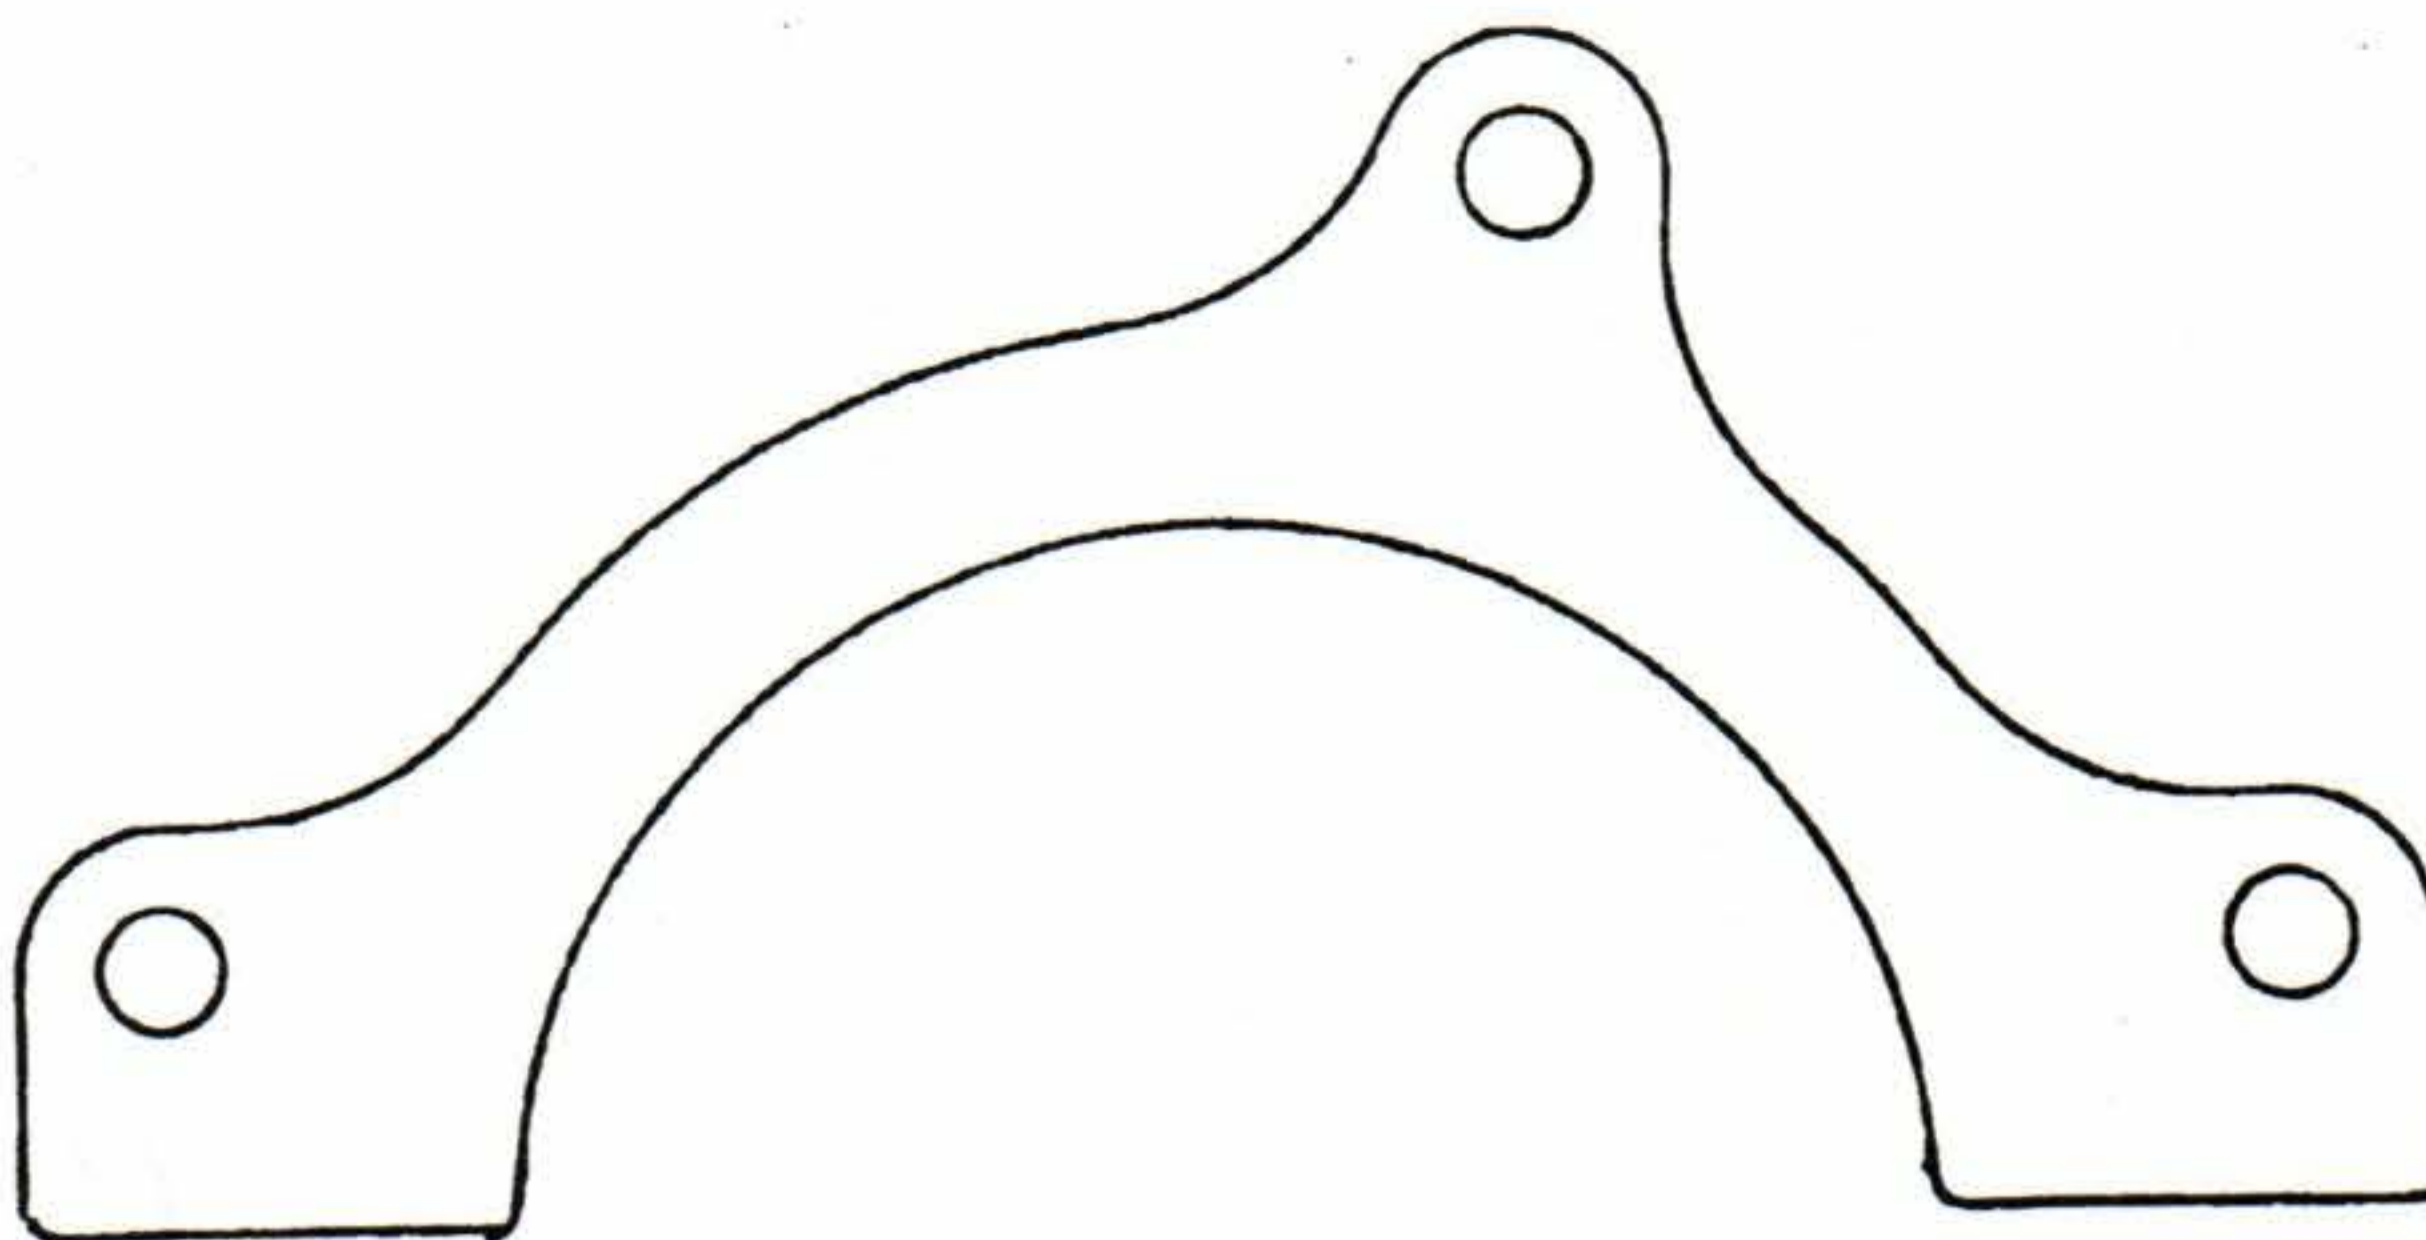
### Crankshaft Seal Retainer

✓ John Nicholson (Ont) - Here is a drawing for a crankshaft seal retainer which I made and installed. The pattern is from a Lycoming part. Two are required for a complete extension. I made them from 1/16" cold rolled steel but aluminum would probably be OK. They were cut out with a hacksaw and filed to contour. They didn't take long to make.

To drill and tap the crankcase, first remove the prop and extension and draw the large prop bolt bushing out of the crankshaft flange using a socket and short 3/8" bolt as a puller. Through this hole you can drill and tap a hole for a 1/4"-20 x 1/2" bolt. Two people are required for this. One will drill and one will give drill alignment. With the airplane parked nose down it is almost impossible to line up the drill by yourself. Install the retainer plates with the 1/4"-20 x 1/2" bolts and lock washers.

*Editor note: If you drill and tap a 1/2" deep hole you'd better use a bottom tap or you may run out of threads before you get the bolt screwed in all the way.*

Reinstall the prop bushings, extension, and prop. You'll now have no more worries about losing your oil.

The installation takes about 2 hours if you have to drill and tap the crankcase, less if your case already has the holes drilled and tapped.
