Prop Extension Failures

While at OSH I heard of an alarming event. The new, O-360-A2A powered, E-Racer of Jimmie and Ferne Hays had an off field landing due to prop extension failure. The occupants escaped without injury but, as you can see in photo one, the E-Racer was severely damaged.

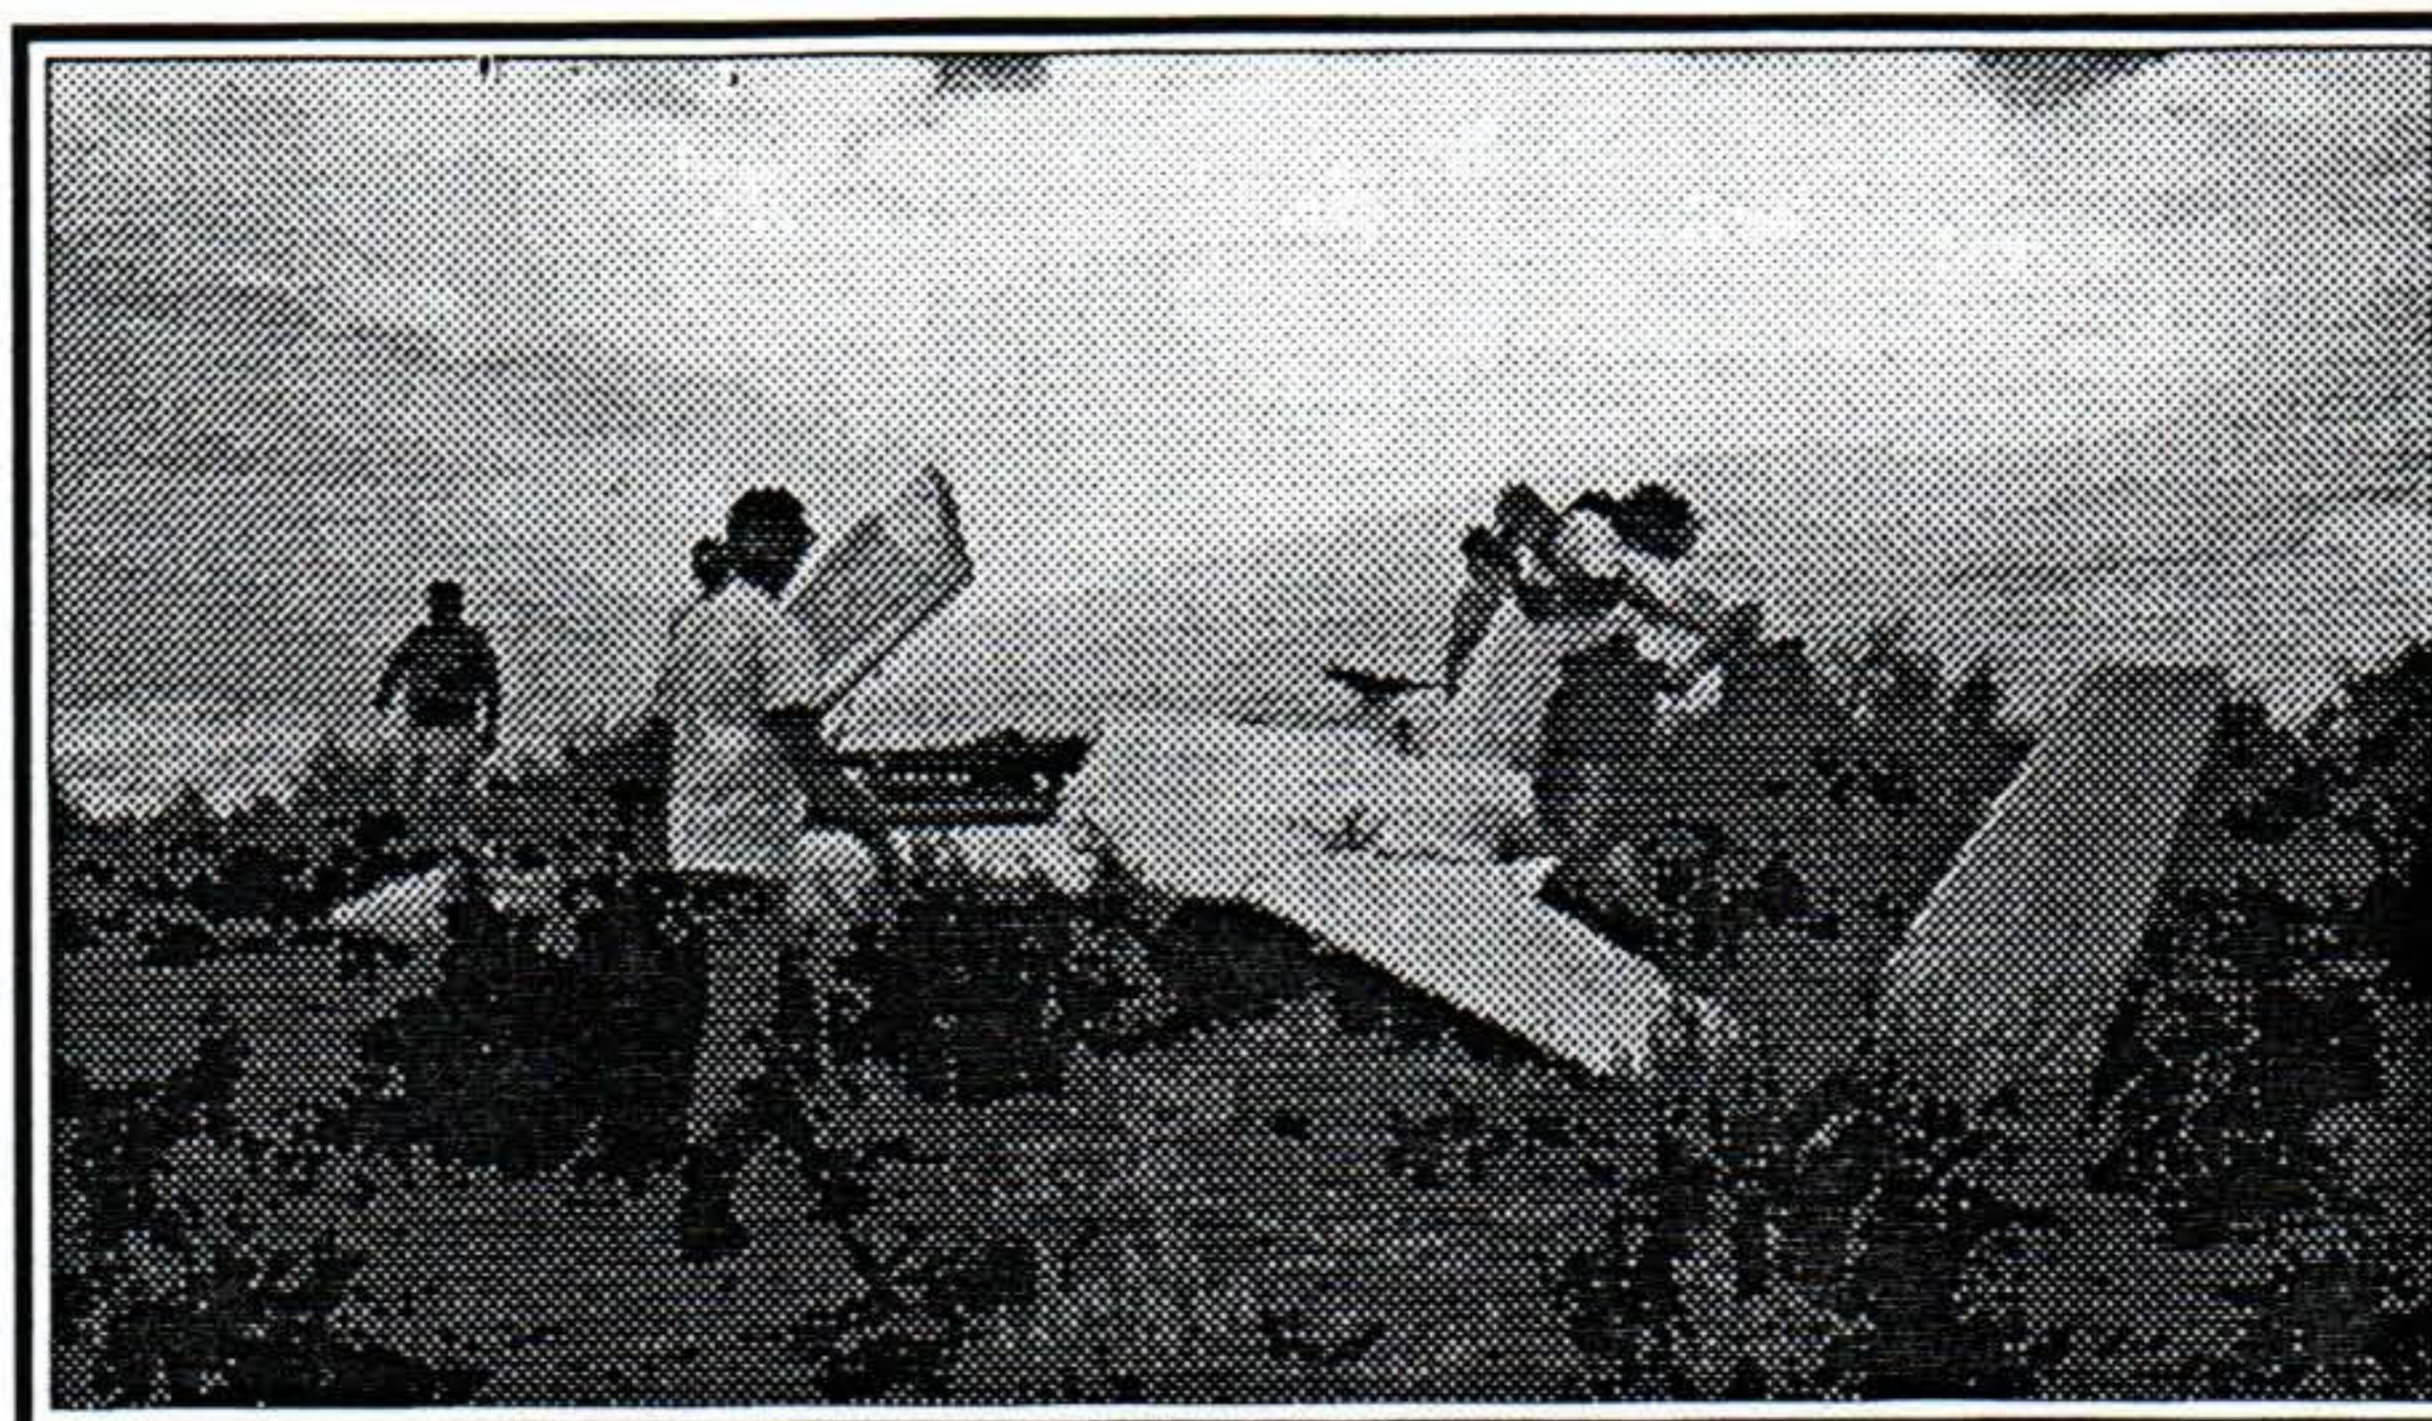
Thanks to Jimmie's skill they both walked away

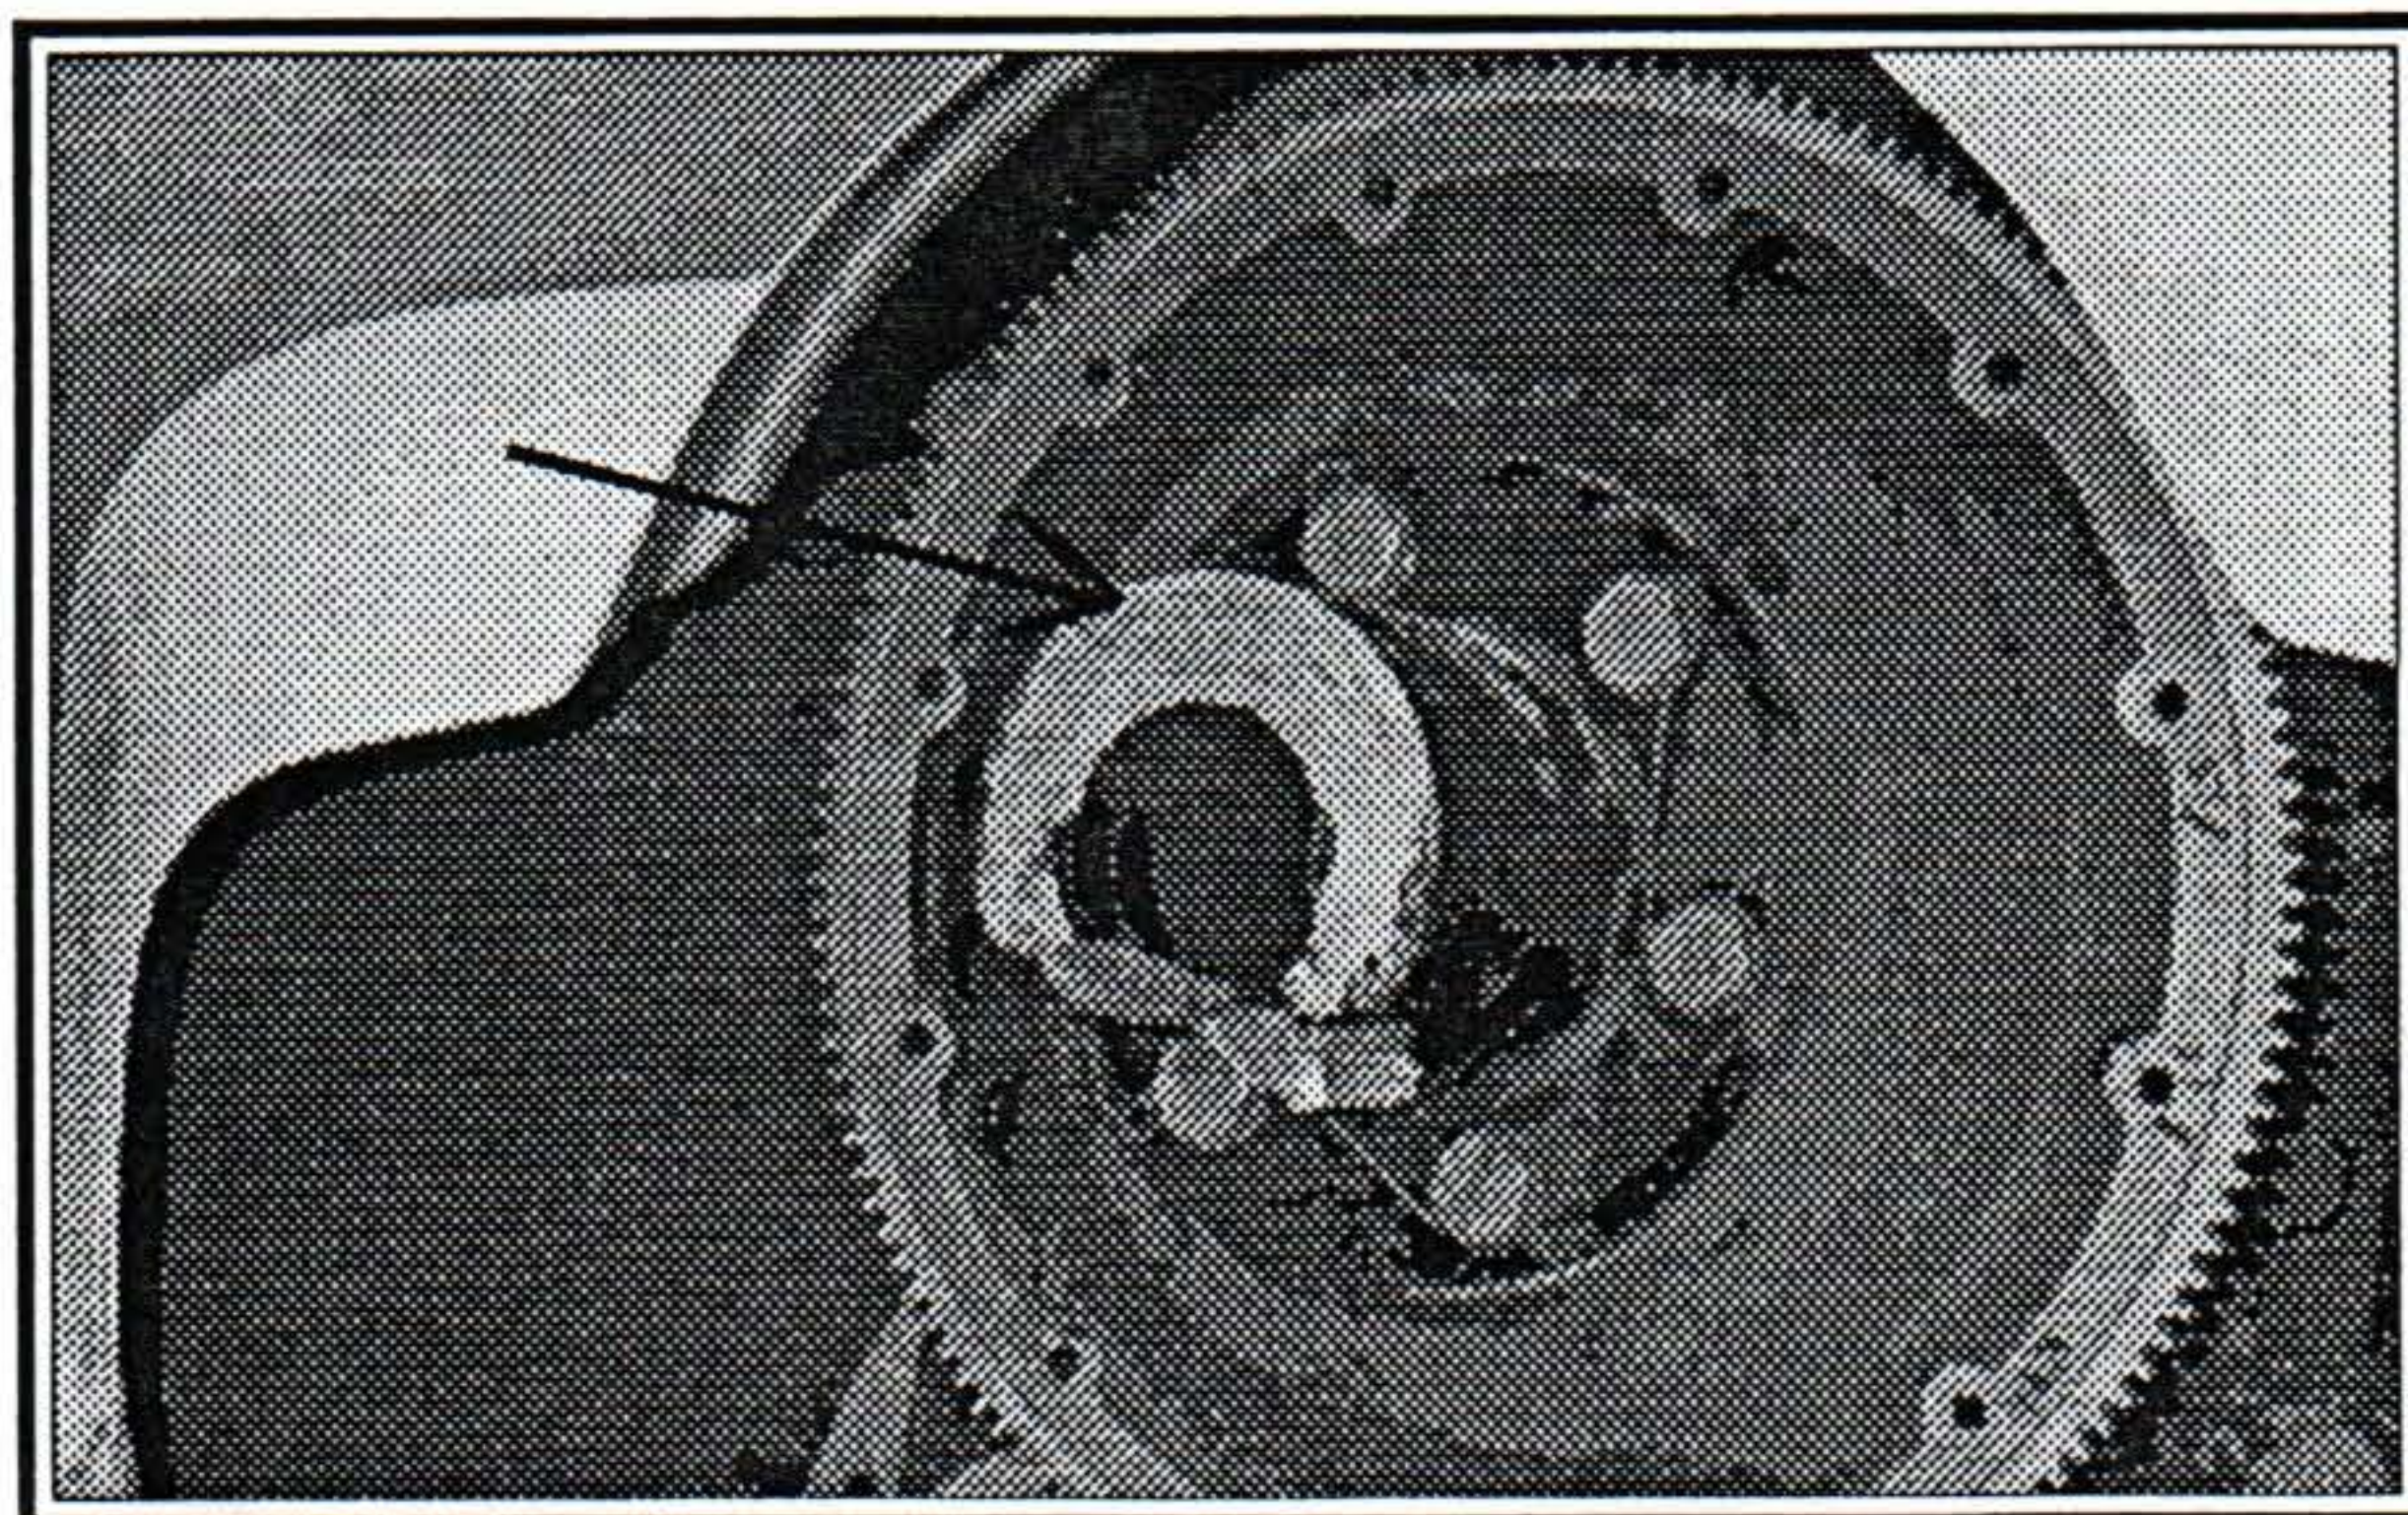
Examination of the second photo, at the top portion of the failed area, shows what looks like a peened surface. The lower separated area looks to have been ripped away.

A recent letter from Gary Hertzler indicated he had the company metalurgy department look at the failed Hays prop extension. They could find nothing in the way of defective material or abusive machining to have caused the failure. The part failed in what is known as high cycle fatigue up to a point where a large chunk was torn out. There was not enough left of the radius to determine if it was excessively small, but looking at the other end of the extension, and without being biased by the failure, the radius looks to be normal for the part.

that crankshaft flange runout could be a contributor to this failure. Lycoming permits a .005" runout on the prop flange. This dimension would be OK if there were no prop extension. With an extension, however, the magnitude of runout will be exaggerated depending upon the extension's length. This flange runout will cause additional prop runout which will increase the vibration and will add to the mean stress on the extension. When the cyclic loads are applied over the top of a possibly elevated mean stress, fatigue crack initiation and propagation may occur.

Nat Puffer called (9-13-94) and told how he and Mike Melvill had independently reached the same conclusion on the Hayes prop extension failure. The Brock 6" extension, when mounted on an O-360, has a resonant frequency of 2750 RPM. Apparently Jimmie ran in the resonant range of the Brock extension possibly causing the extension failure.

Remains of the failed extension shows a peened surface

1. Increase the fillet radius to be as large as possible without having to back spot face to the drive lug bushings.
2. Continue the bore which excepts the crankshaft prop pilot only as deep as necessary to axially clear, continuing the rest of the way with a smaller diameter bore. This will provide added wall thickness at the high stress points.

If you are using a 6" or longer prop extension, especially on the O-360 engine, please check for cracks in the radius area. Gary Hertzler has suggested that we **all** (regardless of engine size) examine our prop exten-
