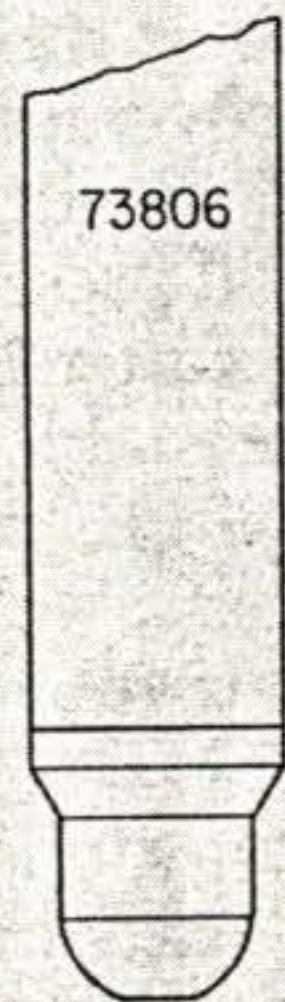
DO NOT USE

Note that pushrods simply marked "73806" are no longer considered airworthy (Lycoming S.B. 453B). The proper markings are "73806-85," "73806#," "73806K," or "T-T 73806."

It may not be a bad idea to remove all of your pushrods and measure their lengths. (Caution: Label each one carefully on removal, so you can later be sure to put it back in the same location.) If any pushrod is less than 11.531 inches long, it shouldn't be. (See Lycoming Service Instruction No. 1388C.) Also, if any pushrod ever *shrinks* more than .015-in. in 100 hours of operation, you should remove that pushrod and inspect it for wear (length), straightness, and looseness of the ball end. (Again, see S.I. 1388C.) Obviously, any pushrod that has a loose ball end or shows signs of mushrooming or splitting should be trash-canned immediately. (Give it a good blow with a hammer before throwing it out, to make sure nobody digs it out of the trash later and reuses it.)

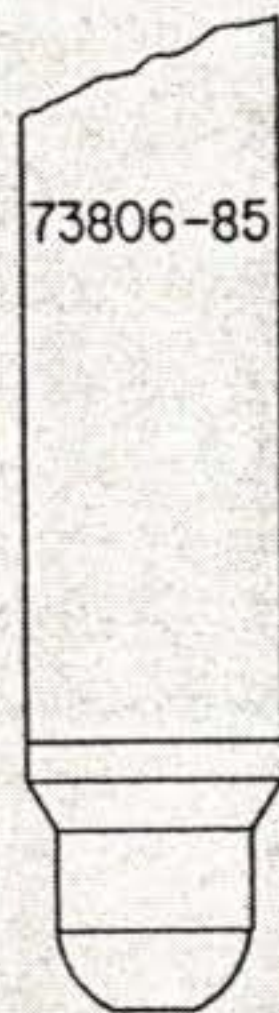
REINSPECTED
AND APPROVED

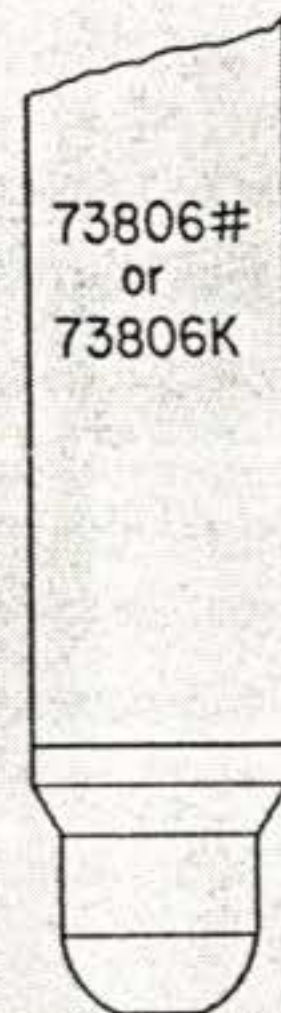
APPROVED

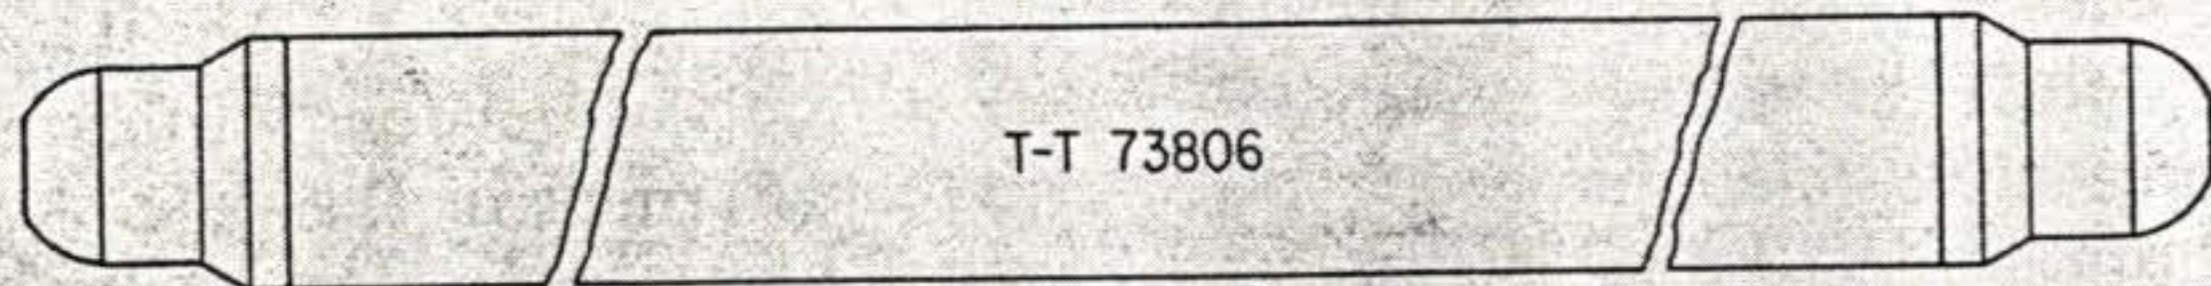
APPROVED

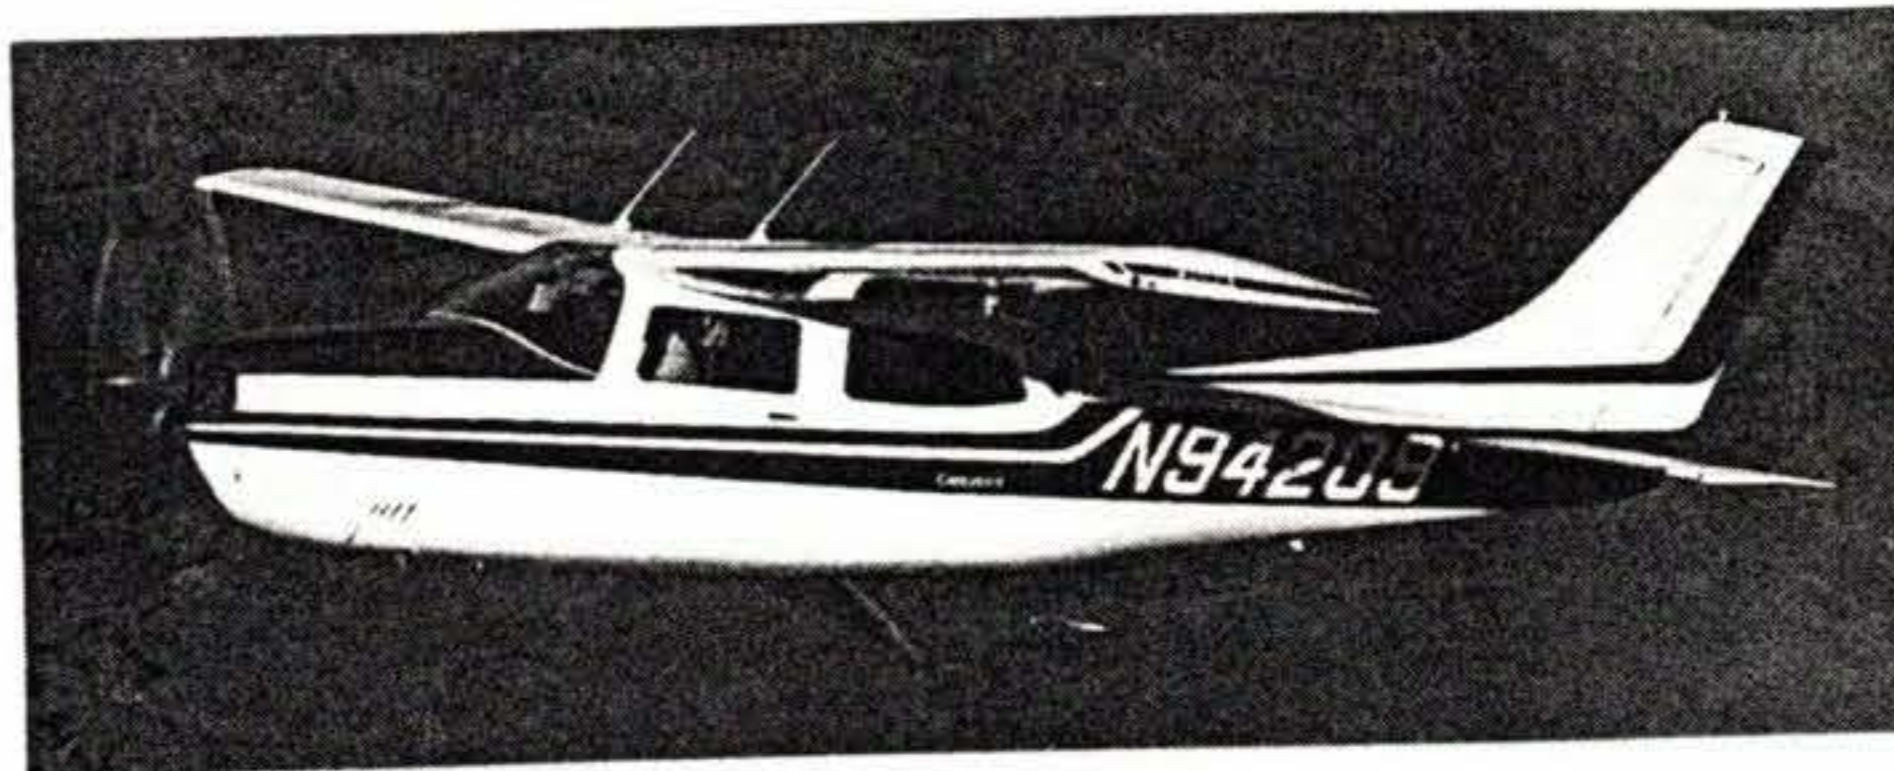
T210 owner found piston pin bushing disintegration in his low-time factory reman. But is it just a fluke—or indicative of greater problems with the engine?

Normally we'd tell you to take the other five cylinders off, and/or overhaul the engine. But frankly, given the age of the engine (150 hours SFRM), we think it's Continental's problem, and they should be happy to take the engine back. If you are outside the normal six-month full-coverage period of your warranty, they may well want to clip you for pro-rata costs on the replacement engine; that's standard policy. (Even so, they should offer you

some labor allowance.) We feel the chances of a fair settlement with Continental are good. You certainly ought to press for a replacement engine, since it would be foolish for TCM—from a liability standpoint, if nothing else—not to want the defective engine back.
