Overhauling the S-1200 Magneto

by Fred Mackerodt

Light Plane Maintenance

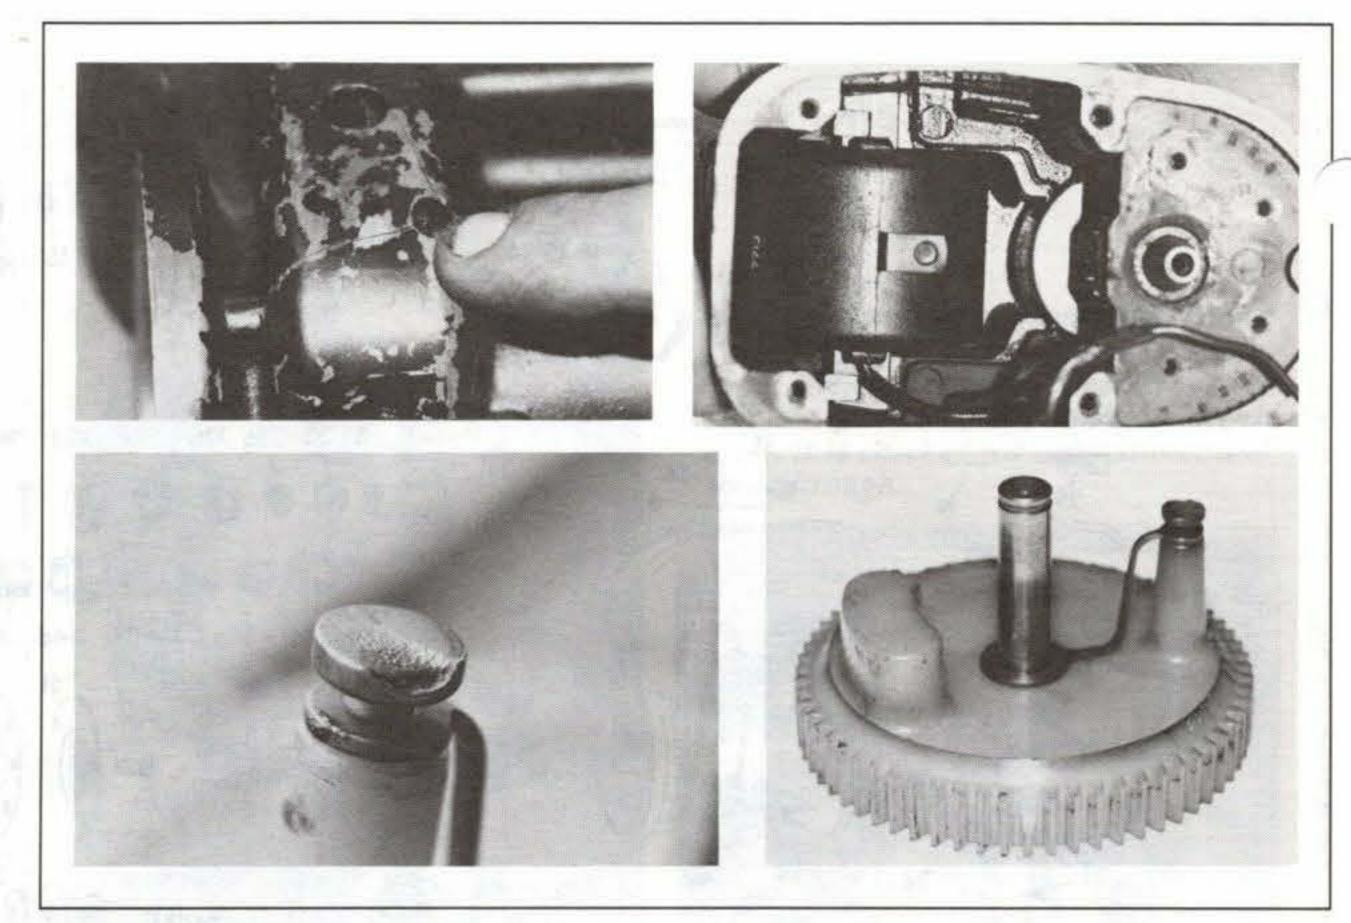
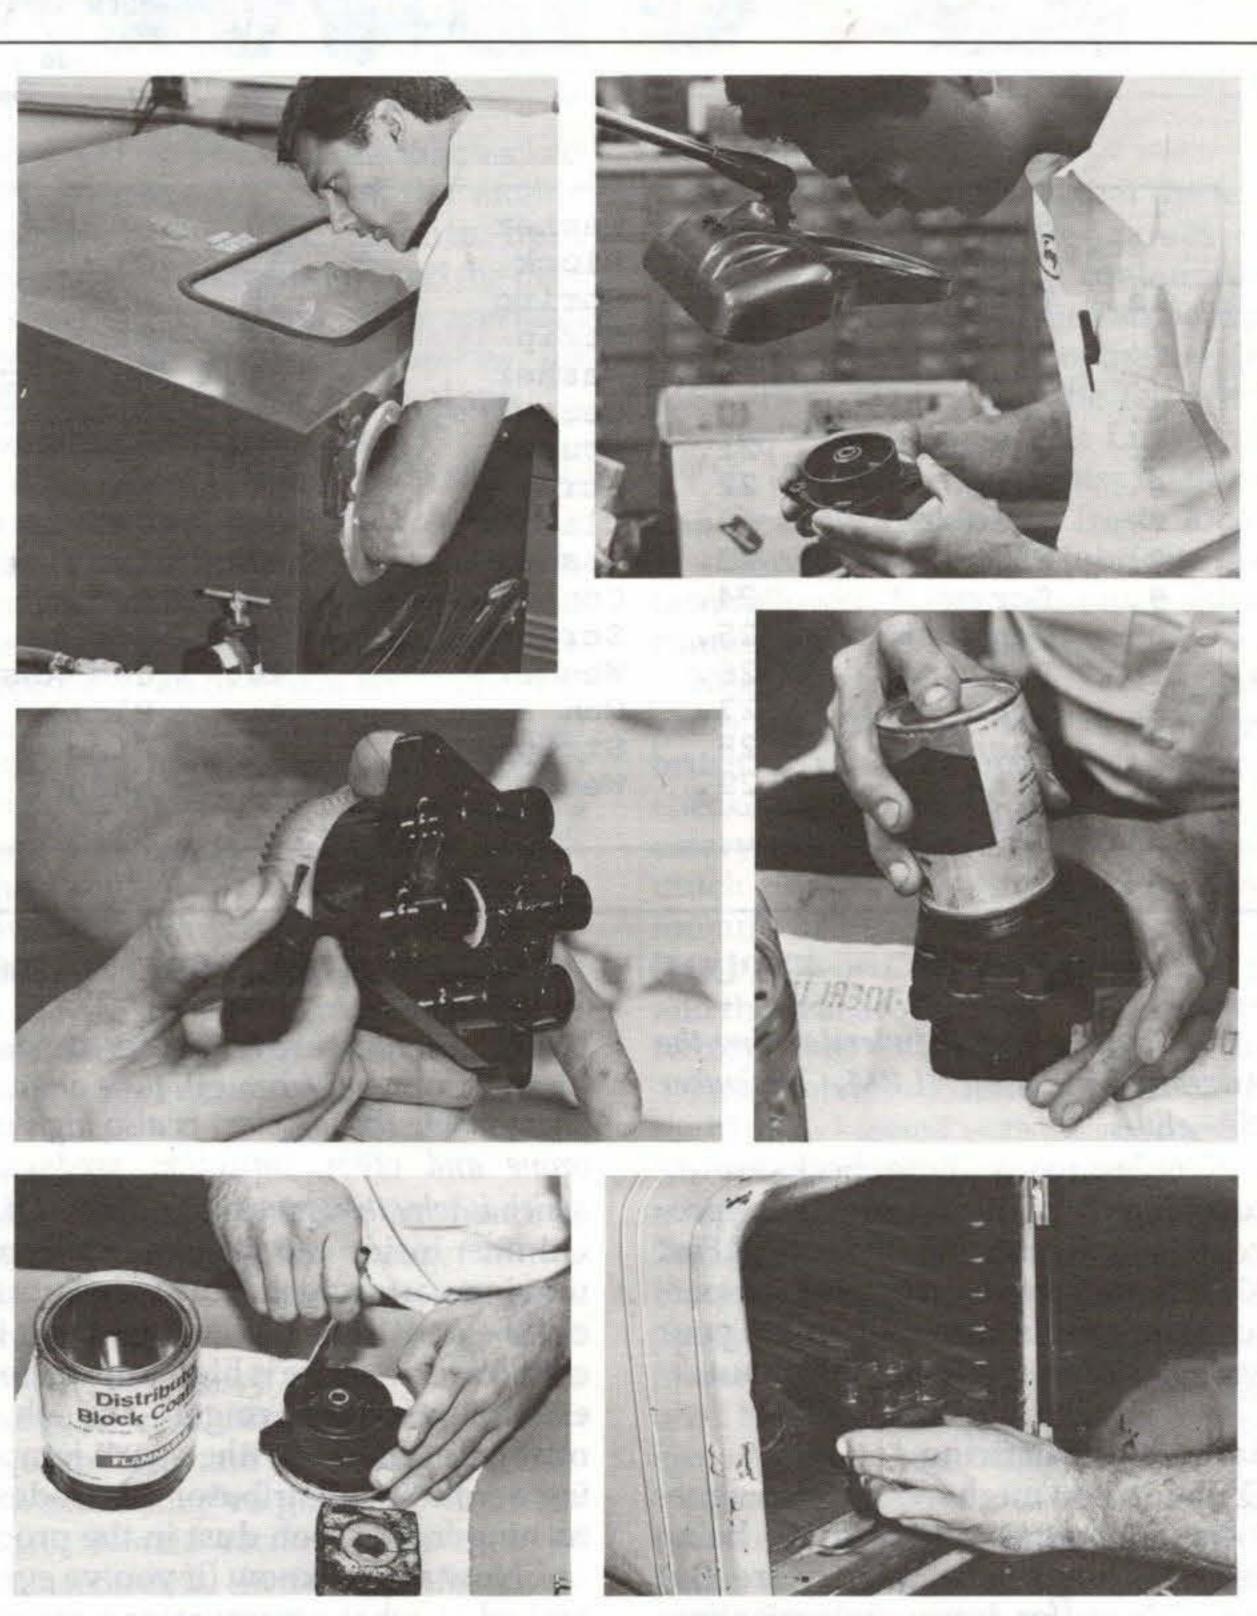
Clockwise from top left: Housing cracks are a rarity in most mags, but the Bendix S-1200 series is prone to cracks of the castmagnesium housing, as shown here. Distributor end removed, it's obvious this mag has accumulated considerable oil and carbon dust inside. (A 500-hour housecleaning is needed if for no other reason than to keep this sort of contamination under control.) If you look carefully at six o'clock on the distributor gear, you can see that a tooth is gone; this was probably caused when a mechanic used a timing lock to install the mag. In the final picture, severe erosion of the distributor finger is evident. The erosion was caused by the distributor gear being installed one tooth off.

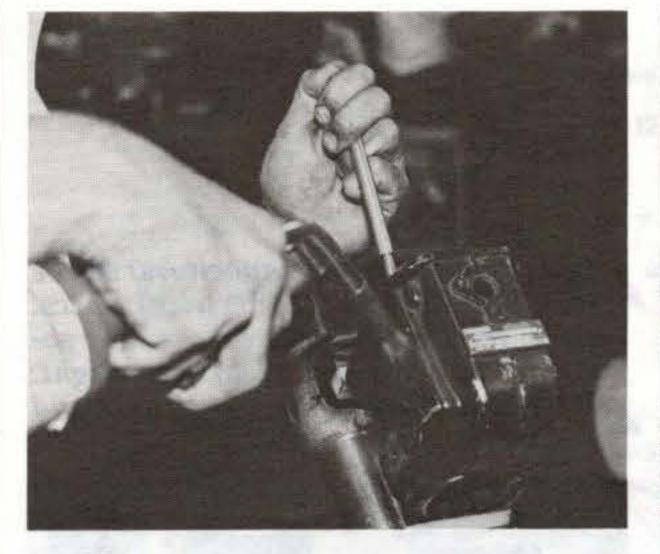
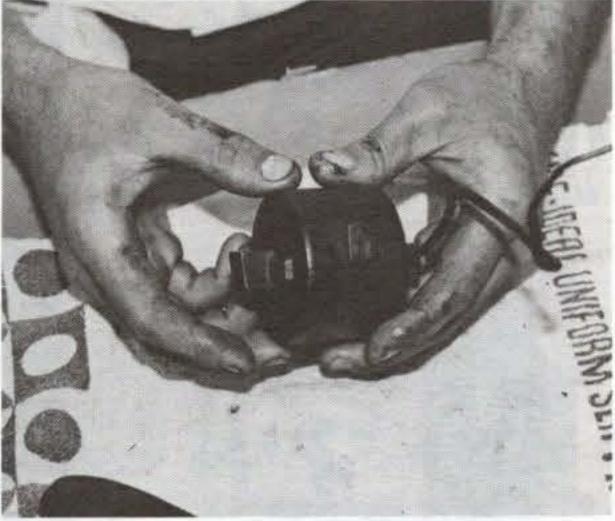
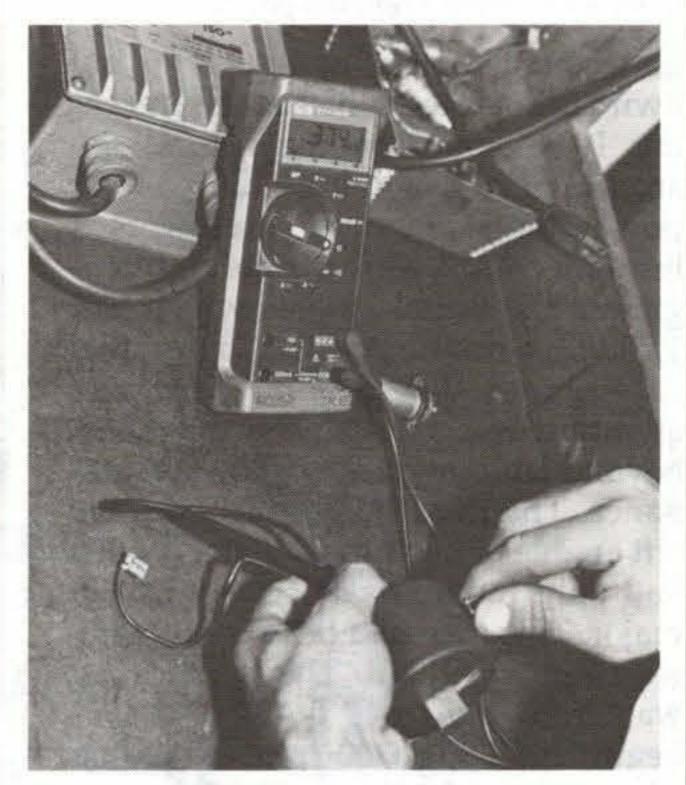
Clockwise from top left: Terry Norris subjects a distributor block to plastic-media blast-cleaning. Care must be taken not to damage the block (newer brown-colored blocks cannot be blast-cleaned). After cleaning, the block is checked carefully for cracks. Then one end is corked and the center cavity filled with special distributor-block lube, and the unit baked in an oven to get the oil to soak into the oilite bushing. Finally, the block gets a coat of special distrbutor sealant (which will insulate the block and cause moisture to bead up rather than wet the surface). If it needs it, the distributor gear timing marks are then repainted on.

After solvent cleaning, the distributor block is blasted with plastic media, carefully controlling the pressure so as not to allow the block to be damaged. This is done to completely clean the block so as to reveal even the smallest crack. (Norris cautions others not to attempt to clean the new brown-colored blocks under pressure, as it will erode them.) After this, the block is washed again in solvent and carefully examined under a 10X magnifying glass, after which it gets placed in an oven (briefly) to evaporate off any

Since cleaning removes all lubricant from the oilite bushing in the center of the block, it's necessary to relube this portion. The bottom end of the block is simply sealed with a small cork while Bendix/TCM Distributor Block Lubricant (P/N 10-391200) is carefully poured into the top to fill the cavity; then the distributor block is placed back in the oven and baked at 190 to 210 degrees Fahrenheit for two hours (which helps the lubricant flow into the pores of the oilite bushing).

With the lubrication done, the block is then coated with a special Bendix/TCM Distributor Block Coating (P/N 10-391400) and allowed to air-dry. This shiny coating makes any water that contacts the surface "bead up" as on a freshly waxed car. It prevents the water from sheeting and the spark from following that continuous sheet of liquid to a point where it's not supposed to be. The key to lubing and coating the block is to make sure the oilite bushing oil doesn't get on the block, and the block coating doesn't get on the oilite bushing.

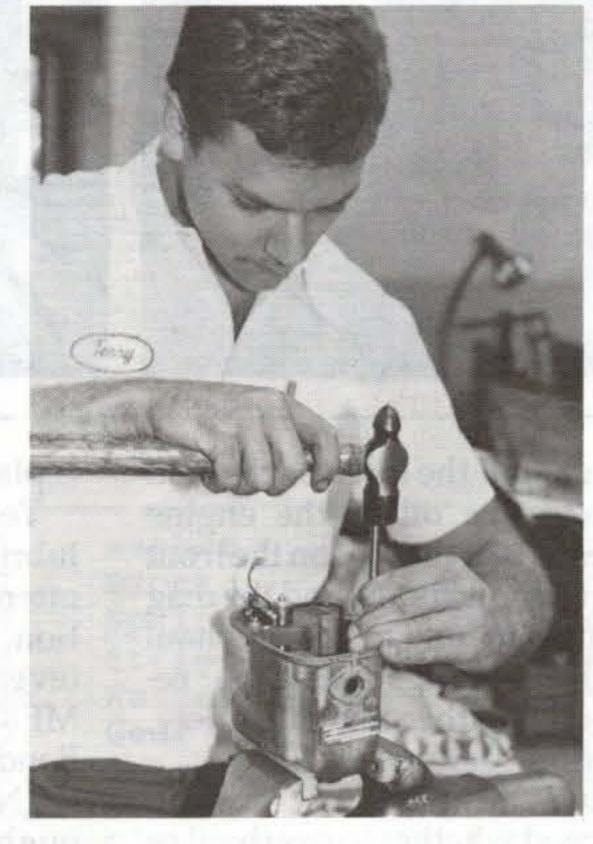
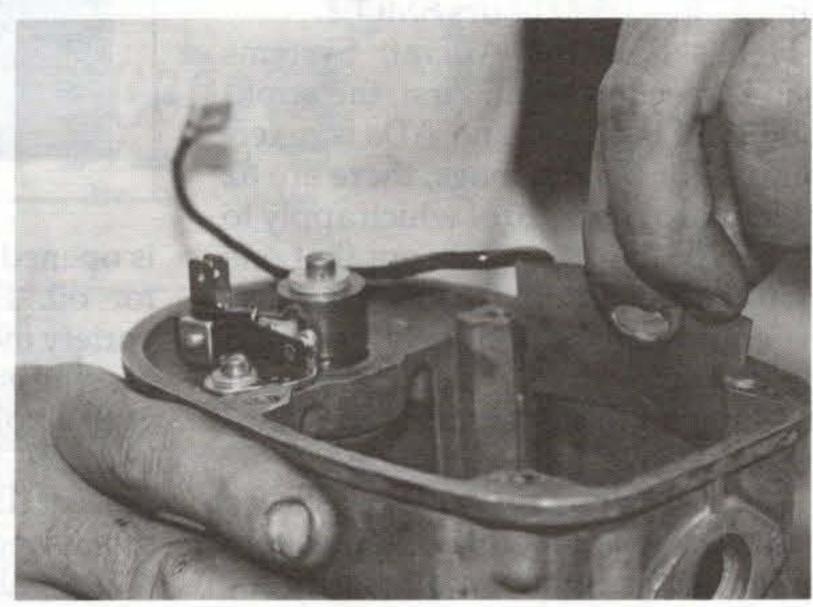
Clockwise from top left: In the S-1200, the coil is held in place by wedges. To remove the coil without damaging it or the magnesium housing, heat (from a torch) is applied very judiciously to expand the housing so the coil can be popped out. Once out, the coil gets a careful visual inspection for damage to the wires and/or cracking of the potting compound. Then checks are made of the primary and secondary coil resistances. (The primary and secondary coils are potted as a unit. So even though we speak of "a coil," we're really talking about two coils.) Fish paper is used to keep coil wires from chafing; and a hammer and drift are used to wedge the coil back into place in its housing.

Next, the coil is removed (see photos for explanation) and it and the capacitor are checked electrically—the coil for primary and secondary resistances (1.0 to 1.5 ohms for primary; 17-23,000 ohms for secondary), and the capacitor for series resistance, leakage, and capacitance (0.30 to 0.45 mfd).

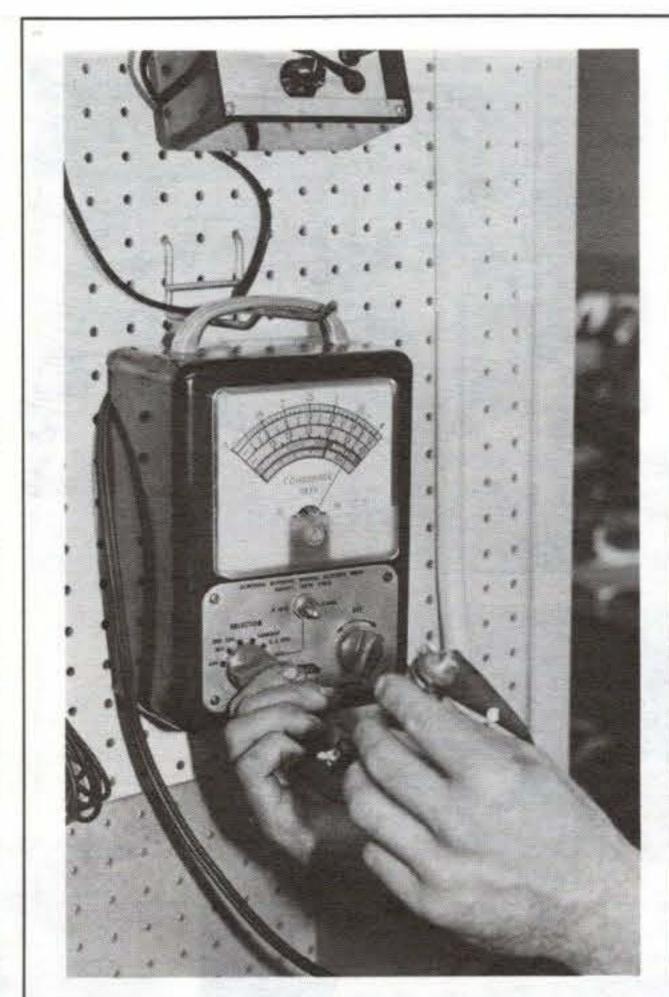
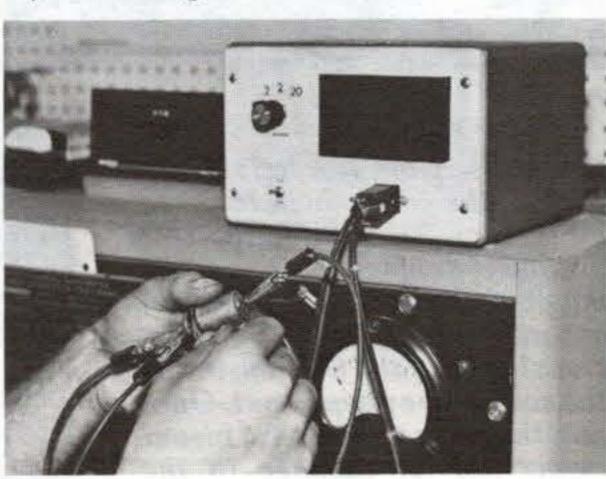
Left: Condensors (or capacitors) can be reused if they meet electrical specs. Here, the condensor is checked for series resistance and leakage. Right: Here, it is checked for capacitance and feed-through.

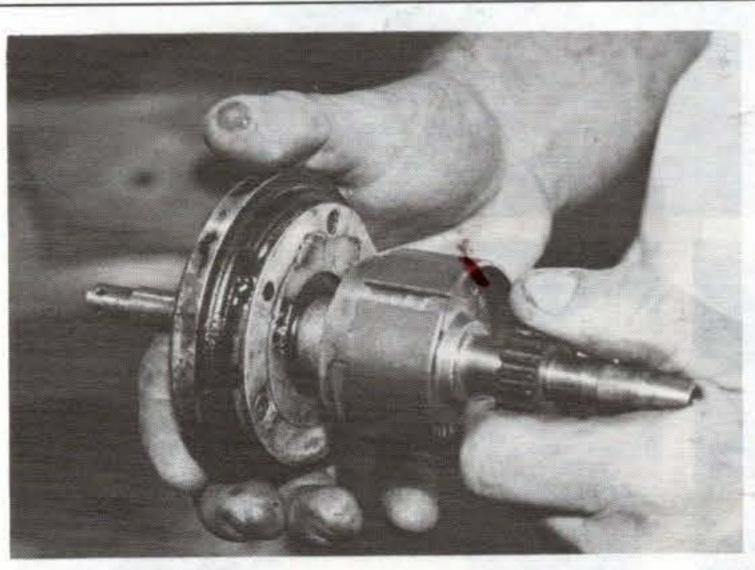
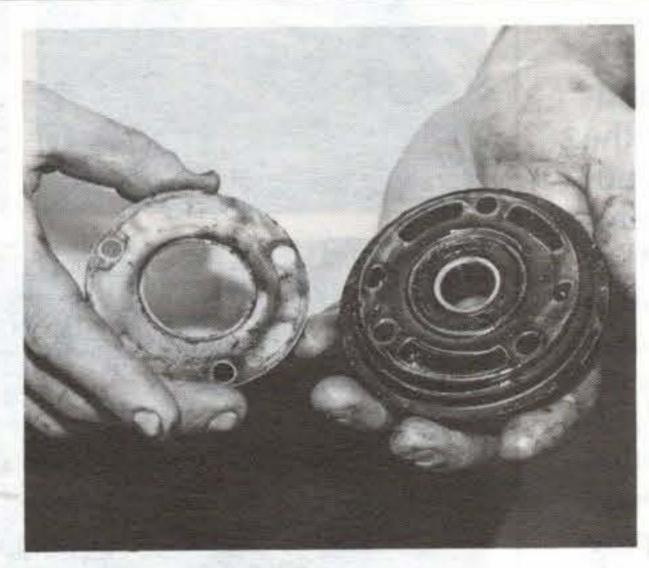
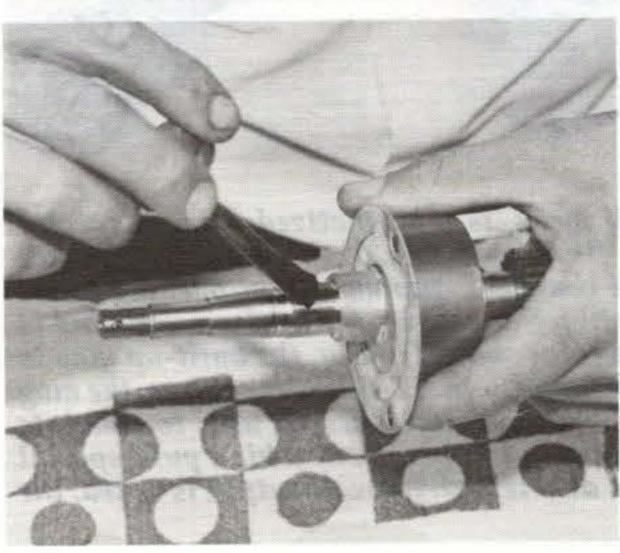
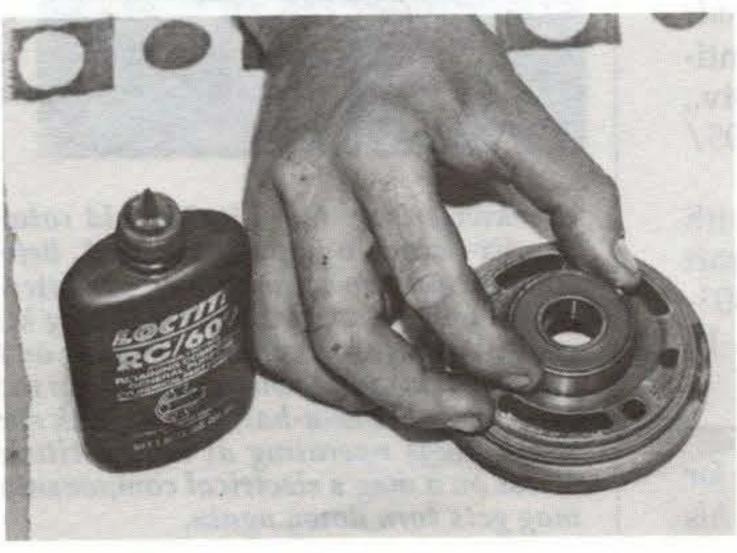
Clockwise from top left: The front bearing on this magneto was definitely passing oil. To get at the bearing, a spacer is removed, the old bearing is pressed out, and the new one is pressed in (using Loctite RC609 to keep the outer race from spinning). A little Loctite is also used on the rotor shaft, to keep the inner race of the new bearing from spinning.

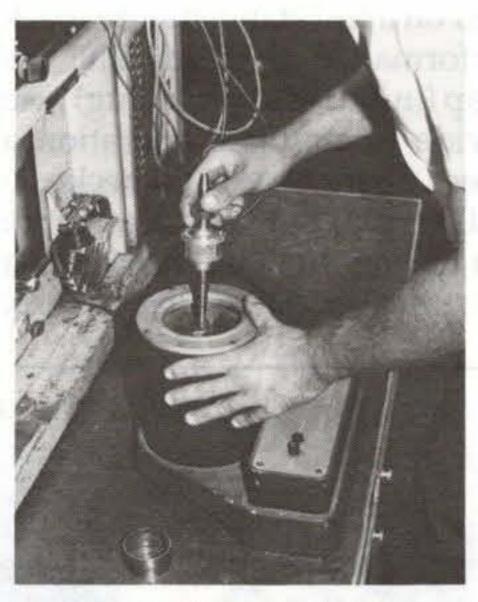
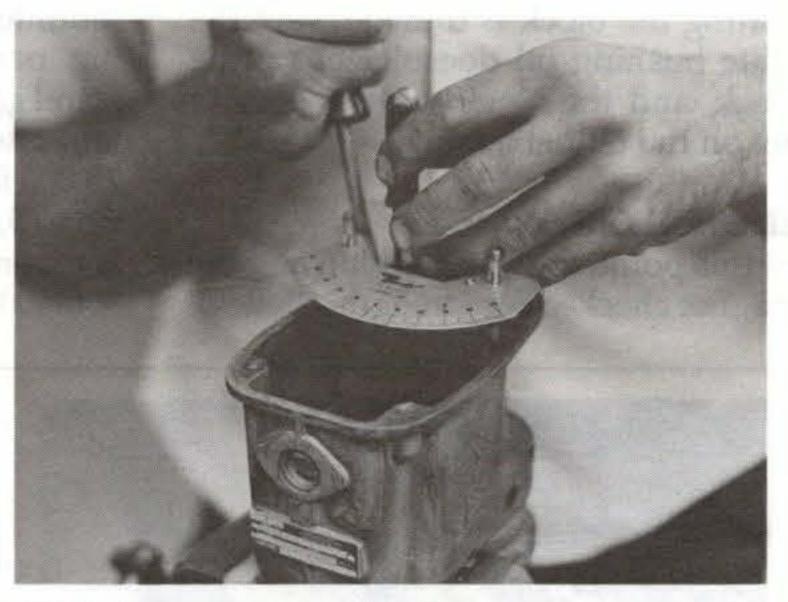
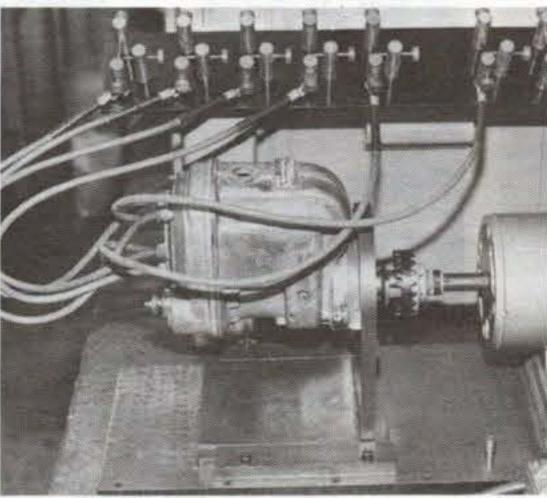
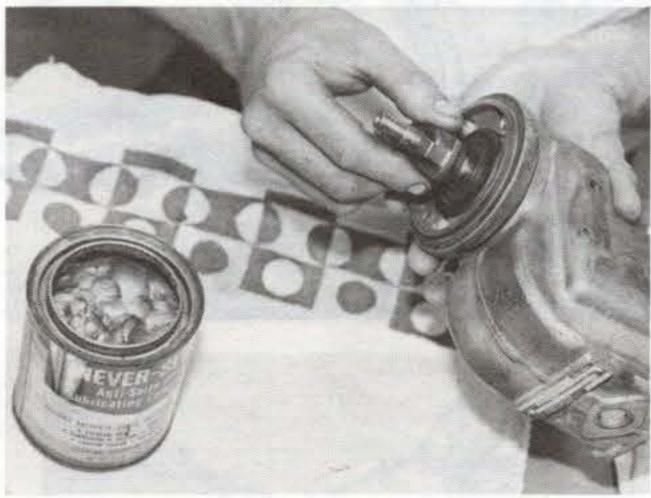
Clockwise from top left: The old rotor, if weak, is remagnetized using a special Bendix-Scintilla apparatus. Next, before final assembly of the mag, the breaker compartment is set up for proper internal timing (E-gap and point opening tolerances) using a special Bendix timing kit and feeler gauges. Anti-seize compound is used when installing the drive gear on the rotor shaft. Finally, the built-up mag is put on a test stand, where it is run up to 5,000 rpm. (On six-cylinder engines, the mag turns at one-and-a-half times crank speed.) Special electrodes are used to simulate spark plugs operating at high altitude. Low-rpm operation, which puts special stress on a mag's electrical components, is also tested. If weak output is noted, the mag gets torn down again.

it or not, magnets are found with low field strength from time to time.) If needed, the rotor can be remagnetized with a P/N 11-1362 Magnet Charger (Bendix-Scintilla) or a Weidenhoff Model D-818.

After the points are adjusted and internal timing is set at the proper E-gap (15 degrees plus or minus two, for 4- and 6-cylinder S-1200s), the mag is mounted on a test stand and its sparking performance checked. The test stand gap (in lieu of a spark plug) is set fairly wide to simulate operation at 25,000 feet. Spark output is checked at up to 5,000 rpm, but special attention is given to how the mag functions at 300-400 rpm also. According to Terry,
