VALVE EROSION IN LYCOMING ENGINES

Will there ever be a cure? Superior Air Parts, armed with German know-how, says yes

by Kas Thomas

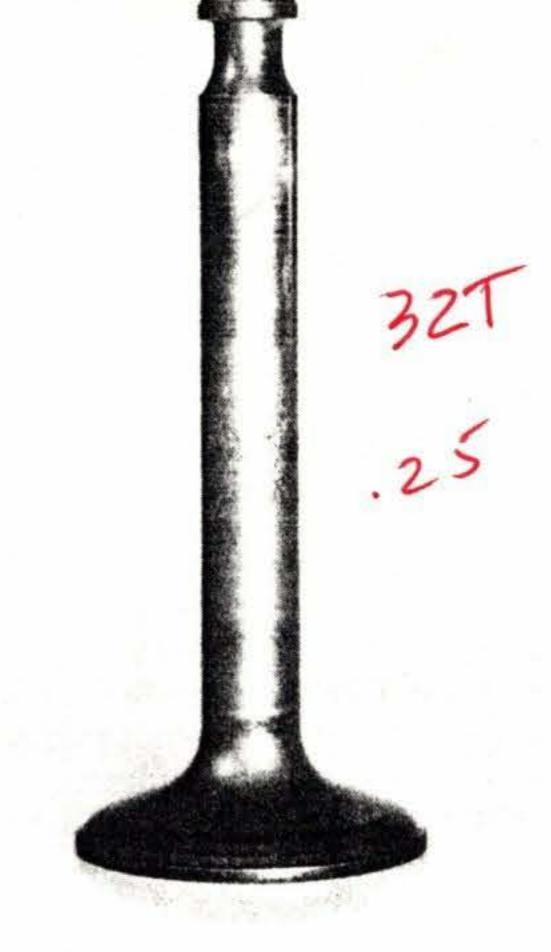
The P/N 74541 sodium-filled valve is used in almost every low compression engine Lycoming makes.

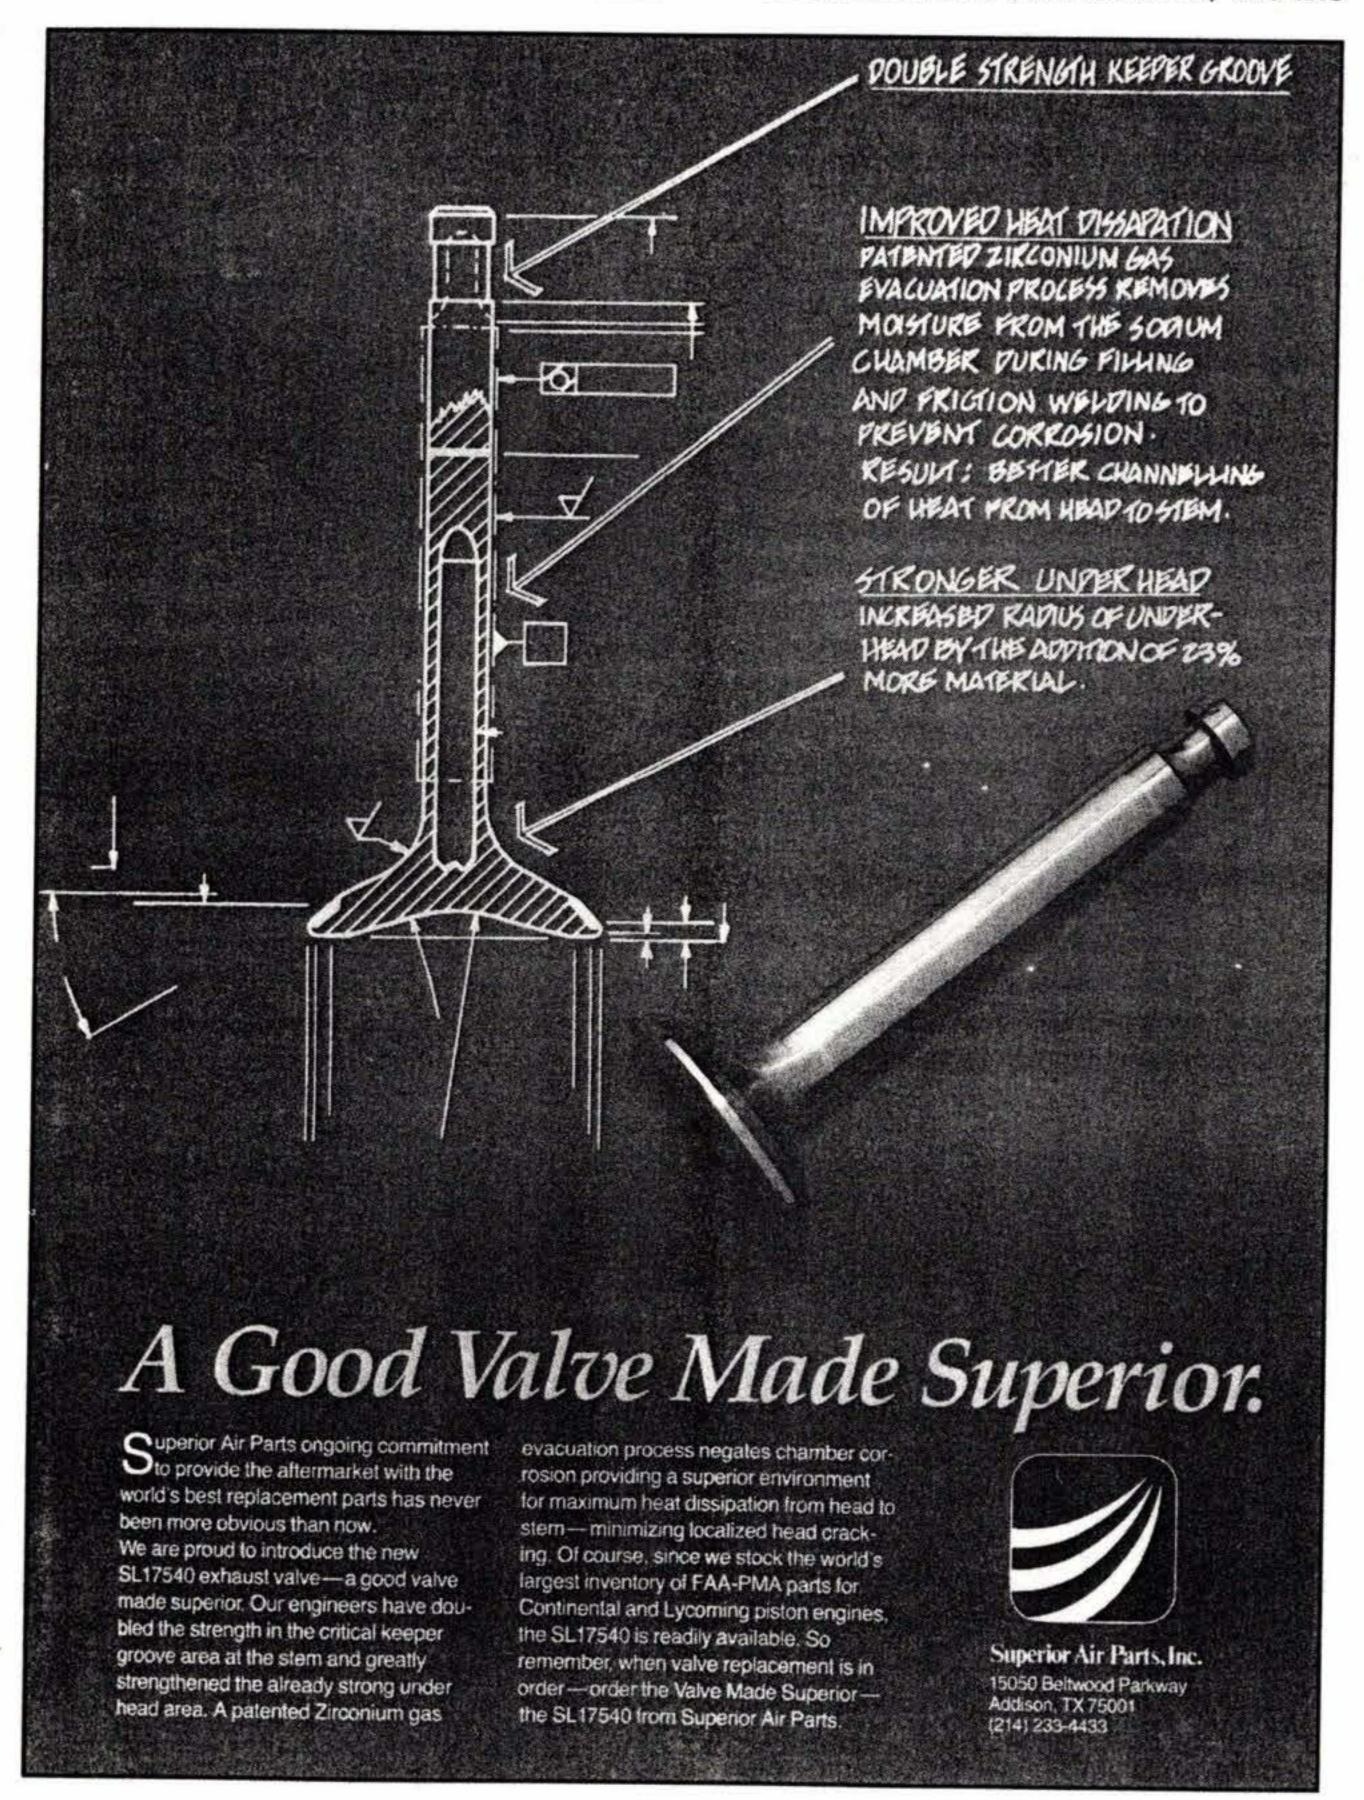
Superior Air Parts' ad for the improved SL17540 valve (a direct replacement for Lycoming P/N 74541 and LW19001) touts strengthened keeper groove, extra head metal, and patented zirconium gas process for filling stem with sodium.

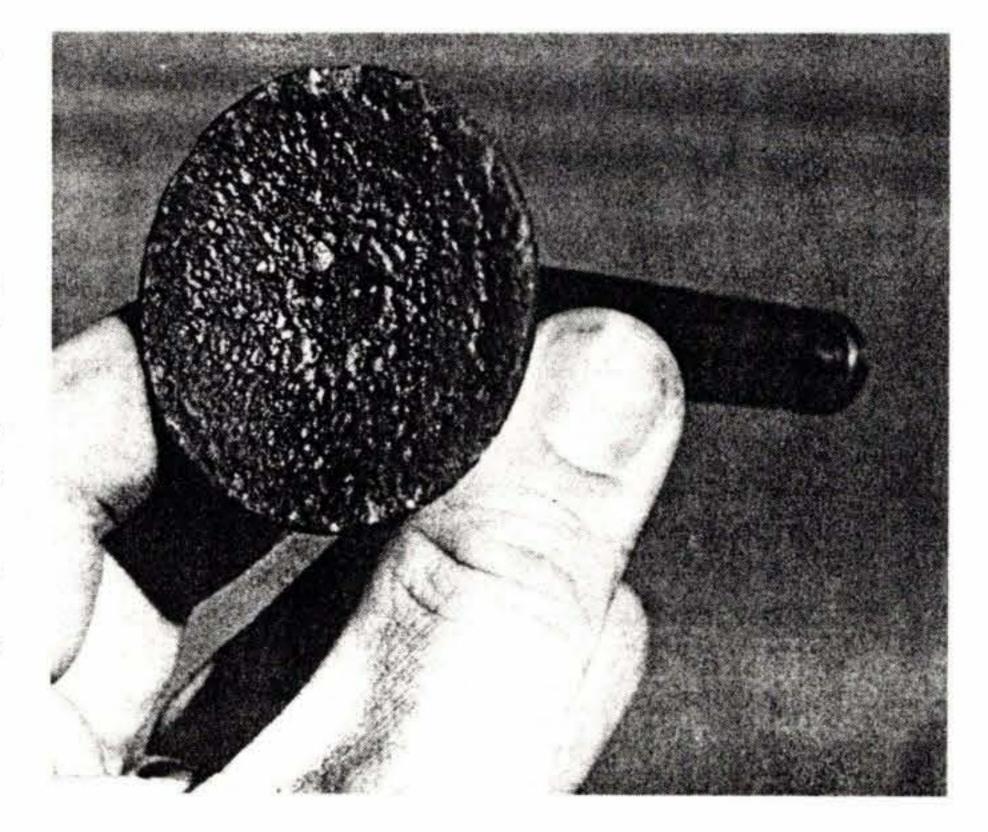
Lead amalgamation claimed this valve at low total time.

Burning and rim cracking would eventually have led to outright failure.

Note the chipped or spalled appearance and the loss of material at 12 o'clock on the face.
