AERO ENGINES INVOLVED IN PROPELLER STRIKE ACCIDENTS

RECOMMENDED PRACTICE

Service Bulletin No. 201C
(Supersedes Service Bulletin No. 201B)
Engineering Aspects are
FAA (DER) Approved

Inspection and Straightening of Bent Crankshaft Flanges

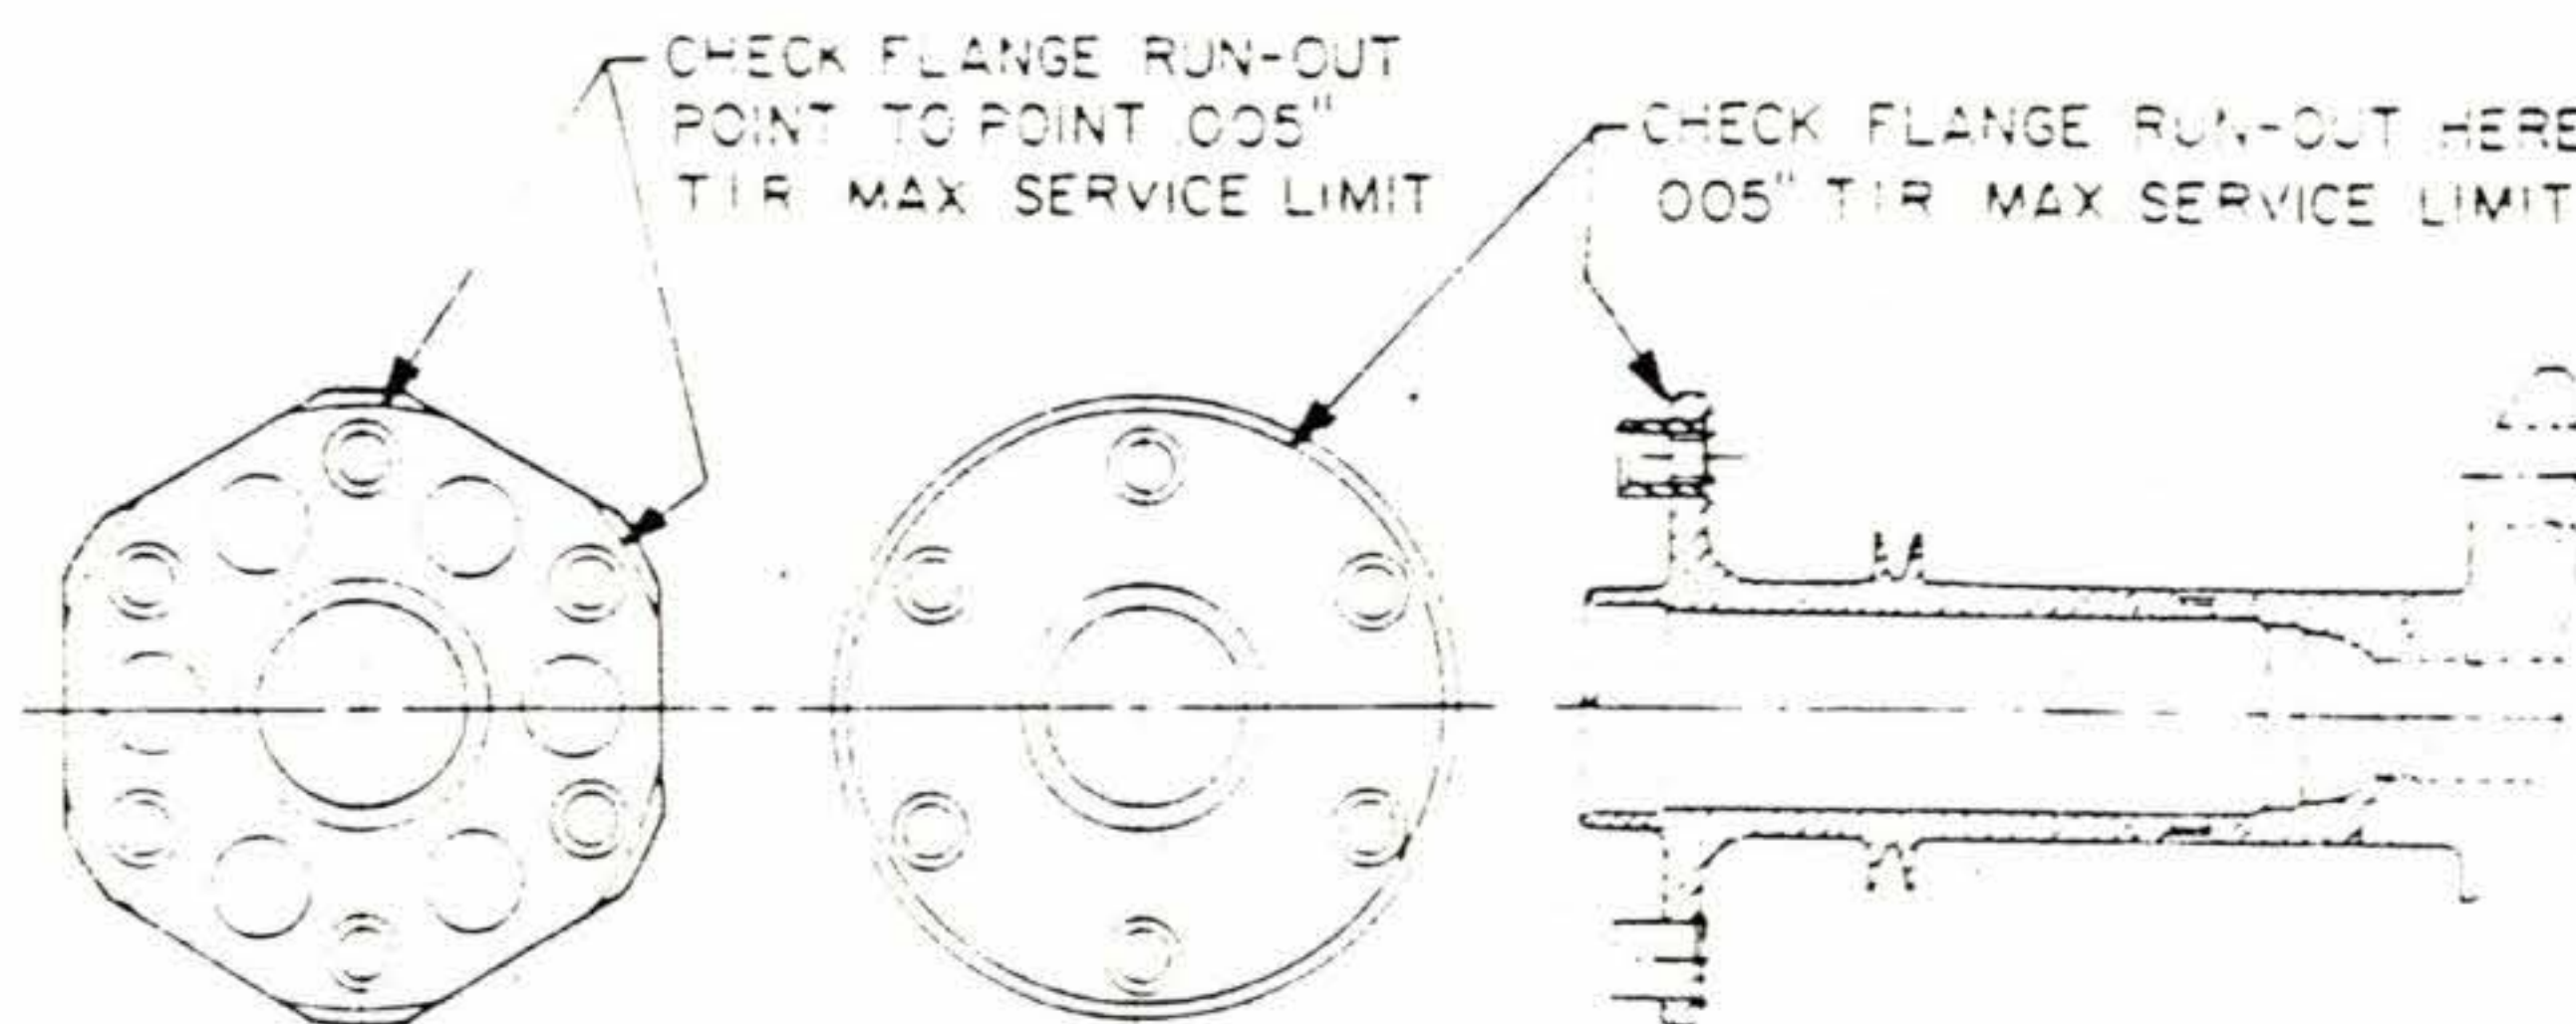
Section Thru Front of Crankshaft Showing Area for Flange Measurement

After removing the propeller and starter ring gear support, gauge the flange thickness and compare with dimension listed in the chart at right. This will determine minimum. Check run-out of the propeller flange with a dial indicator at the location shown in the illustration. If run-out exceeds .005 inch total indicator reading remove the crankshaft and inspect both structurally and dimensionally as described in the Direct Drive Overhaul Manual, Avco Lycoming publication no. 60294-7 and Table of Limits, SSP-1776.

Crankshaft flanges with .018 inch or less run-out

may be straightened by bending or by facing the front surface of the flange to restore maximum run-out to within .005 inch. Thickness of the flange must not be less than that shown in the following chart.
