## A friend in need is a friend indeed - a Long-Ez landing on Shetland Islands.

### Aircraft type: Long-Ez

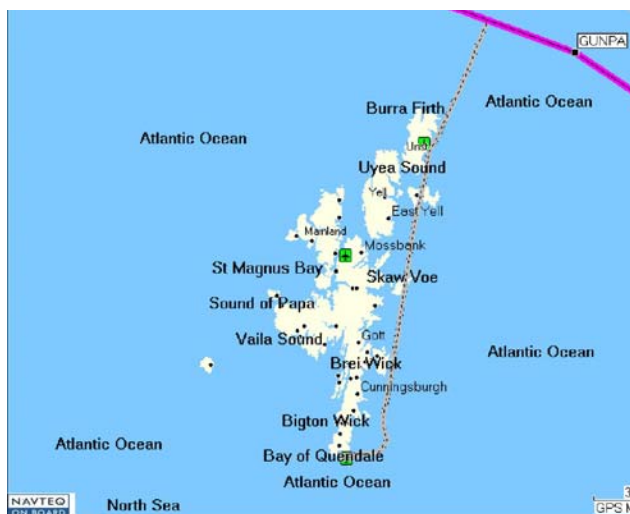
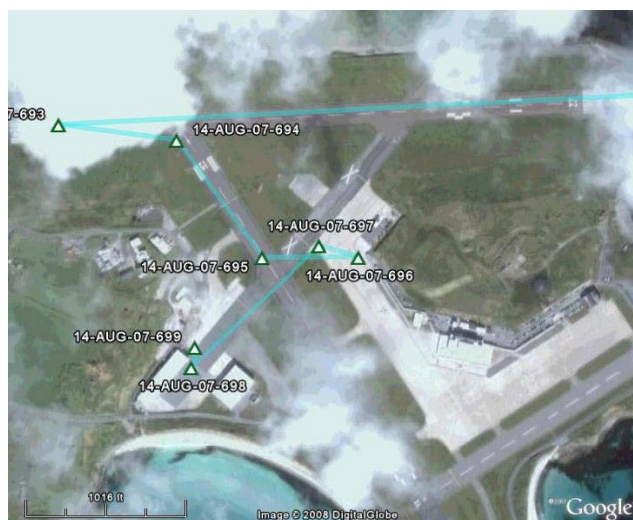
The oil pressure failure came at the right timing close to the Shetland shore.

Whole runway 27 used due to tailwind. A fire engine was on stand-by during landing – but no blue lights and sirens.

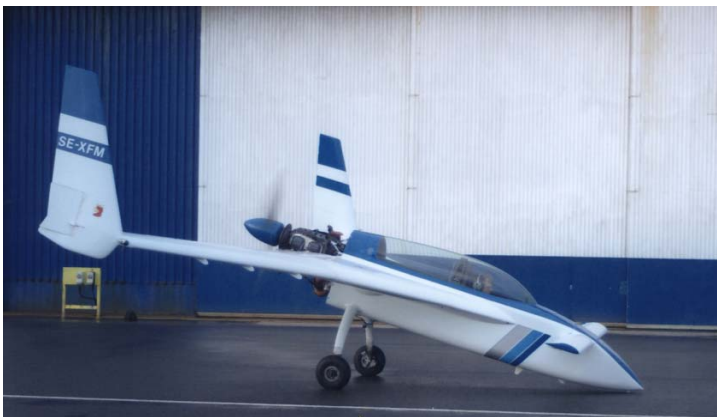
Ground test at Sumburgh - (Photo: Kieran Murray)

All Monday was used to install the engine and Tuesday forenoon I had problems with the new oil temperature probe – there was no reaction. Software set-up was checked and all connections were fine. I had no resistor to use as a fake probe, but rolling out many meters of safety wire out on the hangar floor I created a resistor equal to normal oil temperature – the system showed now the “correct” temperature. Now it was just to connect the probe again and with a heat gun get the temperature up – that helped. The system didn’t like the 6°C hangar temperature, but started first reacting around 15°C – like reptiles. As the engine had new pistons and rings and the

The cylinders had been honed full break-in procedures should be performed with several ground runs following a specific procedure to get the correct surface on the cylinder walls. Neglecting this could give high oil consumption in the future and the only repair would be a new honing of the cylinders. After each run the engine shall cool down to room temperature.
