AeroComposites Advisory Notice

AN-2 Date: 9/22/07

SUBJECT: Propeller Operating Temperature

DISTRIBUTION: AeroComposites Propeller Owners

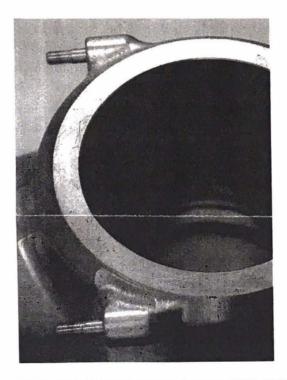
Figure-2 Hub Showing Blade Arm Socket

In the case of a blade made for a 2-bladed propeller, there is the same groove machined in the polyurethane collar for the snap ring but there is no machined groove in the polyurethane collar for the O-ring. In the case of 2-bladed propellers, the O-ring groove is machined into the aluminum hub arm (figure-2). When the blades are installed in the hub arms, the O-rings are compressed and rub on the outer surface of the blade polyurethane collar to form the grease seal.

As is the case for most all materials, the propeller aluminum hub and polyurethane collar materials expand with increasing temperature. This increases the compression of the O-ring seal. In addition, because polyurethane expands at a greater rate than aluminum, this results at extreme temperature conditions in sticking of the blade collar in the hub arm.

The last two incidents occurred more recently under extremely high propeller operating temperatures on the ground. It was reported that the propeller hub was too hot to touch. In these latter two incidents, which occurred during ground operations, the blades after moving to course (high) pitch did not return to low pitch until the engine was turned off and the propeller allowed to cool. After cool down, with the engine shut down, the blades returned to low pitch under return spring force. In both incidents, high air temperatures on the ground were reported (e.g. 115 degrees F). In one of these incidents, the engine had been run at high power during ground testing for a sustained period of time and the propeller rpm was being cycled. It may be that the engine may have been operating with an oil temperature above the manufacturers recommended maximum oil temperature limit. This same hot engine lubrication oil would have been transferred to the propeller during high pitch change actuation.
