COMMENTARY / SAVVY AVIATOR

Cylinder Work: Be Afraid

It is nearly impossible to install a cylinder properly when the engine is on the airplane

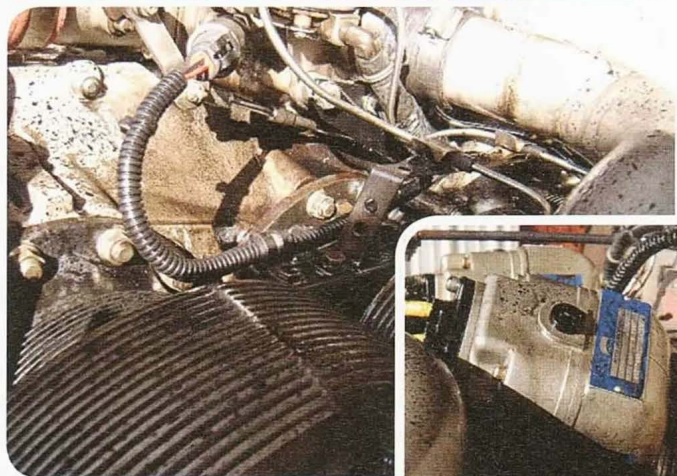
This Continental IO-550 threw the No. 2 rod through the top of the case less than 10 hours after the No. 2 and No. 4 cylinders were replaced at annual.

In short, Fuchs contends that there's a significant risk that an engine might come apart after cylinder work (especially a top overhaul) even when the work is performed exactly as directed by the manufacturer. How can that be? According to Fuchs, the root cause of spun bearings, thrown rods, and separated cylinders is simply "failure to achieve sufficient preload in the assembled fasteners."

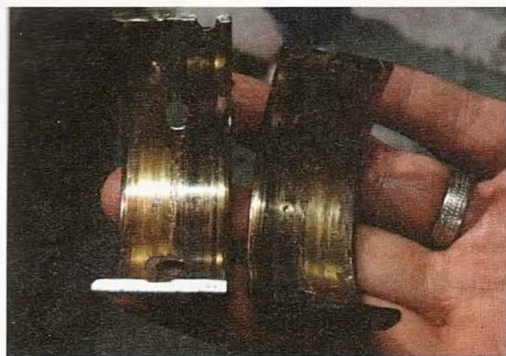
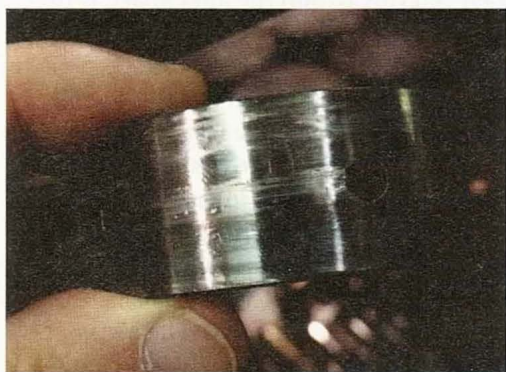
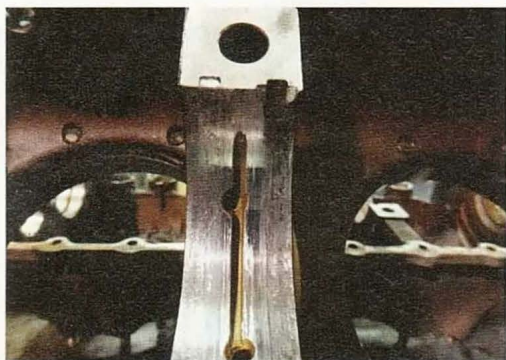
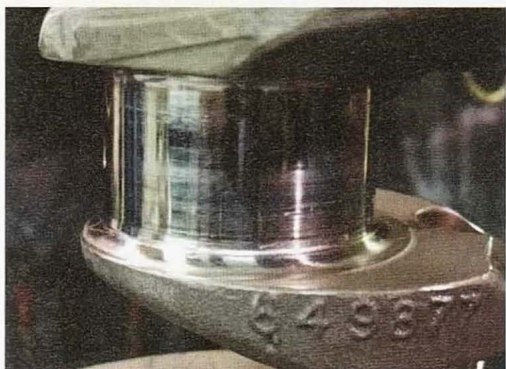
This Continental IO-360 spun a main bearing after cylinder work. Fortunately, the situation was caught at a routine oil change (where the filter was found to have thousands of flakes of bearing metal) literally an hour or two before the engine would have self-destructed in flight.

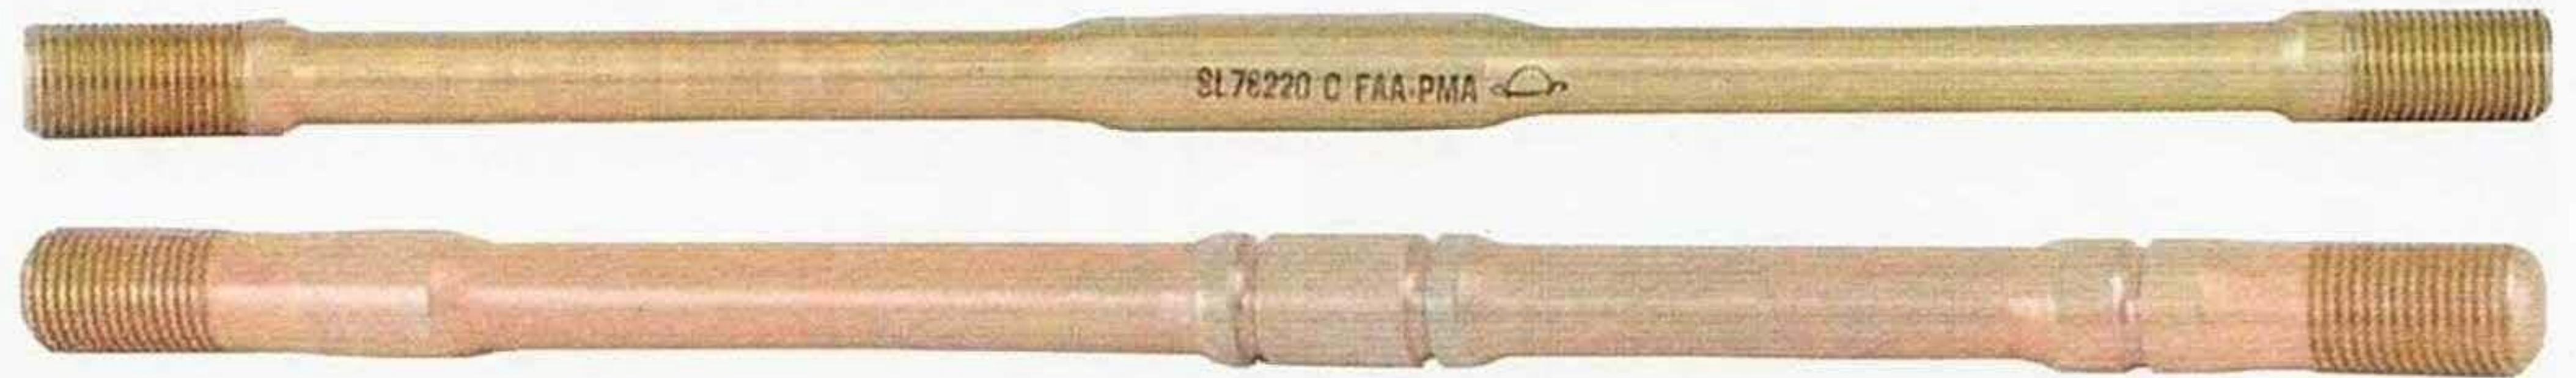
A pair of new through bolts for Lycoming (top) and Continental (bottom) engines. Both have 1/2-inch cad-plated steel threads. The Continental through bolts are stiffer (larger shank diameter) and have grooves for O-rings.

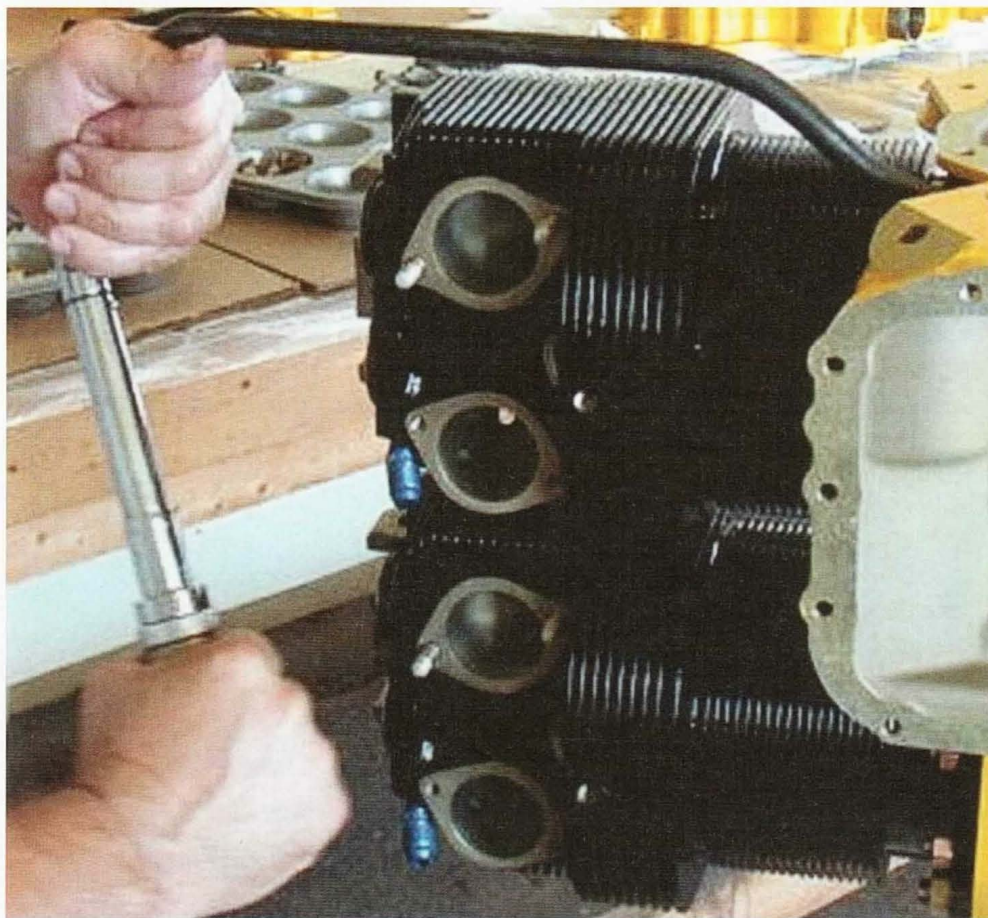
reason for doing it this way is that consistent results can only be obtained if the final tightening sequence is performed using a single continuous motion of the torque wrench. If the movement of the wrench is interrupted, the “click” from the wrench that signifies that the specified torque has been achieved occurs too early because breakaway torque is significantly higher than running torque.

Achieving final torque needs to be accomplished with one smooth motion of the torque wrench. This is usually possible when the engine is out of the airplane and being assembled on a stand, but it's almost impossible when the engine is in the airplane.
