COMMENTARY / SAVVY AVIATOR

How hard could it be to manage the maintenance of a Skyhawk?

A Highly Modified Skyhawk

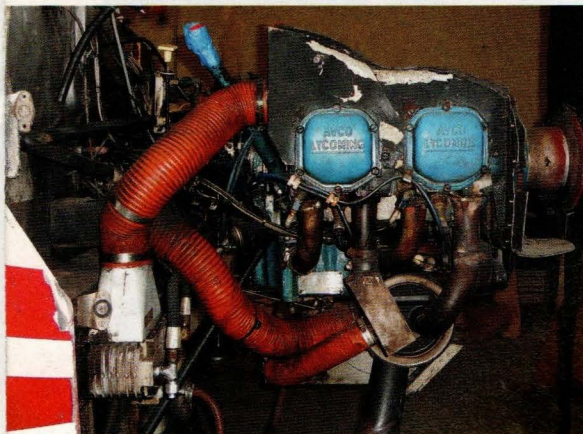
The 1976 Skyhawk's original 150-hp Lycoming O-320-E2D engine and 53-inch pitch prop was modified with a high-compression piston STC and a 57-inch pitch prop STC to produce 160 hp.

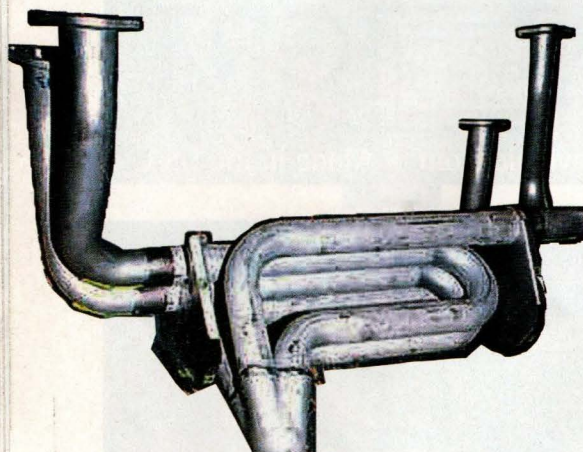
The tuned exhaust system from Power Flow Systems probably added an additional 13 to 20 hp, causing the owners to have the prop pitch increased further.

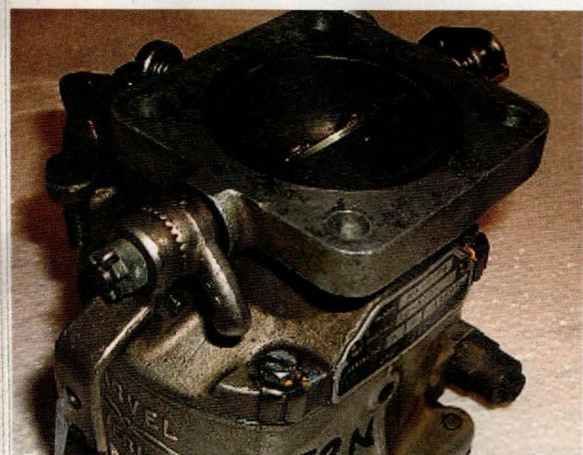
The O-320's carburetor was re-jetted to increase takeoff fuel flow from 12.5 to 13.5 gph.

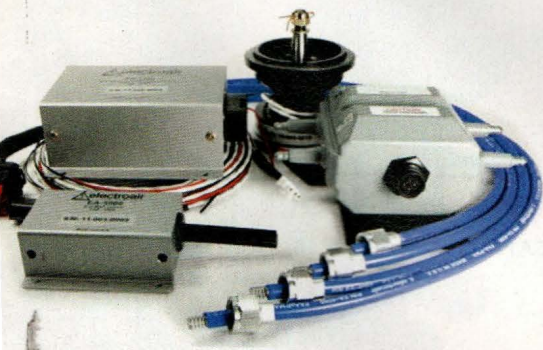
The O-320's right magneto was replaced with an Electroair electronic ignition system.
