Prop Extension Failures

Broken Brock Engine Mount

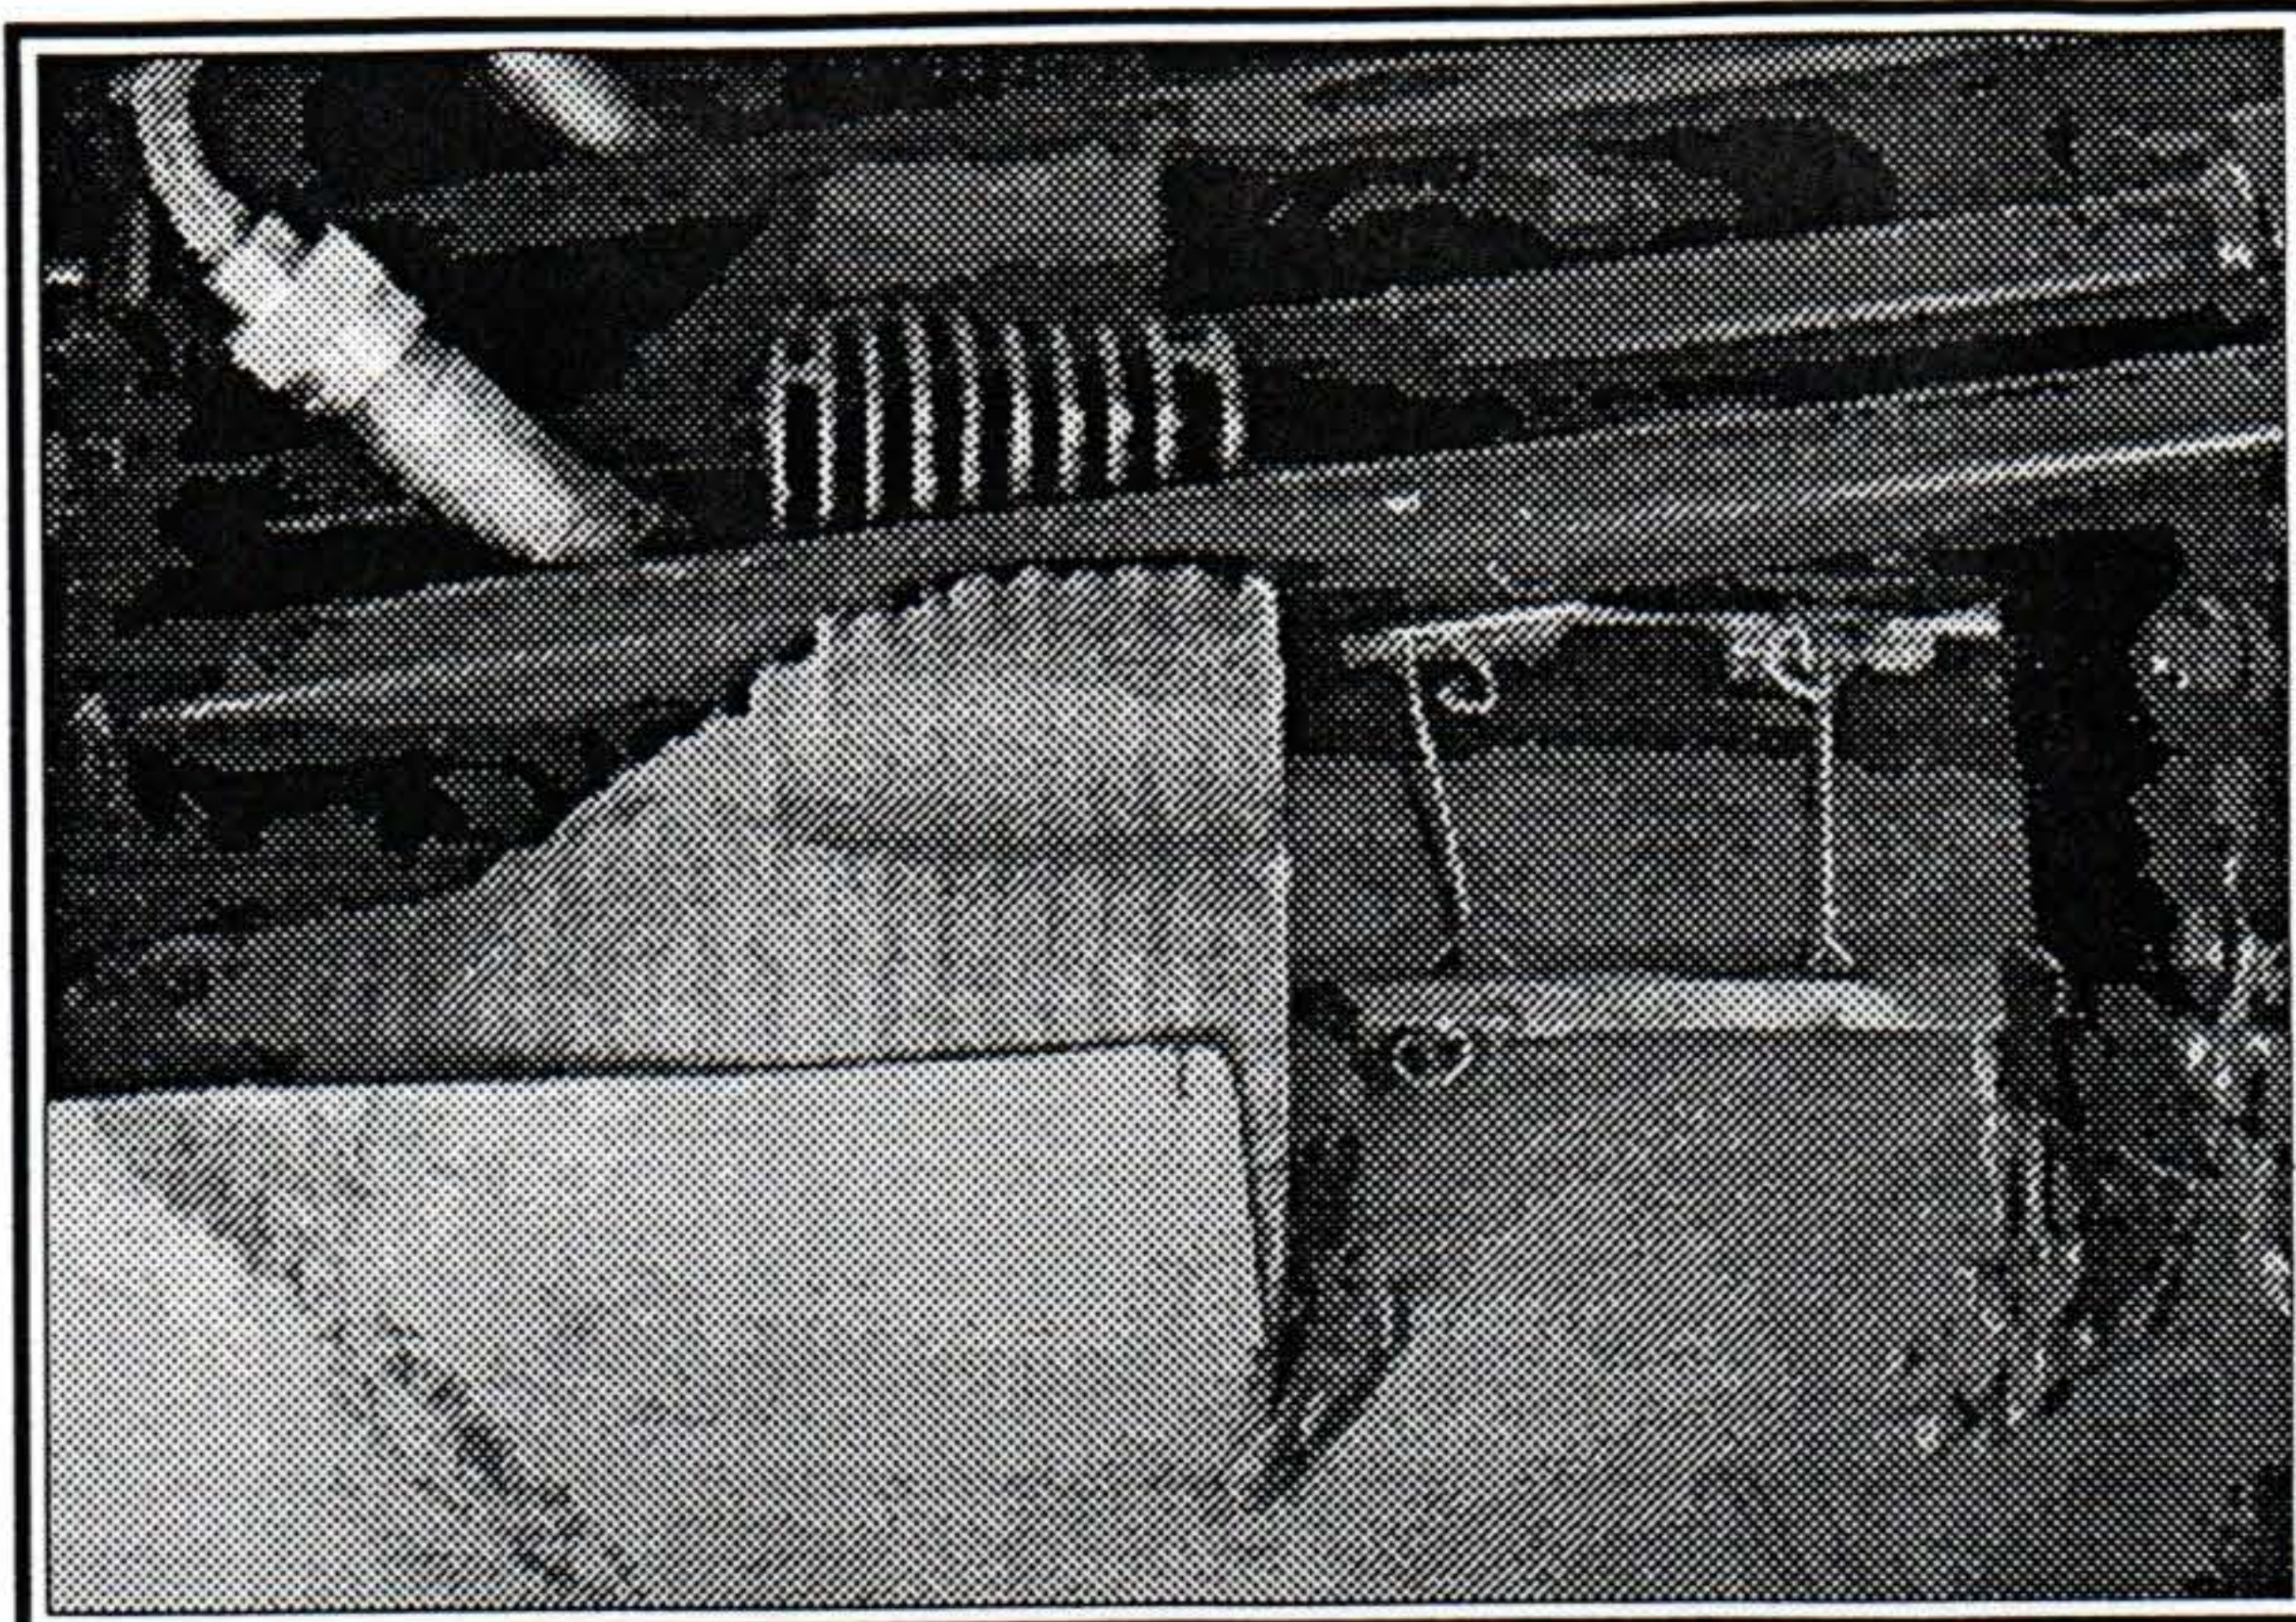
Well contoured, very close, lightweight baffles

As we all know, baffling the barrel of the cylinder is fairly simple, since it is nice and uniform. Getting metal to conform around the head though is beyond me. Try this - Lay a single piece of thin, lightweight fiberglass on Saran Wrap, thoroughly impregnate with RTV squeegeed all the way through, then build up the RTV to about 1/16" above the fiberglass. Lay against the cylinder with the Saran Wrap side out, trim to fit, and simply massage onto the fins with your hand, then peel off the Saran Wrap. The layer of RTV which stood up adheres to the fins.

Use separate pieces around the front of # 1 and # 2 and back of # 3 and # 4 and another across the top between the cylinders. Leave a 2" gap at the top of each cylinder and bring down the front and the back far enough to be below the front and back baffle bulkheads.

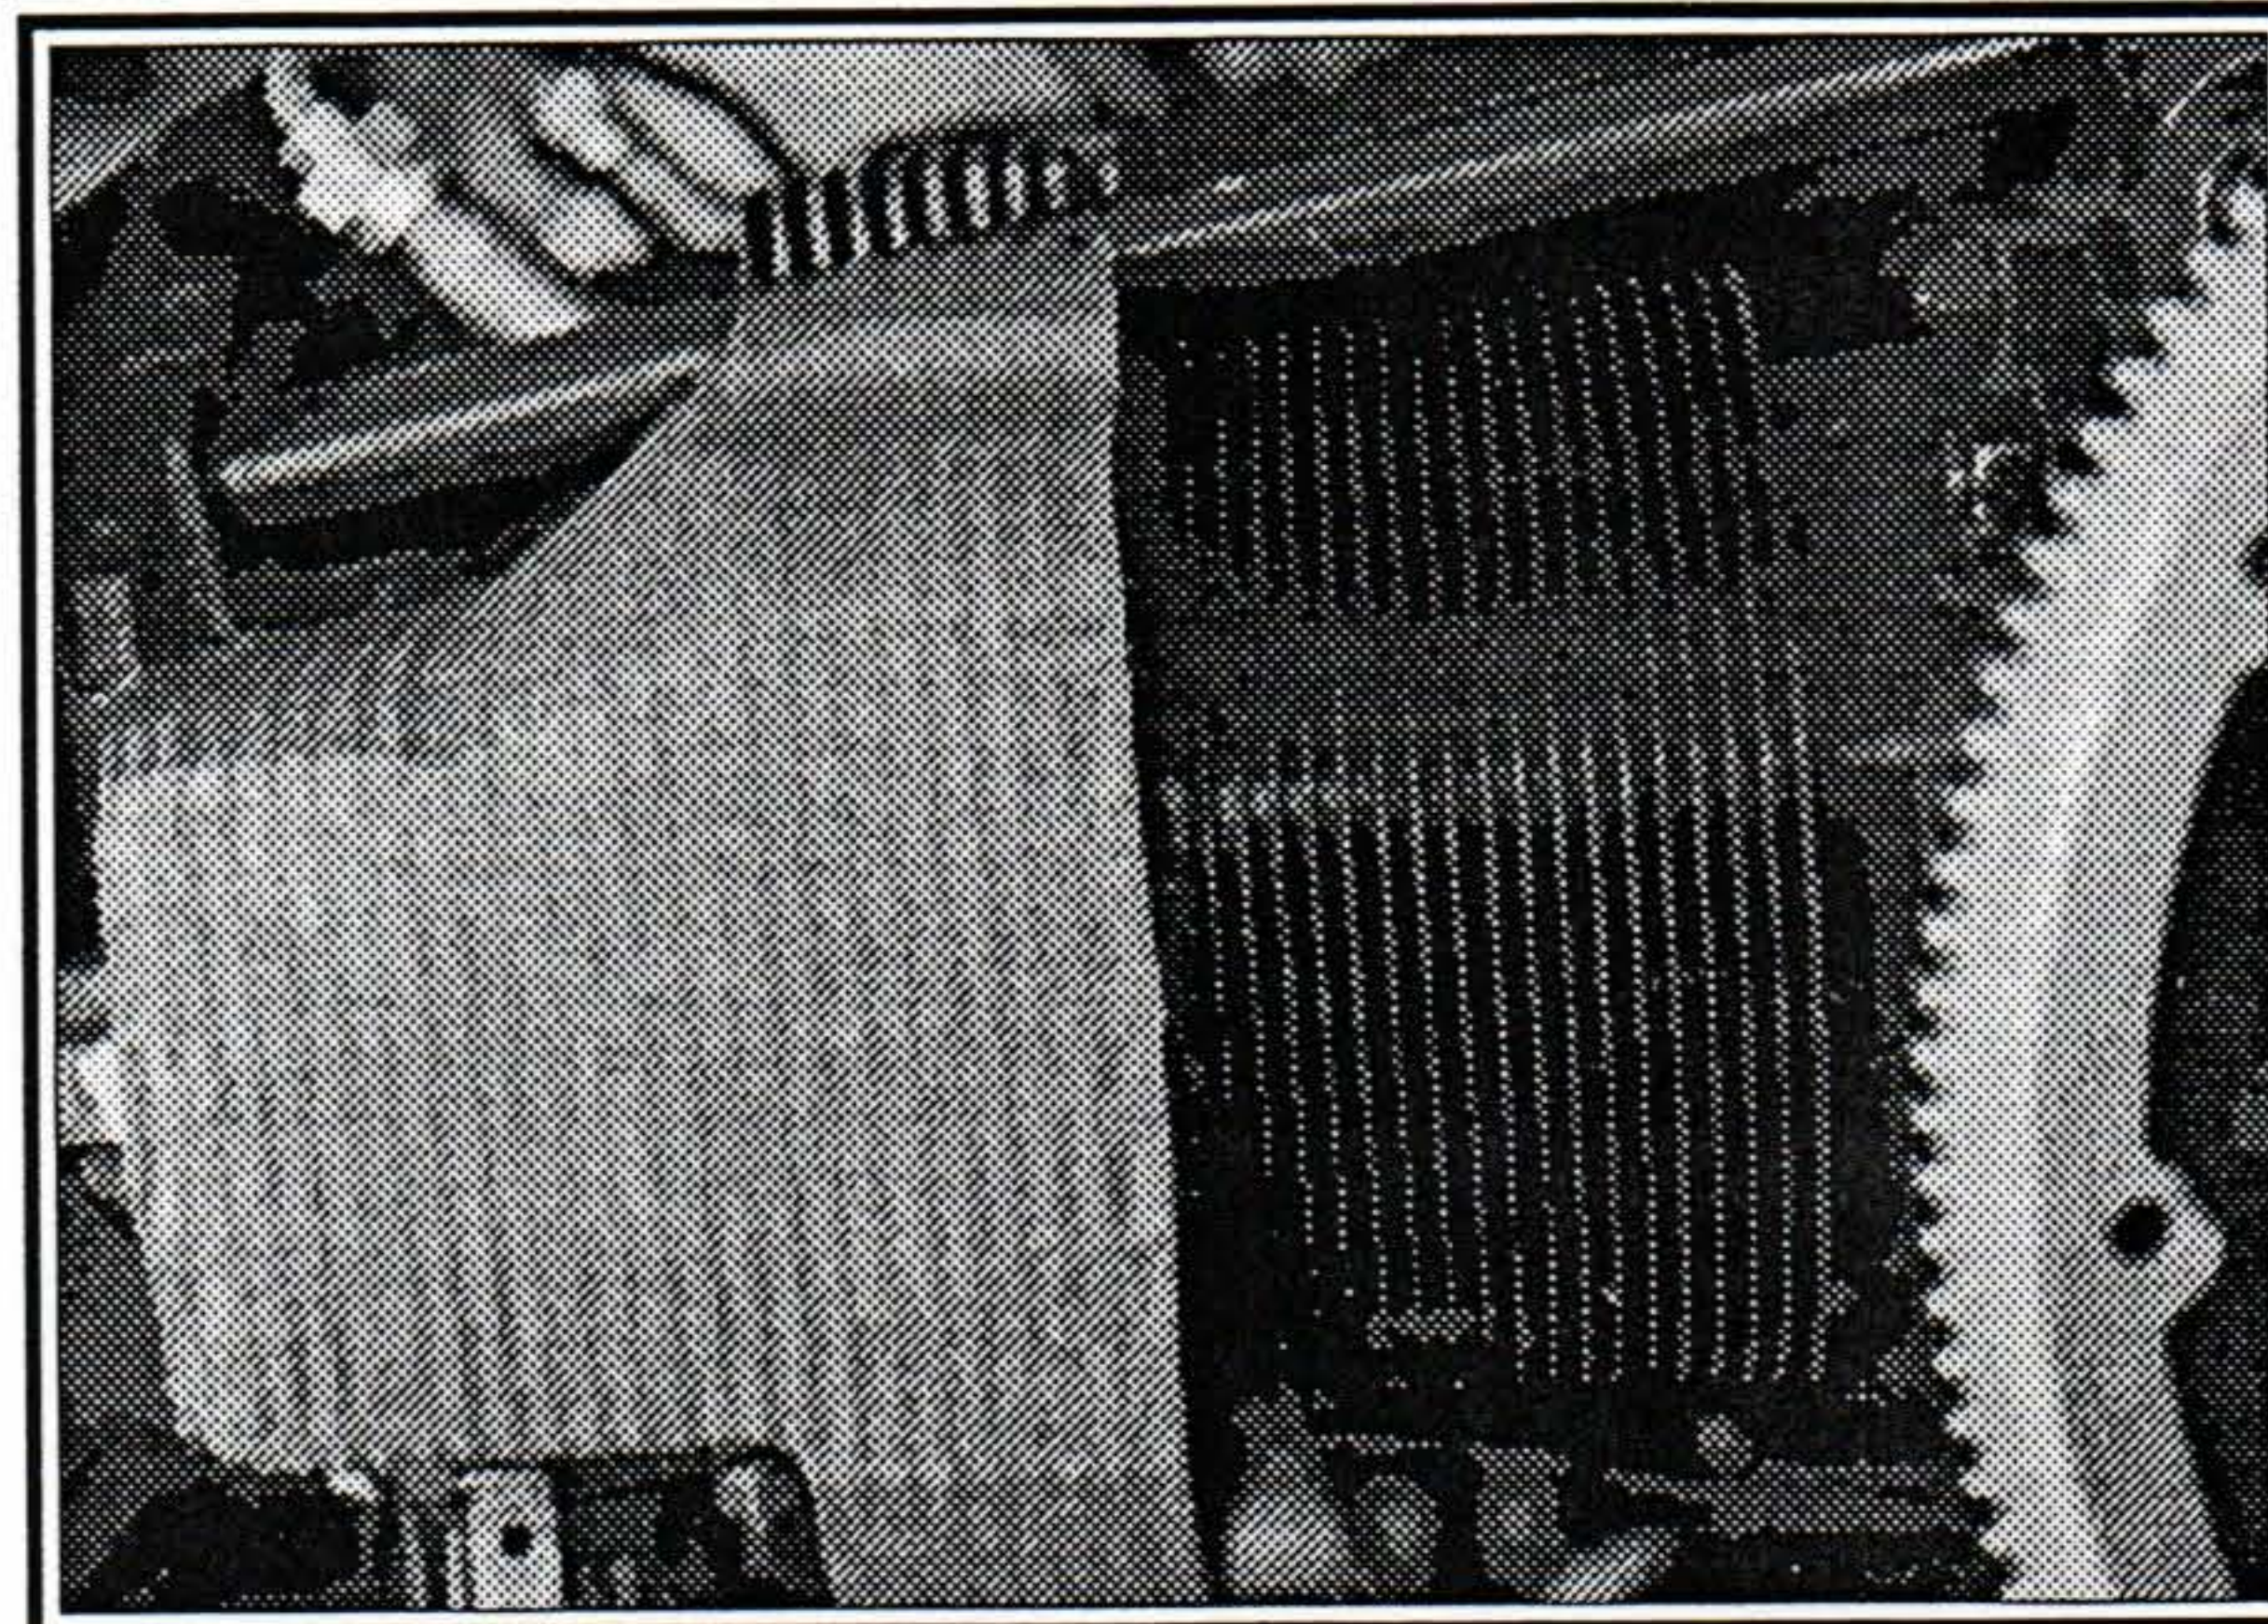
This should answer the baffle leak problem

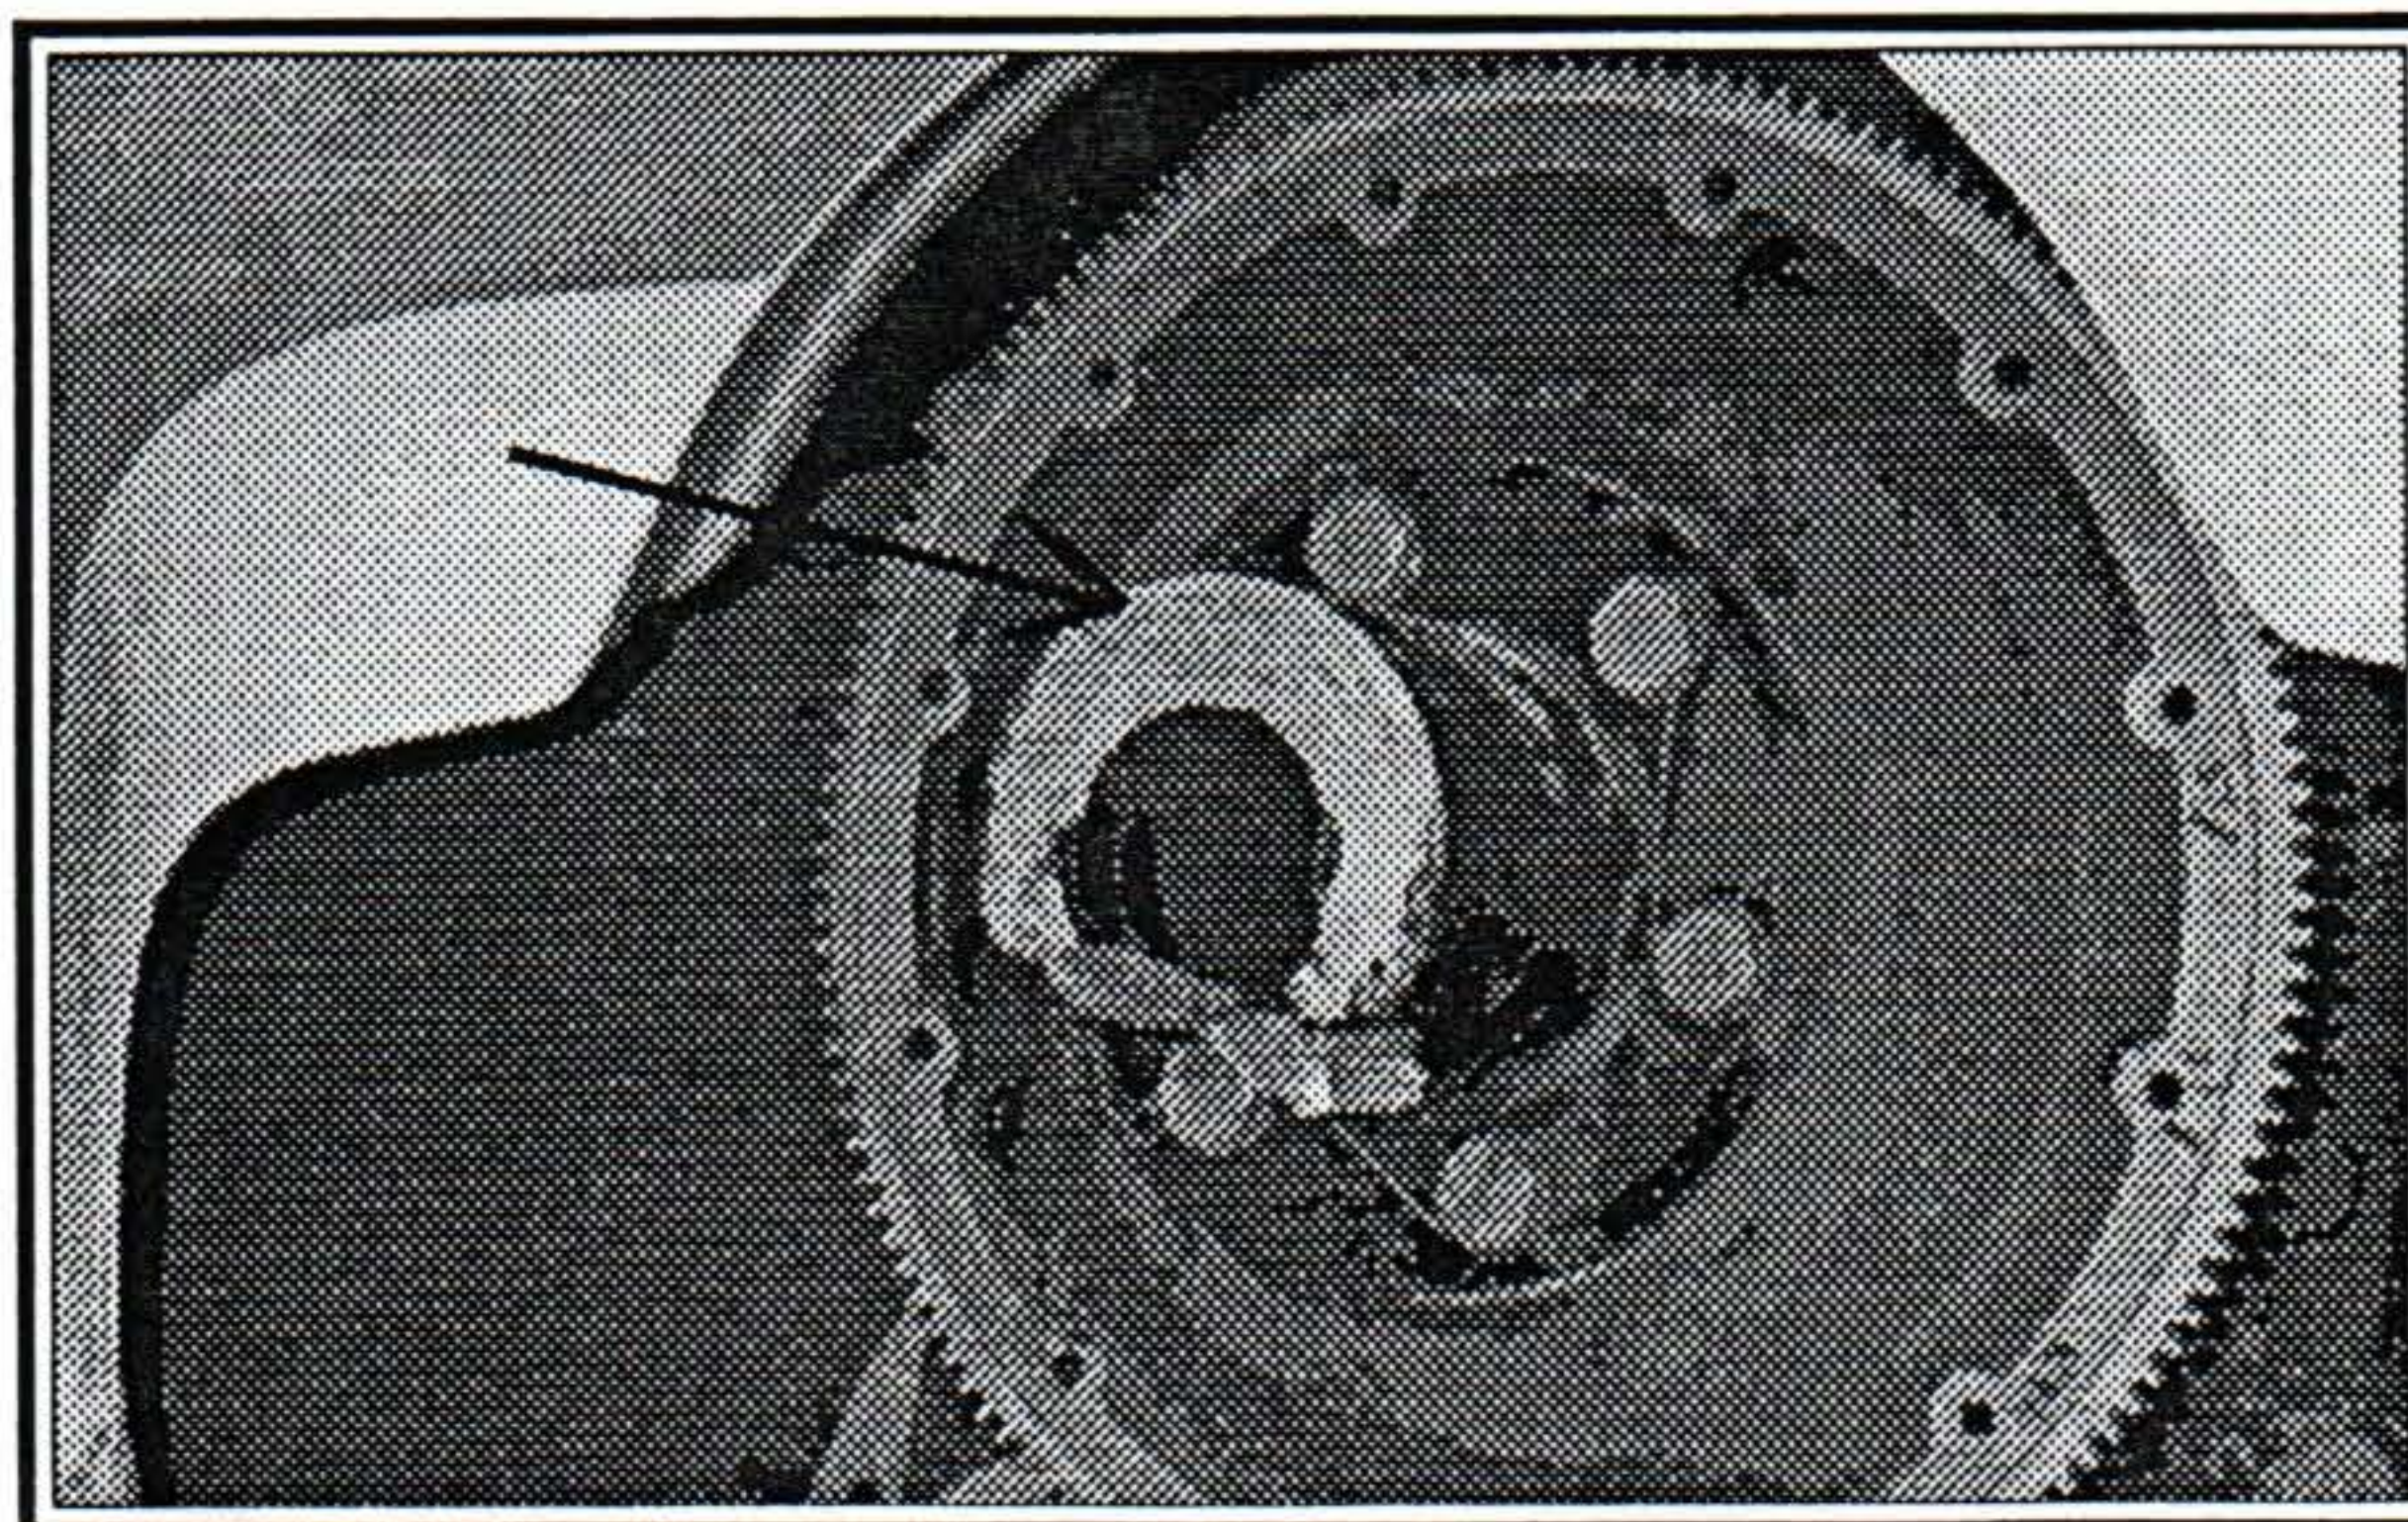
Examination of the second photo, at the top portion of the failed area, shows what looks like a peened surface. The lower separated area looks to have been ripped away.

that crankshaft flange runout could be a contributor to this failure. Lycoming permits a .005" runout on the prop flange. This dimension would be OK if there were no prop extension. With an extension, however, the magnitude of runout will be exaggerated depending upon the extension's length. This flange runout will cause additional prop runout which will increase the vibration and will add to the mean stress on the extension. When the cyclic loads are applied over the top of a possibly elevated mean stress, fatigue crack initiation and propagation may occur.

Nat Puffer called (9-13-94) and told how he and Mike Melvill had independently reached the same conclusion on the Hayes prop extension failure. The Brock 6" extension, when mounted on an O-360, has a resonant frequency of 2750 RPM. Apparently Jimmie ran in the resonant range of the Brock extension possibly causing the extension failure.

Remains of the failed extension shows a peened surface

If you are using a 6" or longer prop extension, especially on the O-360 engine, please check for cracks in the radius area. Gary Hertzler has suggested that we **all** (regardless of engine size) examine our prop exten-

The latest Cozy Newsletter (10-4-94) indicates you should do all things possible to not over speed your engine and possibly get into the resonant RPM range: Check prop flange run-out. Keep it under .002". Check and balance the prop. Check the prop to see if the blade profile is symmetrical from blade to blade. I have seen prop airfoil sections that varied considerably from one blade to the other. That causes uneven thrust from blade to blade and hence creates vibration. Mike Melvill limits his cruise RPM to 2600, well under the resonant frequency

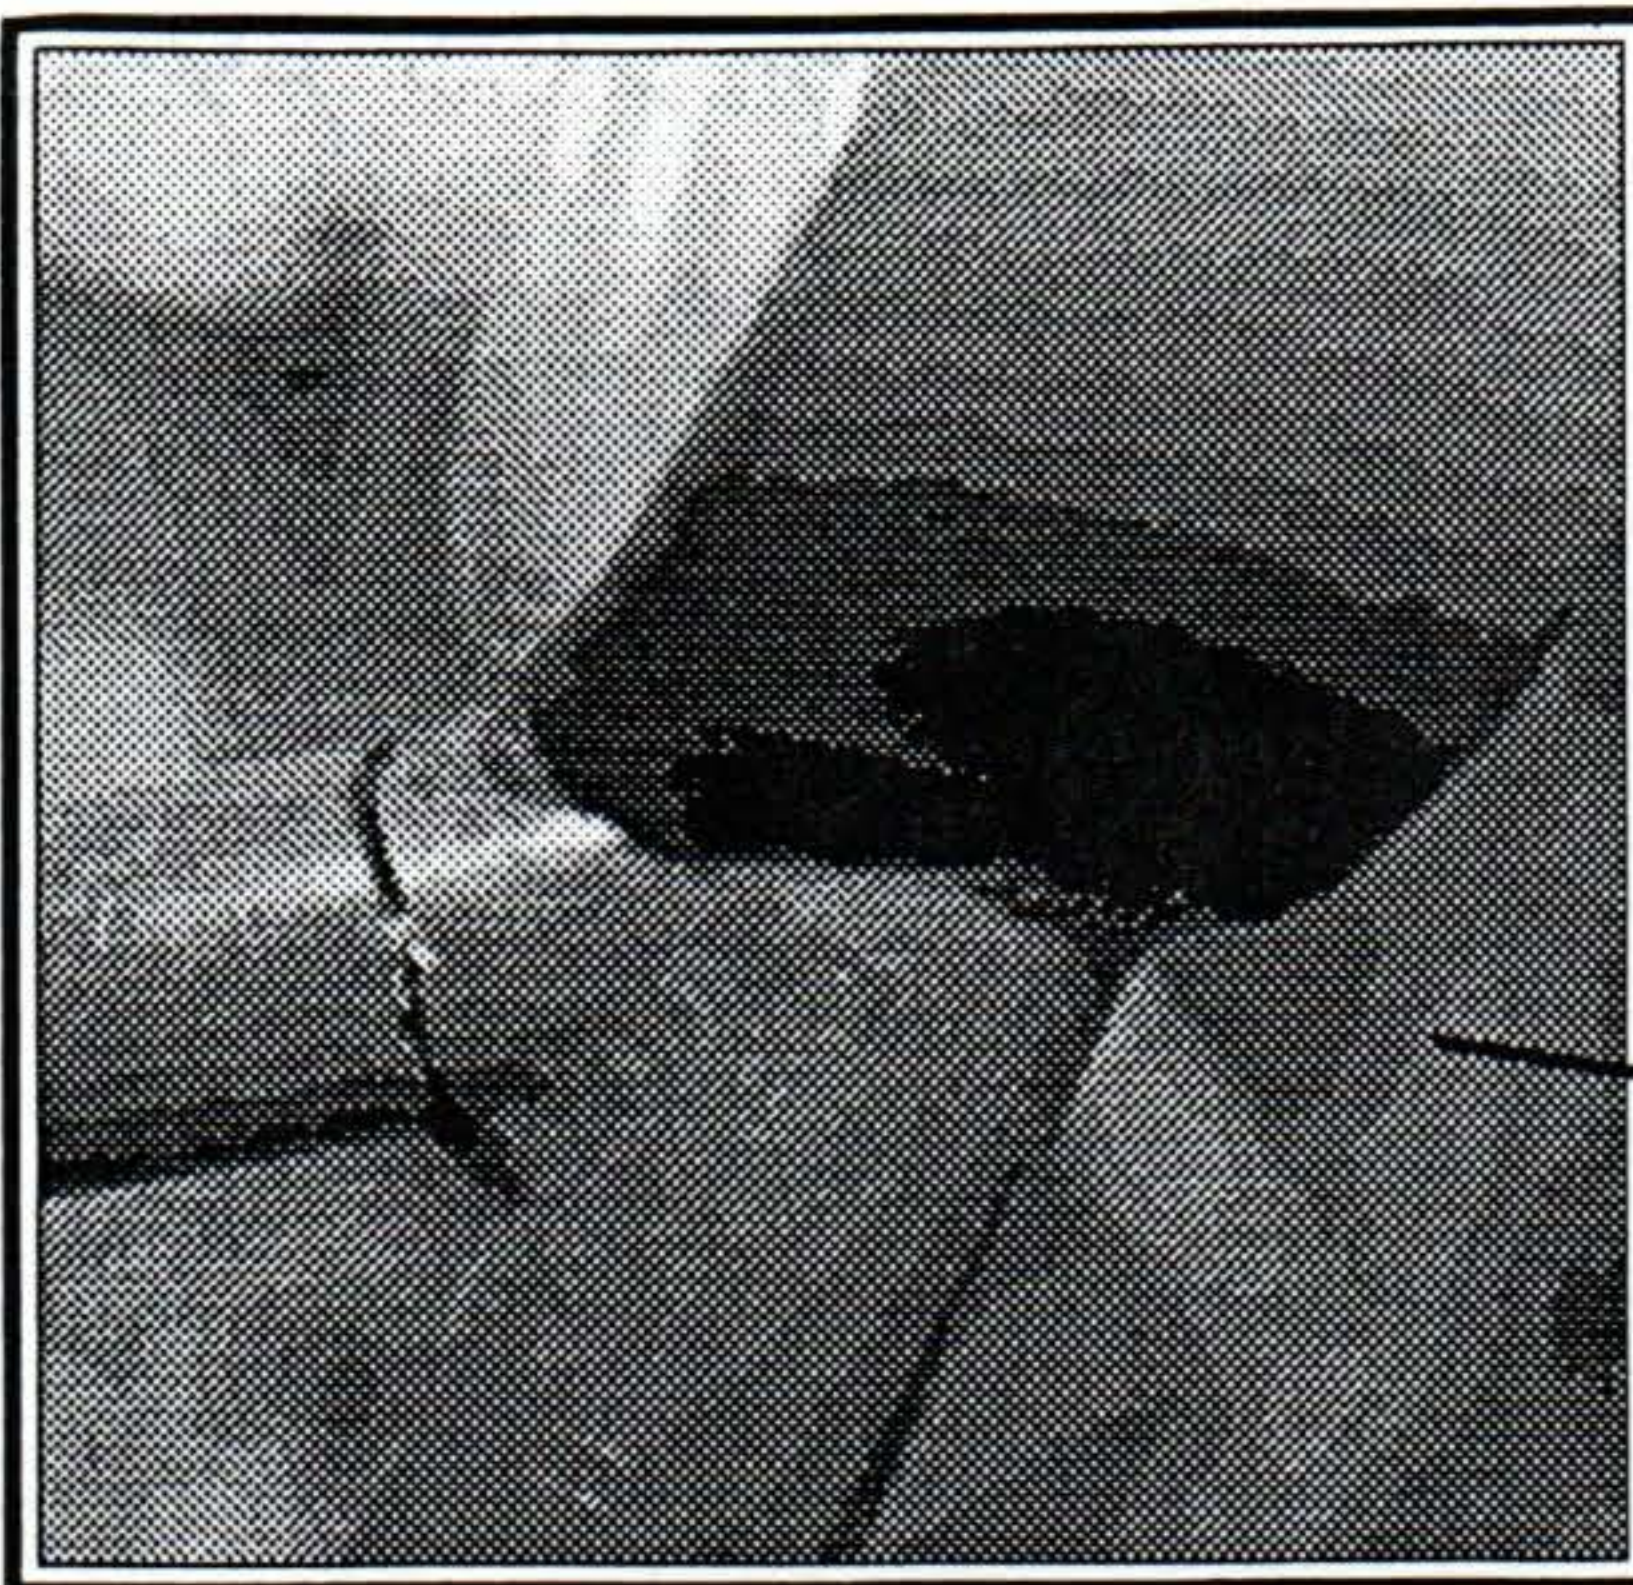
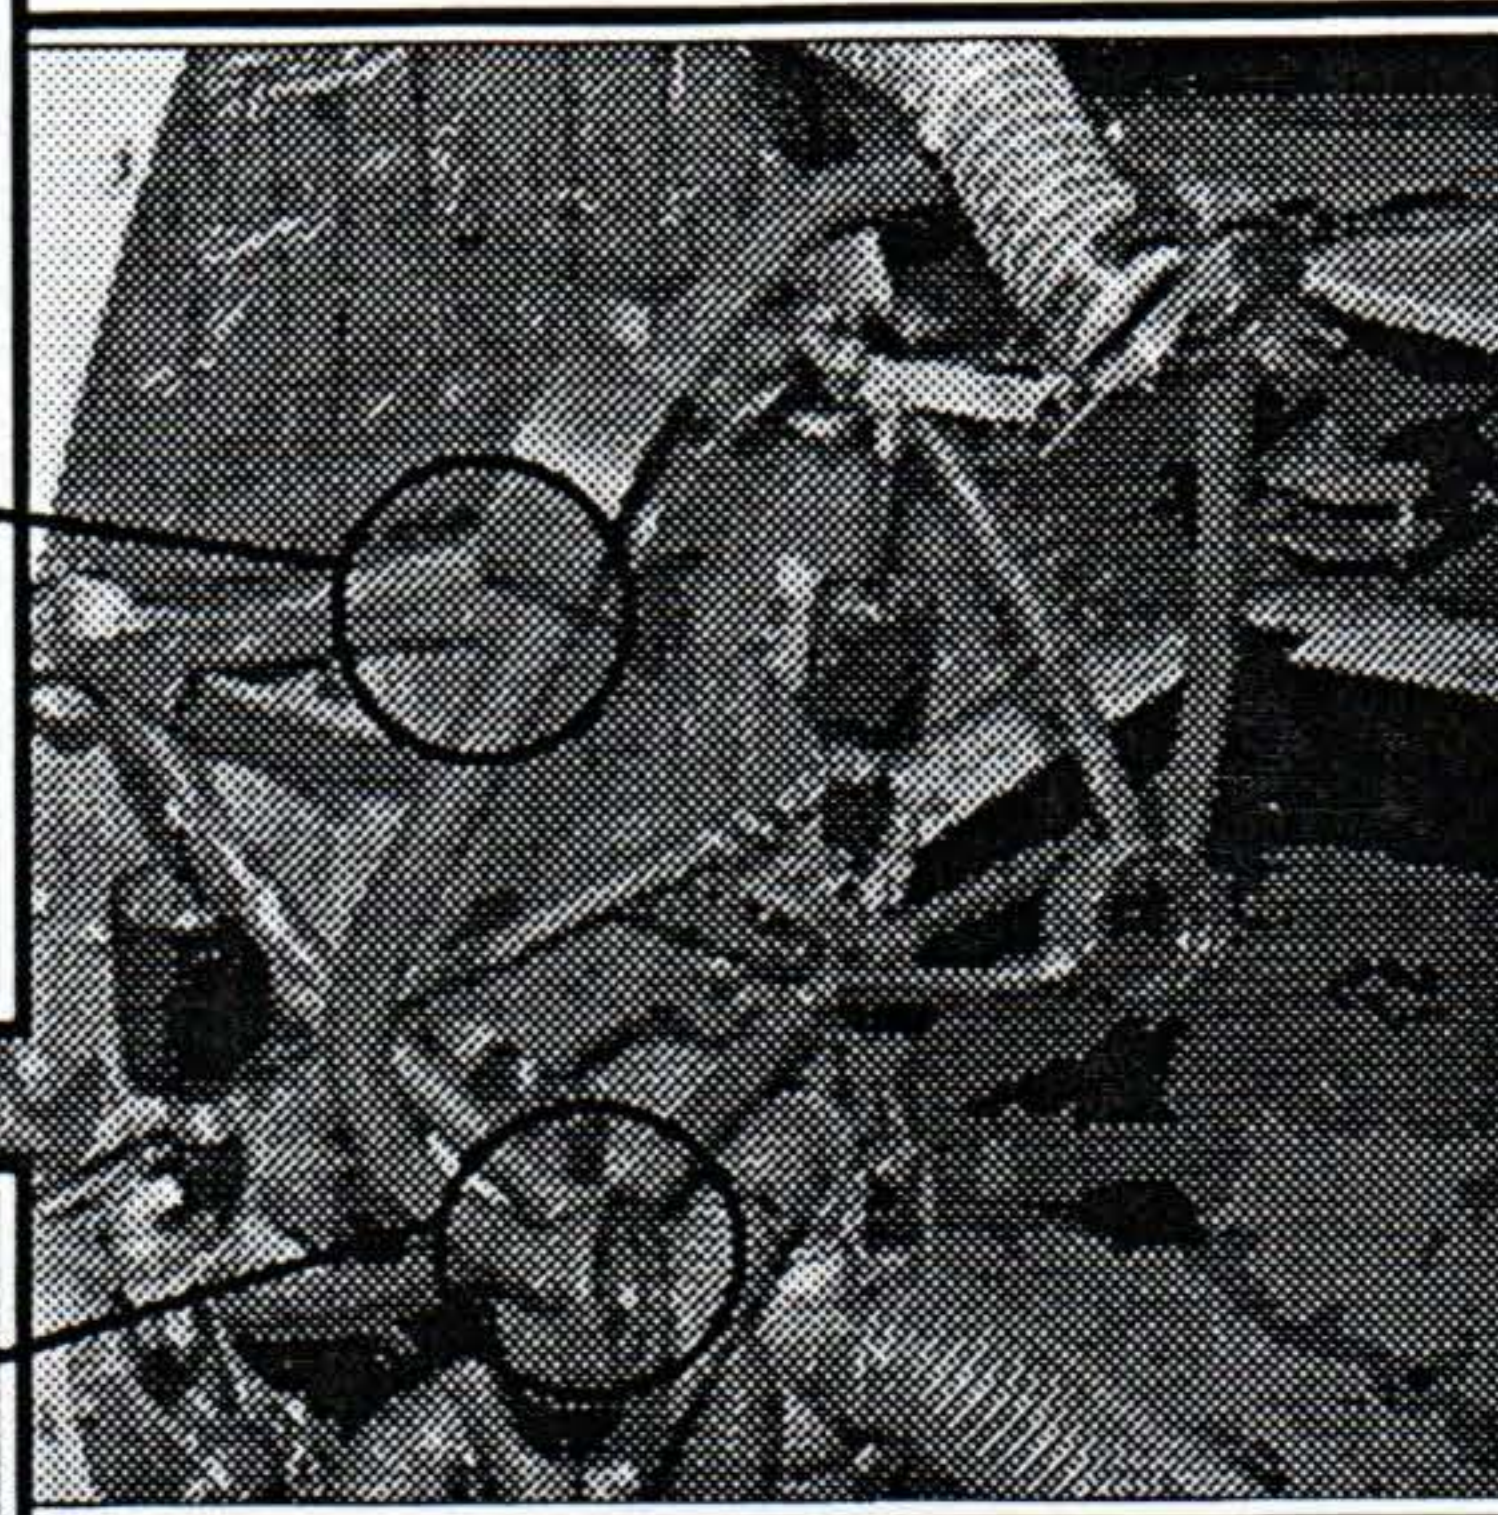
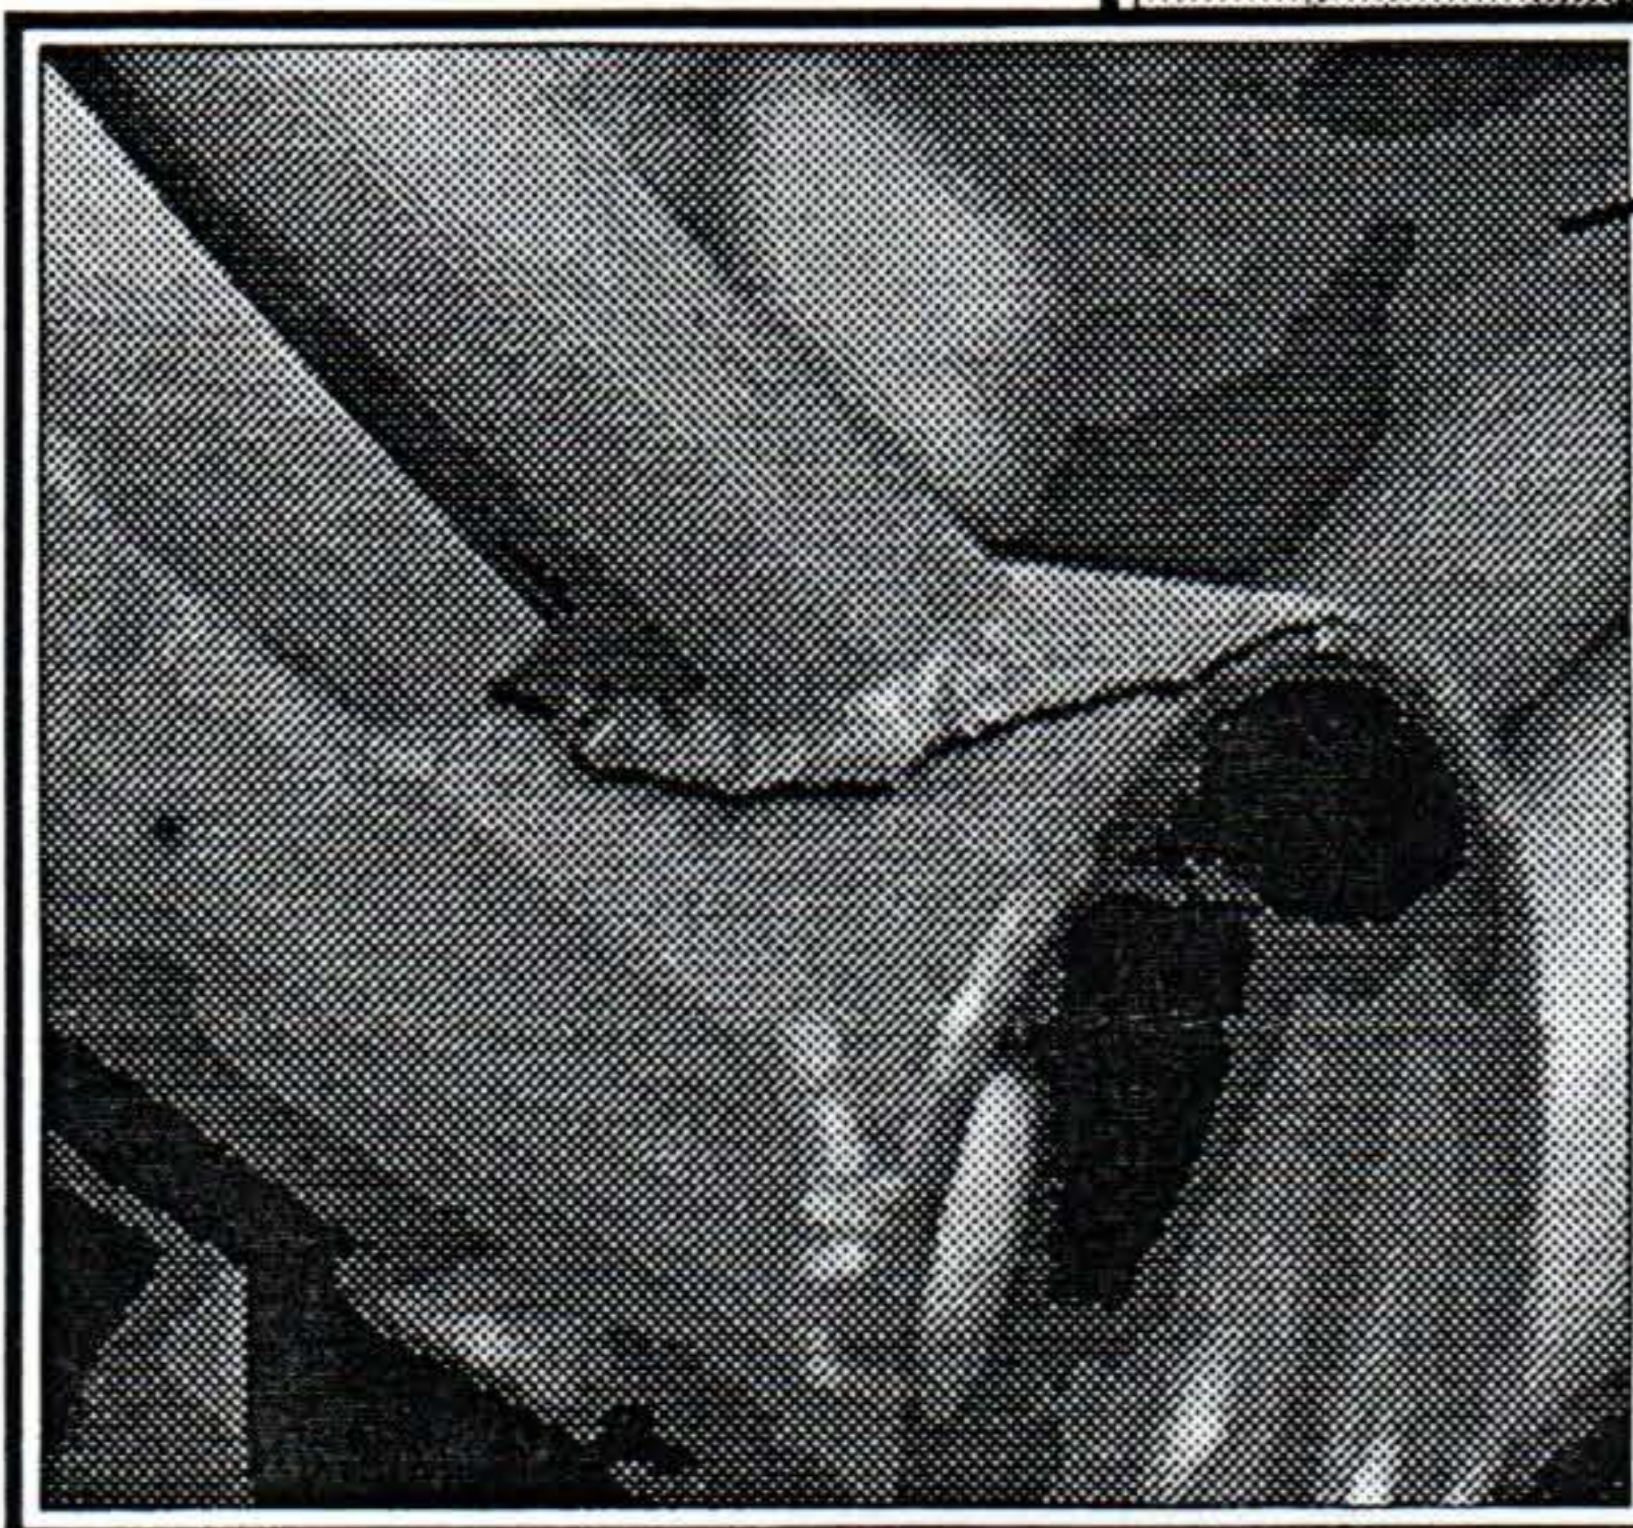
George Walters (SC) - Recently, while repairing a bad left mag I discovered a severely broken engine mount. The Brock mount had 1250 hours on it. The mount was completely broken on the upper left tube, almost completely on

the bottom left tube, and the upper right was cracked in half as well. Very shortly the engine would have left the airplane.

two days before during an annual inspection and saw nothing. There was some rust on the upper left crack so it had been cracked for a while.

Obviously, the mount is not strong enough to hold an O-320 with starter and alternator. The airplane has not been subjected to any out of balance propellers or spinners to cause severe vibration. I consider myself lucky to have found this in time.

Please check yours frequently!
