Service Letter SL 32 Rev.1

DOA - No.
 EASA.21J.020

All MT-; MTE- and MTV- Propellers with Natural Composite Blades

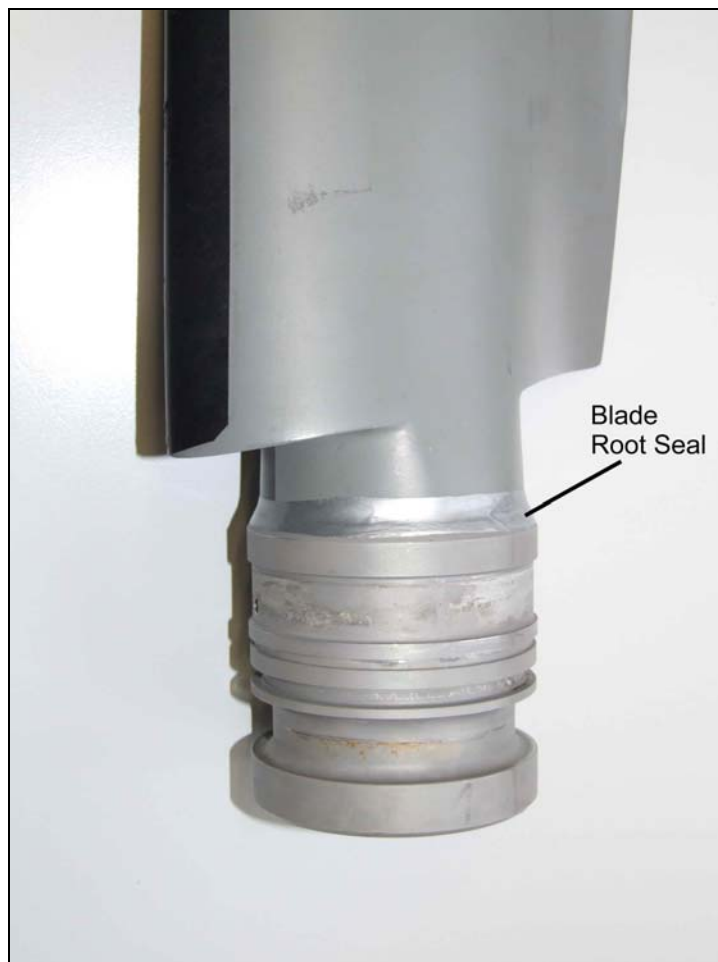
Possible Damage: Cuts due to incorrect spinner installation.

Repair: Clean the affected area and fill up the affected area with Silicone
(Refer to List of Materials)

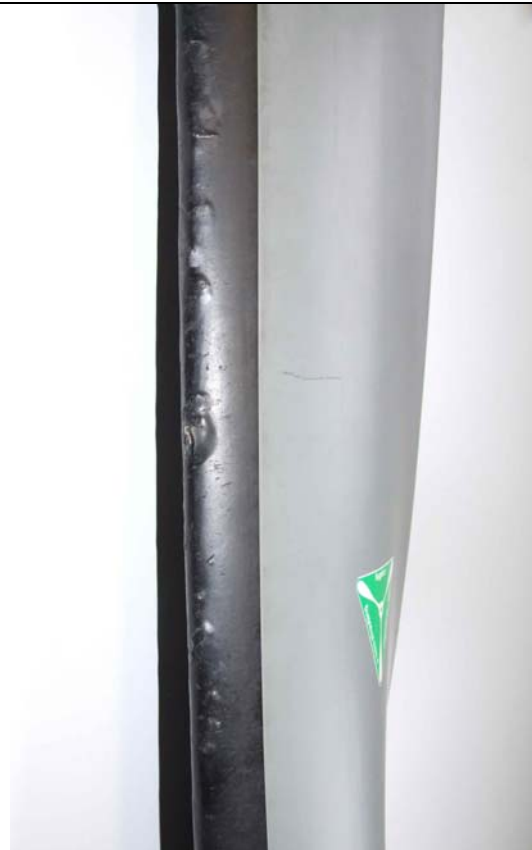
Typical Damage: Punched through PU-Strip

Possible Damage: Punched through or missing.

Repair: Completely replace erosion strip according to SI.37A

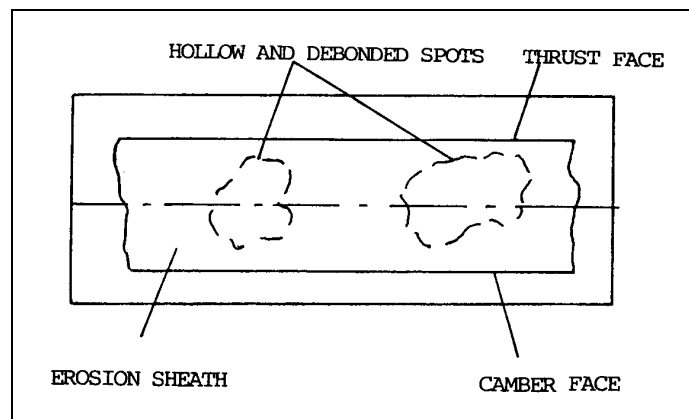
In case of debonding only very limited repair is possible. However the extent of debonding where repair is required is defined and not every debonding requires repair.

If any hollow and debonded spots exist, mark them. Whenever performing pre-flight inspection, monitor whether there are further delamination and/or whether the already existing delamination has become worse. The inspection can be executed by using an appropriate coin (Tab-Test).

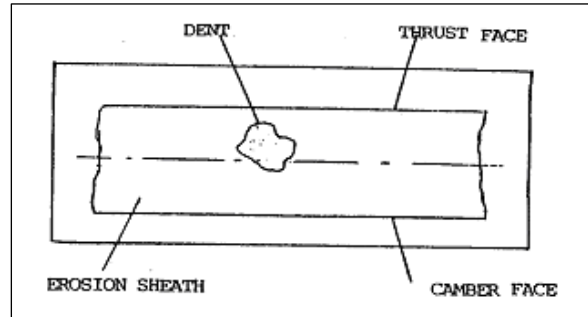
- ✓ Circular dents not more than 0,24 inch x 0,24 inch (6 mm x 6mm)
- ✓ Pointed dents not more than 0,24 inch x 0,24 inch (6 mm x 6 mm)
- ✓ If within 51 mm (2 inches) no other dents of that size are visible, the dent size may exceed the original maximum size by 3 mm (0,12 inch) to a maximum of 9 mm x 9 mm (0,36 inch x 0,36 inch).
- ✓ If within 76 mm (3 inches) no other dents of that size are visible, the dent size may exceed the original maximum size by 5 mm (0,197 inch) to a maximum of 11 mm x 11 mm (0,433 inch x 0,433 inch).

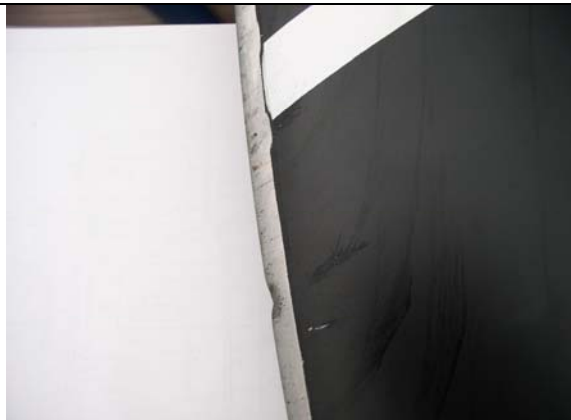
FOD below 6 mm x 6 mm (0,24 inch x 0,24 inch):
If within 51 mm (2 inches) no other dents of that size are visible, the dent size may exceed the original maximum size by 3 mm (0,12 inch) to a maximum of 9 mm x 9 mm (0,36 inch x 0,36 inch).
If within 76 mm (3 inches) no other dents of that size are visible, the dent size may exceed original maximum size by 5 mm (0,197 inch) to a maximum of 11 mm x 11 mm (0,433 inch x 0,433 inch)
No action necessary if not delaminated or punched through.
Dents may be filled with Epoxy!

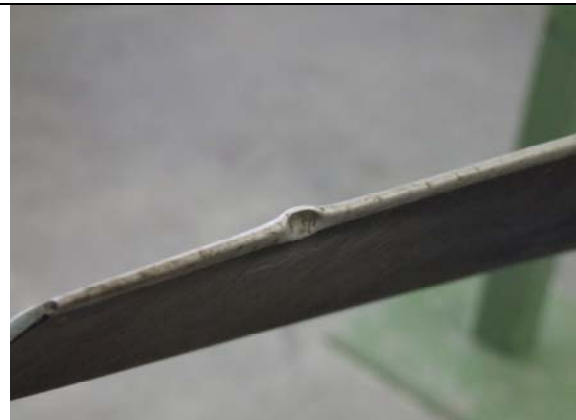
FOD exceeding limits shown on the left side.

Replace Erosion Sheath as soon as possible!

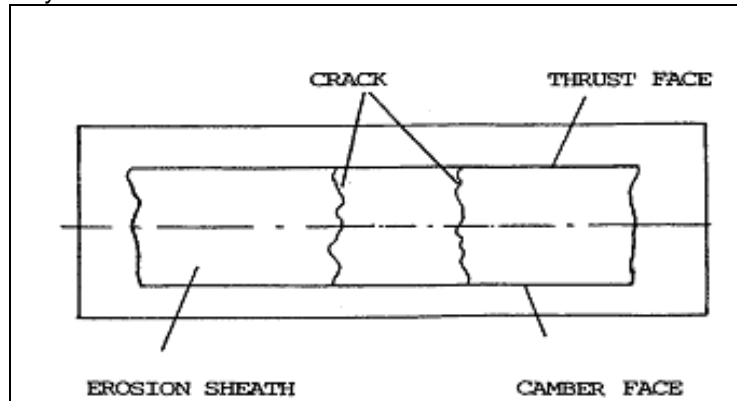
Cracked erosion sheaths require immediate repair. If chordwise cracks appear, return the propeller to the manufacturer or any authorized Service station.

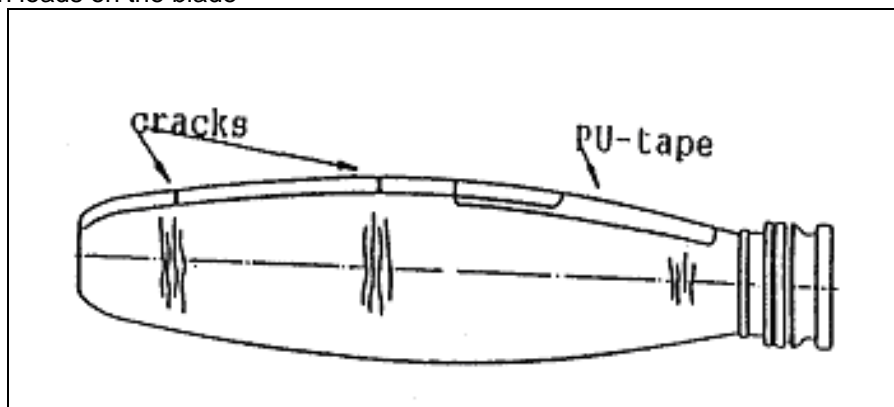
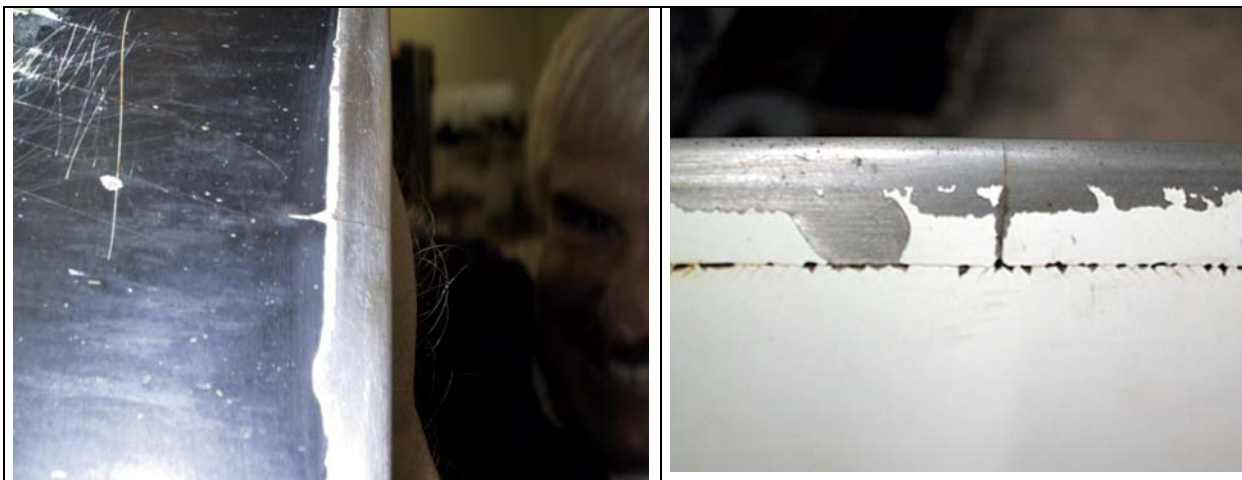
Chordwise cracks in the erosion sheath may also occur together with fine surface cracks indicating high vibration loads on the blade

When Erosion Sheath is cracked chordwise no field repair is possible

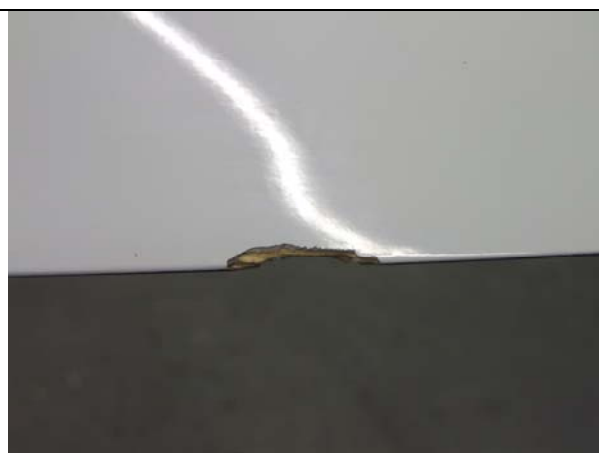
Tow bar damage, seal with Epoxy or repair permanently with fiber glass

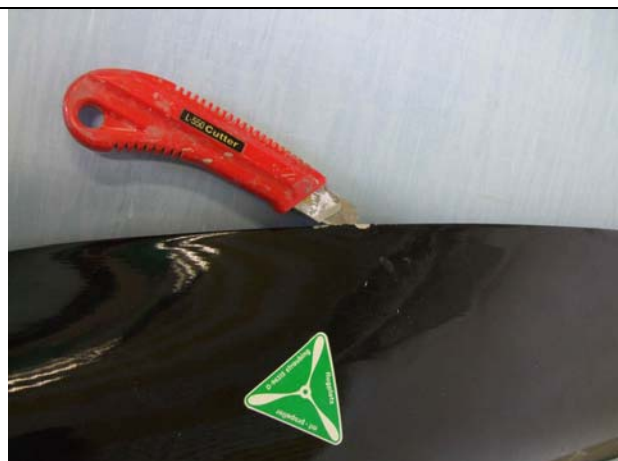
Delaminated composite shell on the trailing edge

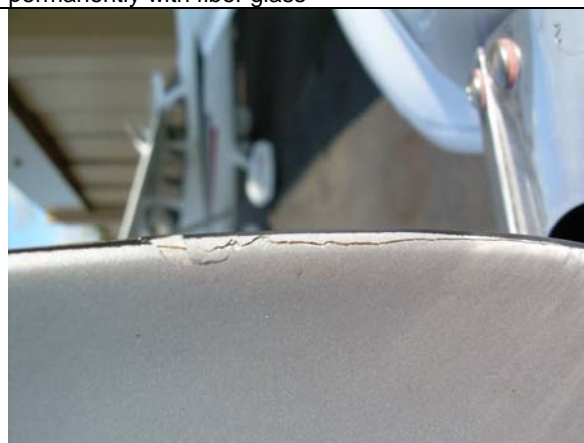
Damage caused by Cowling, seal and fill up with epoxy

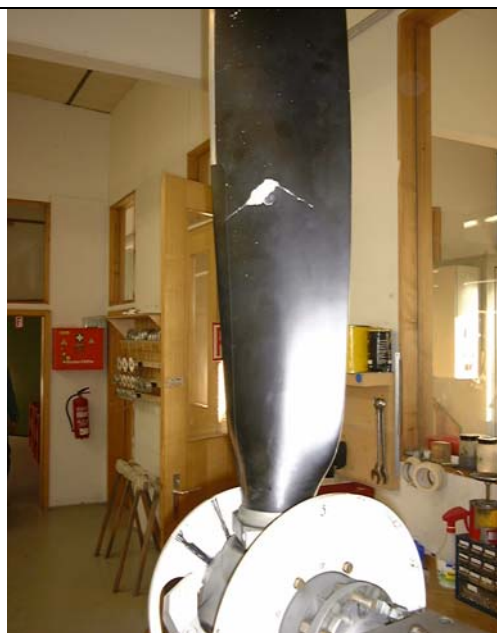
Blade Surface damage obviously exceeding the field
repair limits

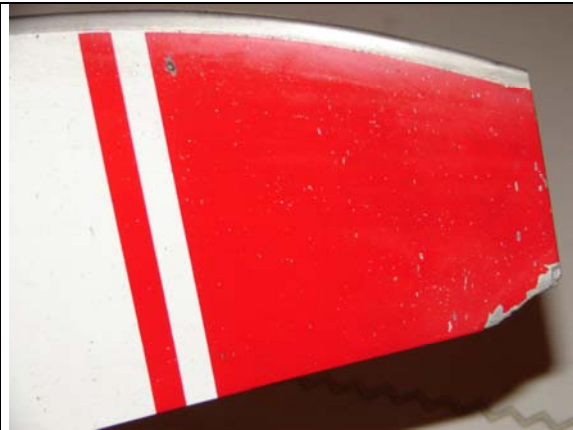
Hangar Damage: Broken Tip Trailing Edge
Seal with 5 Minute Epoxy or permanent repair with
Fiber Glass

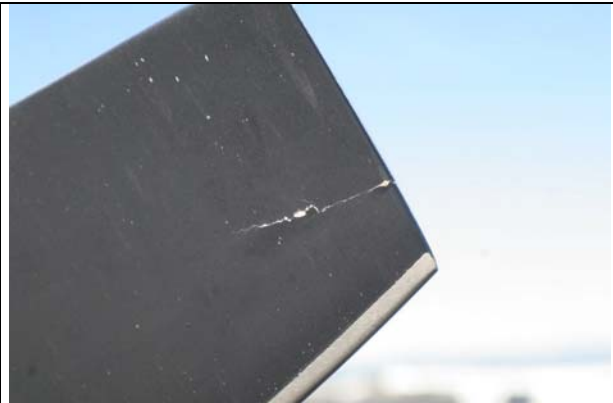
Split Blade tip. Repair with fiber glass

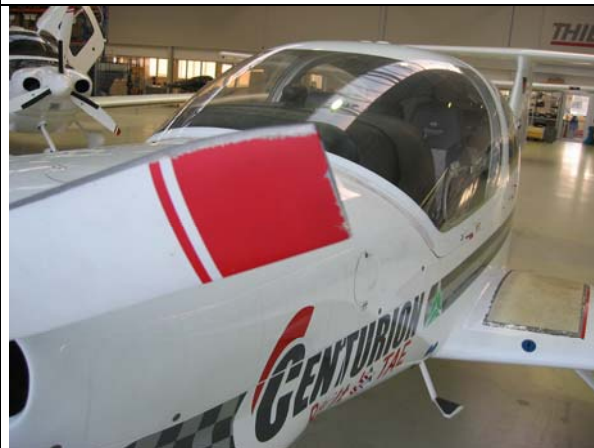
Paint and Filler Material scratched off from Blade Tip.
Seal with 5 Minute Epoxy

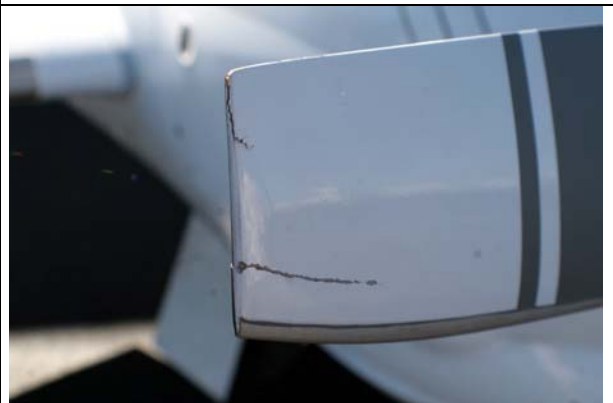
Split Blade Tip and delaminated trailing Edge.
Rebond Trailing Edge with 5 minute Epoxy.
Repair split Tip with Fiber Glass
