Gary Hertzler's Vari-Eze

Carl Denk - Cosy Classic

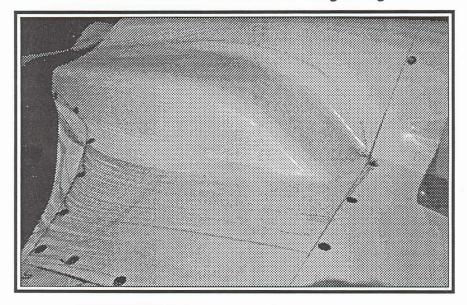
I was most pleased with the flow around the gear leg fairing. There does not seem to be any significant disturbance downstream. I was most concerned with this because of the non-perpendicular intersection between the gear leg and fuselage sides.

oil flow shows no disturbance from gear leg

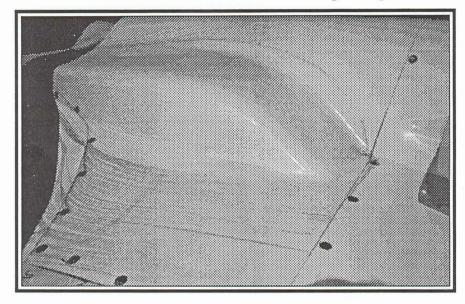
I was most pleased with the flow around the gear leg fairing. There does not seem to be any significant disturbance downstream. I was most concerned with this because of the non-perpendicular intersection between the gear leg and fuselage sides.

oil flow shows no disturbance from gear leg

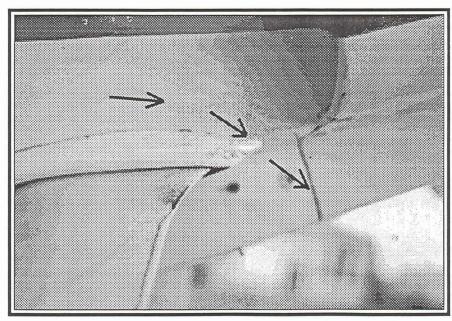
Oil flow and earlier tuft testing showed why. Note the air flow curves down the side of the fuselage between the gear leg and the arm pit inlet. It avoids entering the cowl. I guess you can't blame it. The temperature is pretty high in there. This is a test. What do you think should be done to get the air into the cowl?

cool air by passes cowl inlet

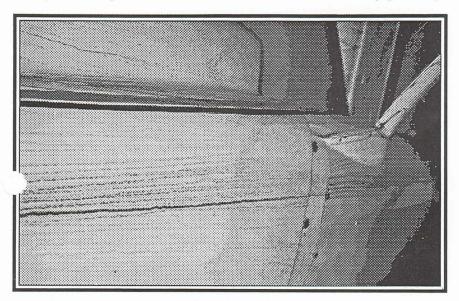
air goes straight back into inlet and is not affected by gear leg

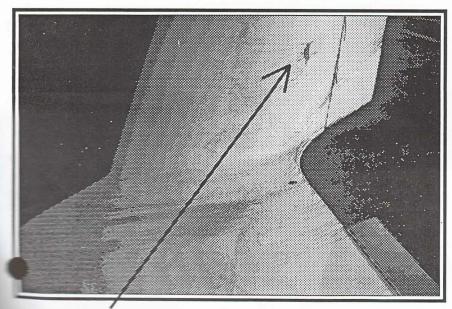
Very straight flow around gear leg fairing

The landing gear strut airfoil has been elongated to align with the flow but separation still occurs before 50% chord. It appears Klaus's previously printed airfoil (CSA Jan 95 p 32) is what is needed to keep the air from separating. On my Long-EZ that airfoil would be nearly 11" long.

Air flow separation begins

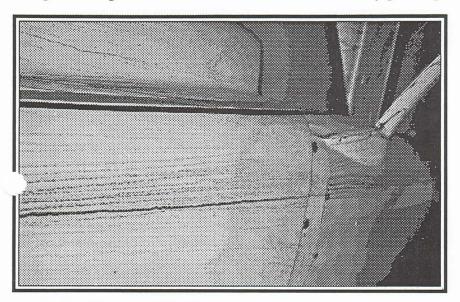
air goes straight back into inlet and is not affected by gear leg

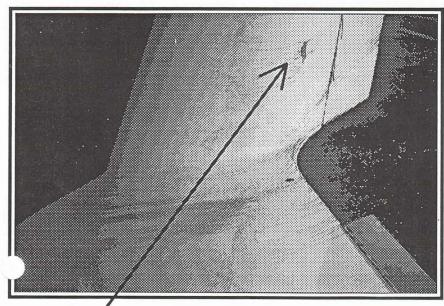
Very straight flow around gear leg fairing
