## Bob Davenport's Long-EZ

*Bob Davenport (FL)* - The photos show oil flow on my new boat tail cowl and modified Sport Flight wheel pants. Flow lines are light as I was unable to get to the drain oil. I used engine oil with light grease mixed in.

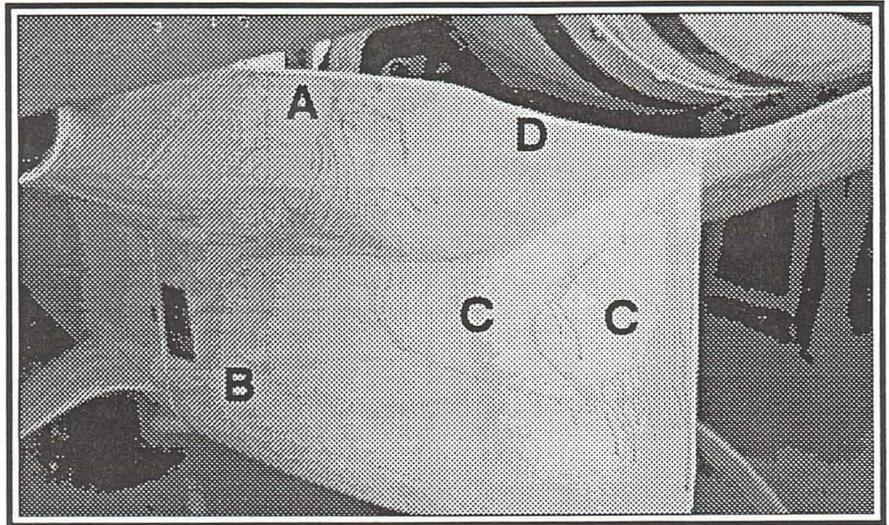
It appears the gear leg intersection creates a large turbulent area, "A". Areas "B" & "C" are believed to be caused by the reverse curve in the rear cowl sides with probably some influence from the bubble over the alternator at "D". The bubble is minimal in size and I doubt there is much else I can do with it.

The flow separation on the cowl sides proves Klaus was correct when he told me the cowl length was too short to use a reverse curve without causing drag. The sides should continuously curve from firewall to tail post.

Unattached flow caused by alternator dome

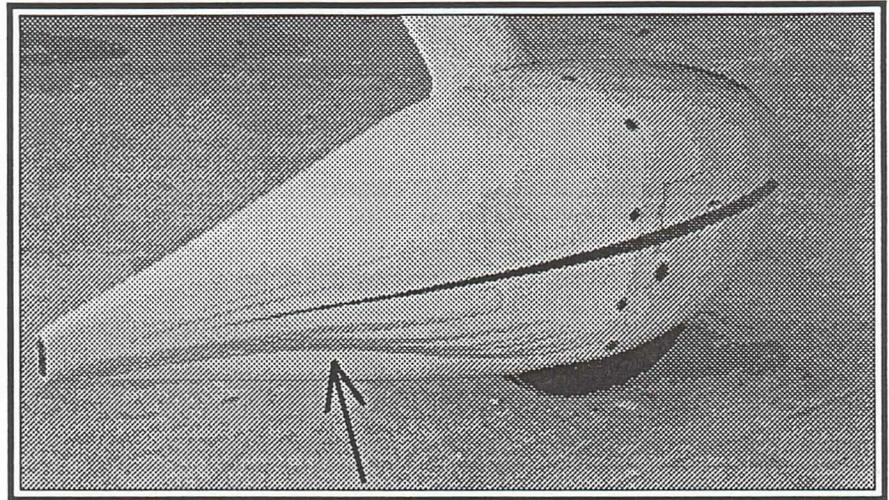
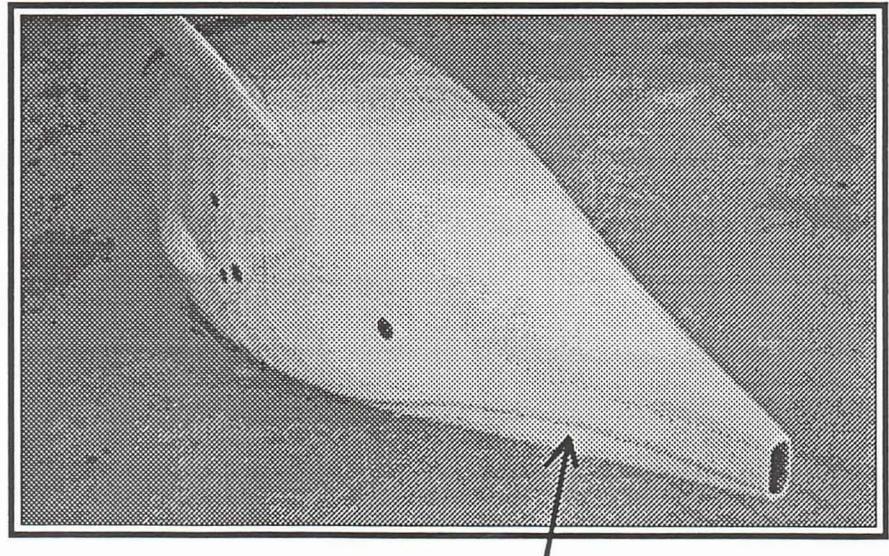
The tire extending below the wheel pant seems to cause a lot of turbulence on the underside of the pant.

It would be interesting to see how Rob Martinson's fairing aft of the tire would affect the curved air flow

*Editor: At Wendover 95 Rob Martinson addressed this with a small fairing aft of the tire under the pant.*

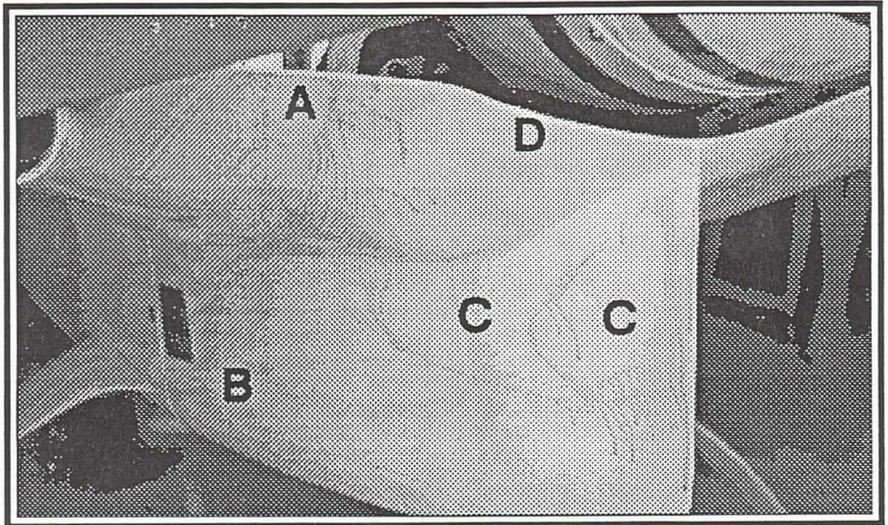
It appears the gear leg intersection creates a large turbulent area, "A". Areas "B" & "C" are believed to be caused by the reverse curve in the rear cowl sides with probably some influence from the bubble over the alternator at "D". The bubble is minimal in size and I doubt there is much else I can do with it.

The flow separation on the cowl sides proves Klaus was correct when he told me the cowl length was too short to use a reverse curve without causing drag. The sides should continuously curve from firewall to tail post.

Unattached flow caused by alternator dome

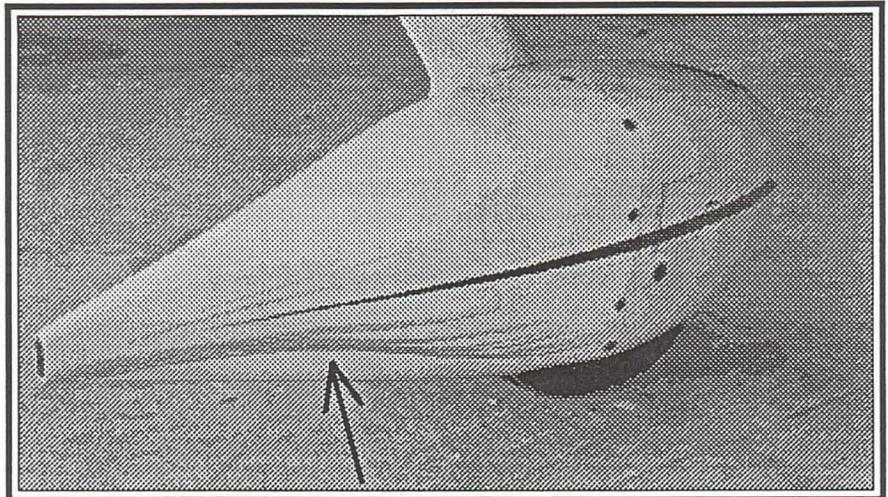
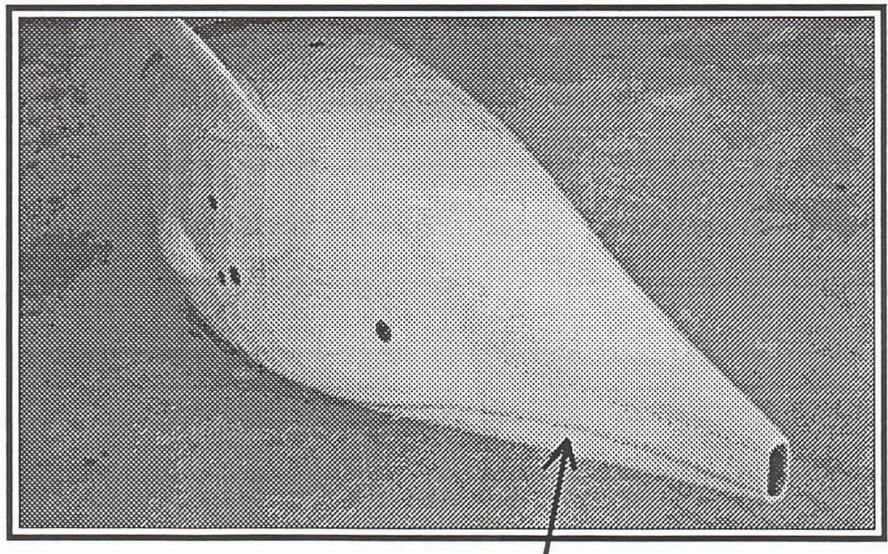
The tire extending below the wheel pant seems to cause a lot of turbulence on the underside of the pant.

It would be interesting to see how Rob Martinson's fairing aft of the tire would affect the curved air flow

*Editor: At Wendover 95 Rob Martinson addressed this with a small fairing aft of the tire under the pant.*
