## New Berkut Canard Deck

*James Redmon (TX) - I first installed the original design canard deck over 4 years before writing this section. I never included it on the website, but I thought I'd share the re-installation process as it is a Berkut exclusive.*

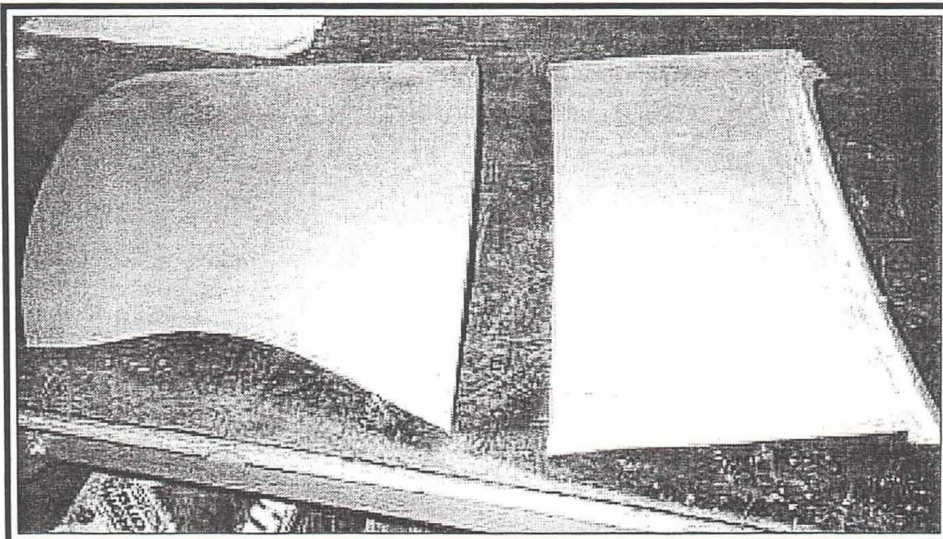
Berkut supplied 2 piece canard deck

As expected, the first step is cutting off the old 2-piece canard deck. I think it physically hurt taking an air-saw and slicing off chunks of the very thing I am trying to put together, but it all turned out great in the end.

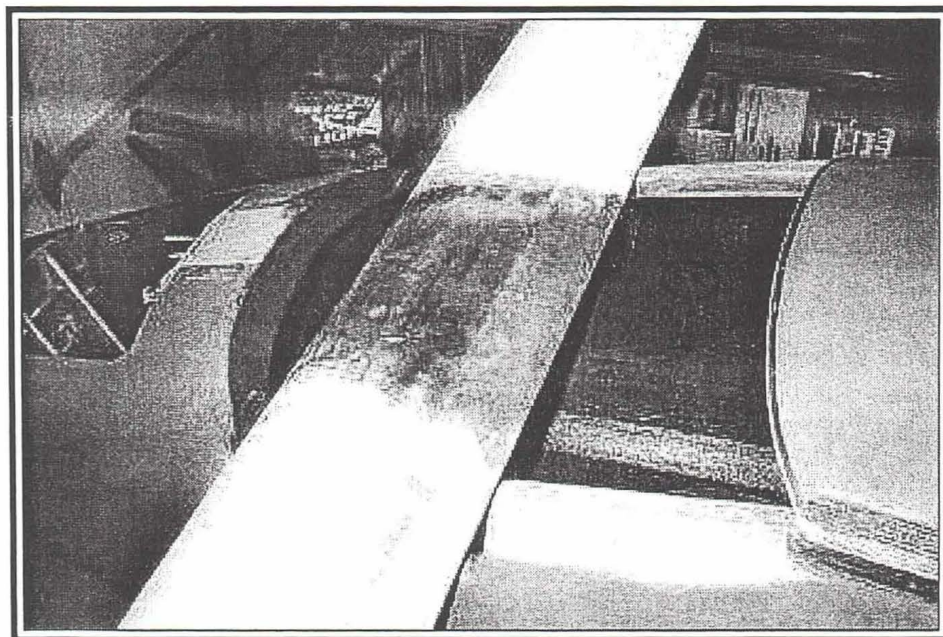
canard attached to bulkhead

The deck is then bonded onto the canard. Once cured, the front edge of the deck is cut back to be bonded to the forward deck bulkhead. The forward canard bulkhead is also cut back to allow micro to be placed between it and the deck.

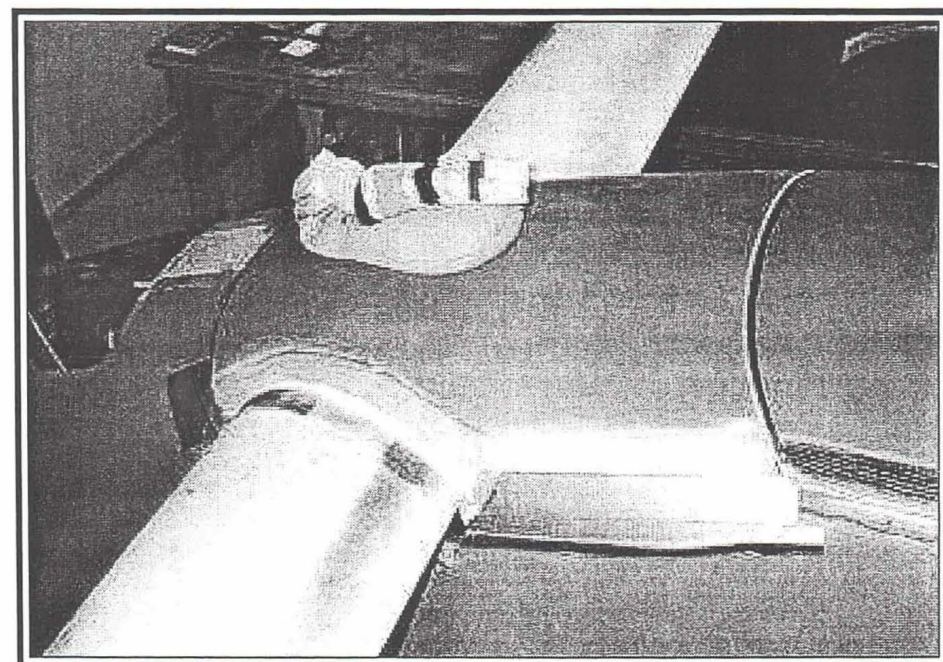
single piece canard and deck ready for screw attachments  
issue 67 page 27

Hefty plys of BID are placed over the tapes on the longerons to form a "C" shaped lip, just like what is on the canopy sides. This will allow the aft

end of the deck to be attached to the longerons via a set of screws and nuts, more on that later.

Finally, the whole canard deck assembly is replaced and bolted back into position on top of the front bulkhead and the new "C" shaped side rails. Est Fini!!
