Fuel Cap Loss Causes Two Fatalities

Emergency Bulletin

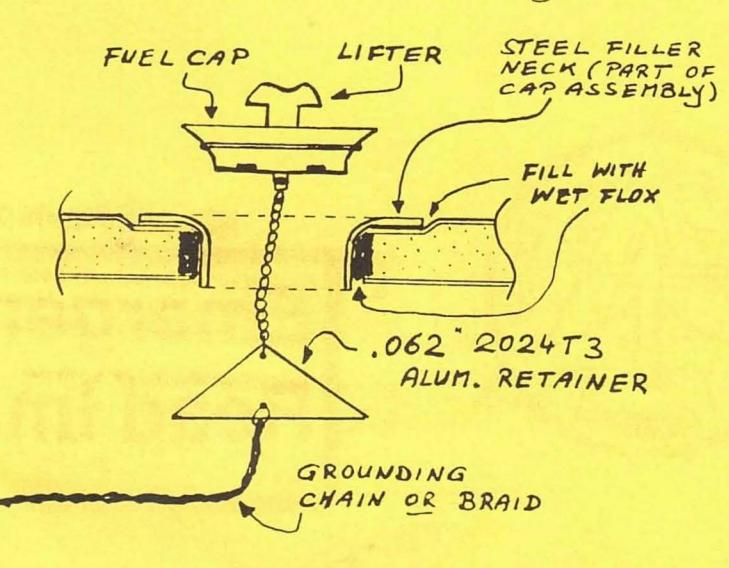
COSY Classic plans show an interesting idea for providing static electric protection while also serving as a fuel cap retainer. It is easy to make, cheap, light weight, will not contaminate the fuel tank. I've reprinted it for your convenience.
