# Leaky MA-3 Carburetor?

My O-235-C powered Long-EZ has over 1,000 hours on it with the same badly worn MA-3 carburetor which was on it at first flight. I decided it would be a good time to comply with all the service bulletins and replace the throttle shaft, 2 piece venturi, and finally change from the composite float.

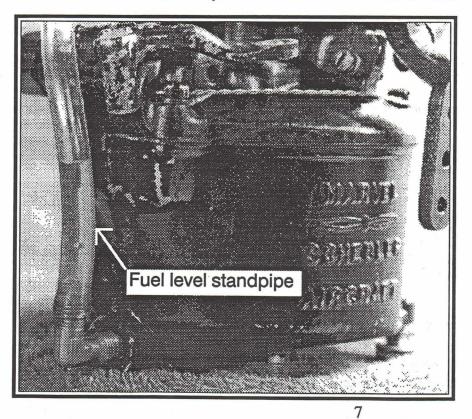
I then screwed a fitting into the float bowl drain and rigged a clear tube sight gage to so I could monitor fuel level while the carb was under pressure. I found the fuel level was moving swiftly up to the desired level and then **SLOWLY** moving higher and higher until it overflowed out the float chamber vent. (See adjacent photo)

That indicated the brand new Precision Alrmotive needle and seat assembly must be leaking. I replaced it with a STC'd Consolidated Fuel Systems part and **PRESTO** the fuel level stayed right where it should have stayed. Ahh, so much for OEM high priced parts. Or so I thought.

I then sent it away to one of those high dollar repair places and for \$158.60 I found the \$3 clip that holds the needle to the float assembly was at fault. It no longer provided proper alignment between the needle and seat. I reinstalled the carb and it seemed to work properly. I now have two flights on it and nothing is running out the bottom of the cowl. Could it be the problem is **solved**?
