# Common Overhaul Mistakes (and How to Survive Them)

by Kas Thomas

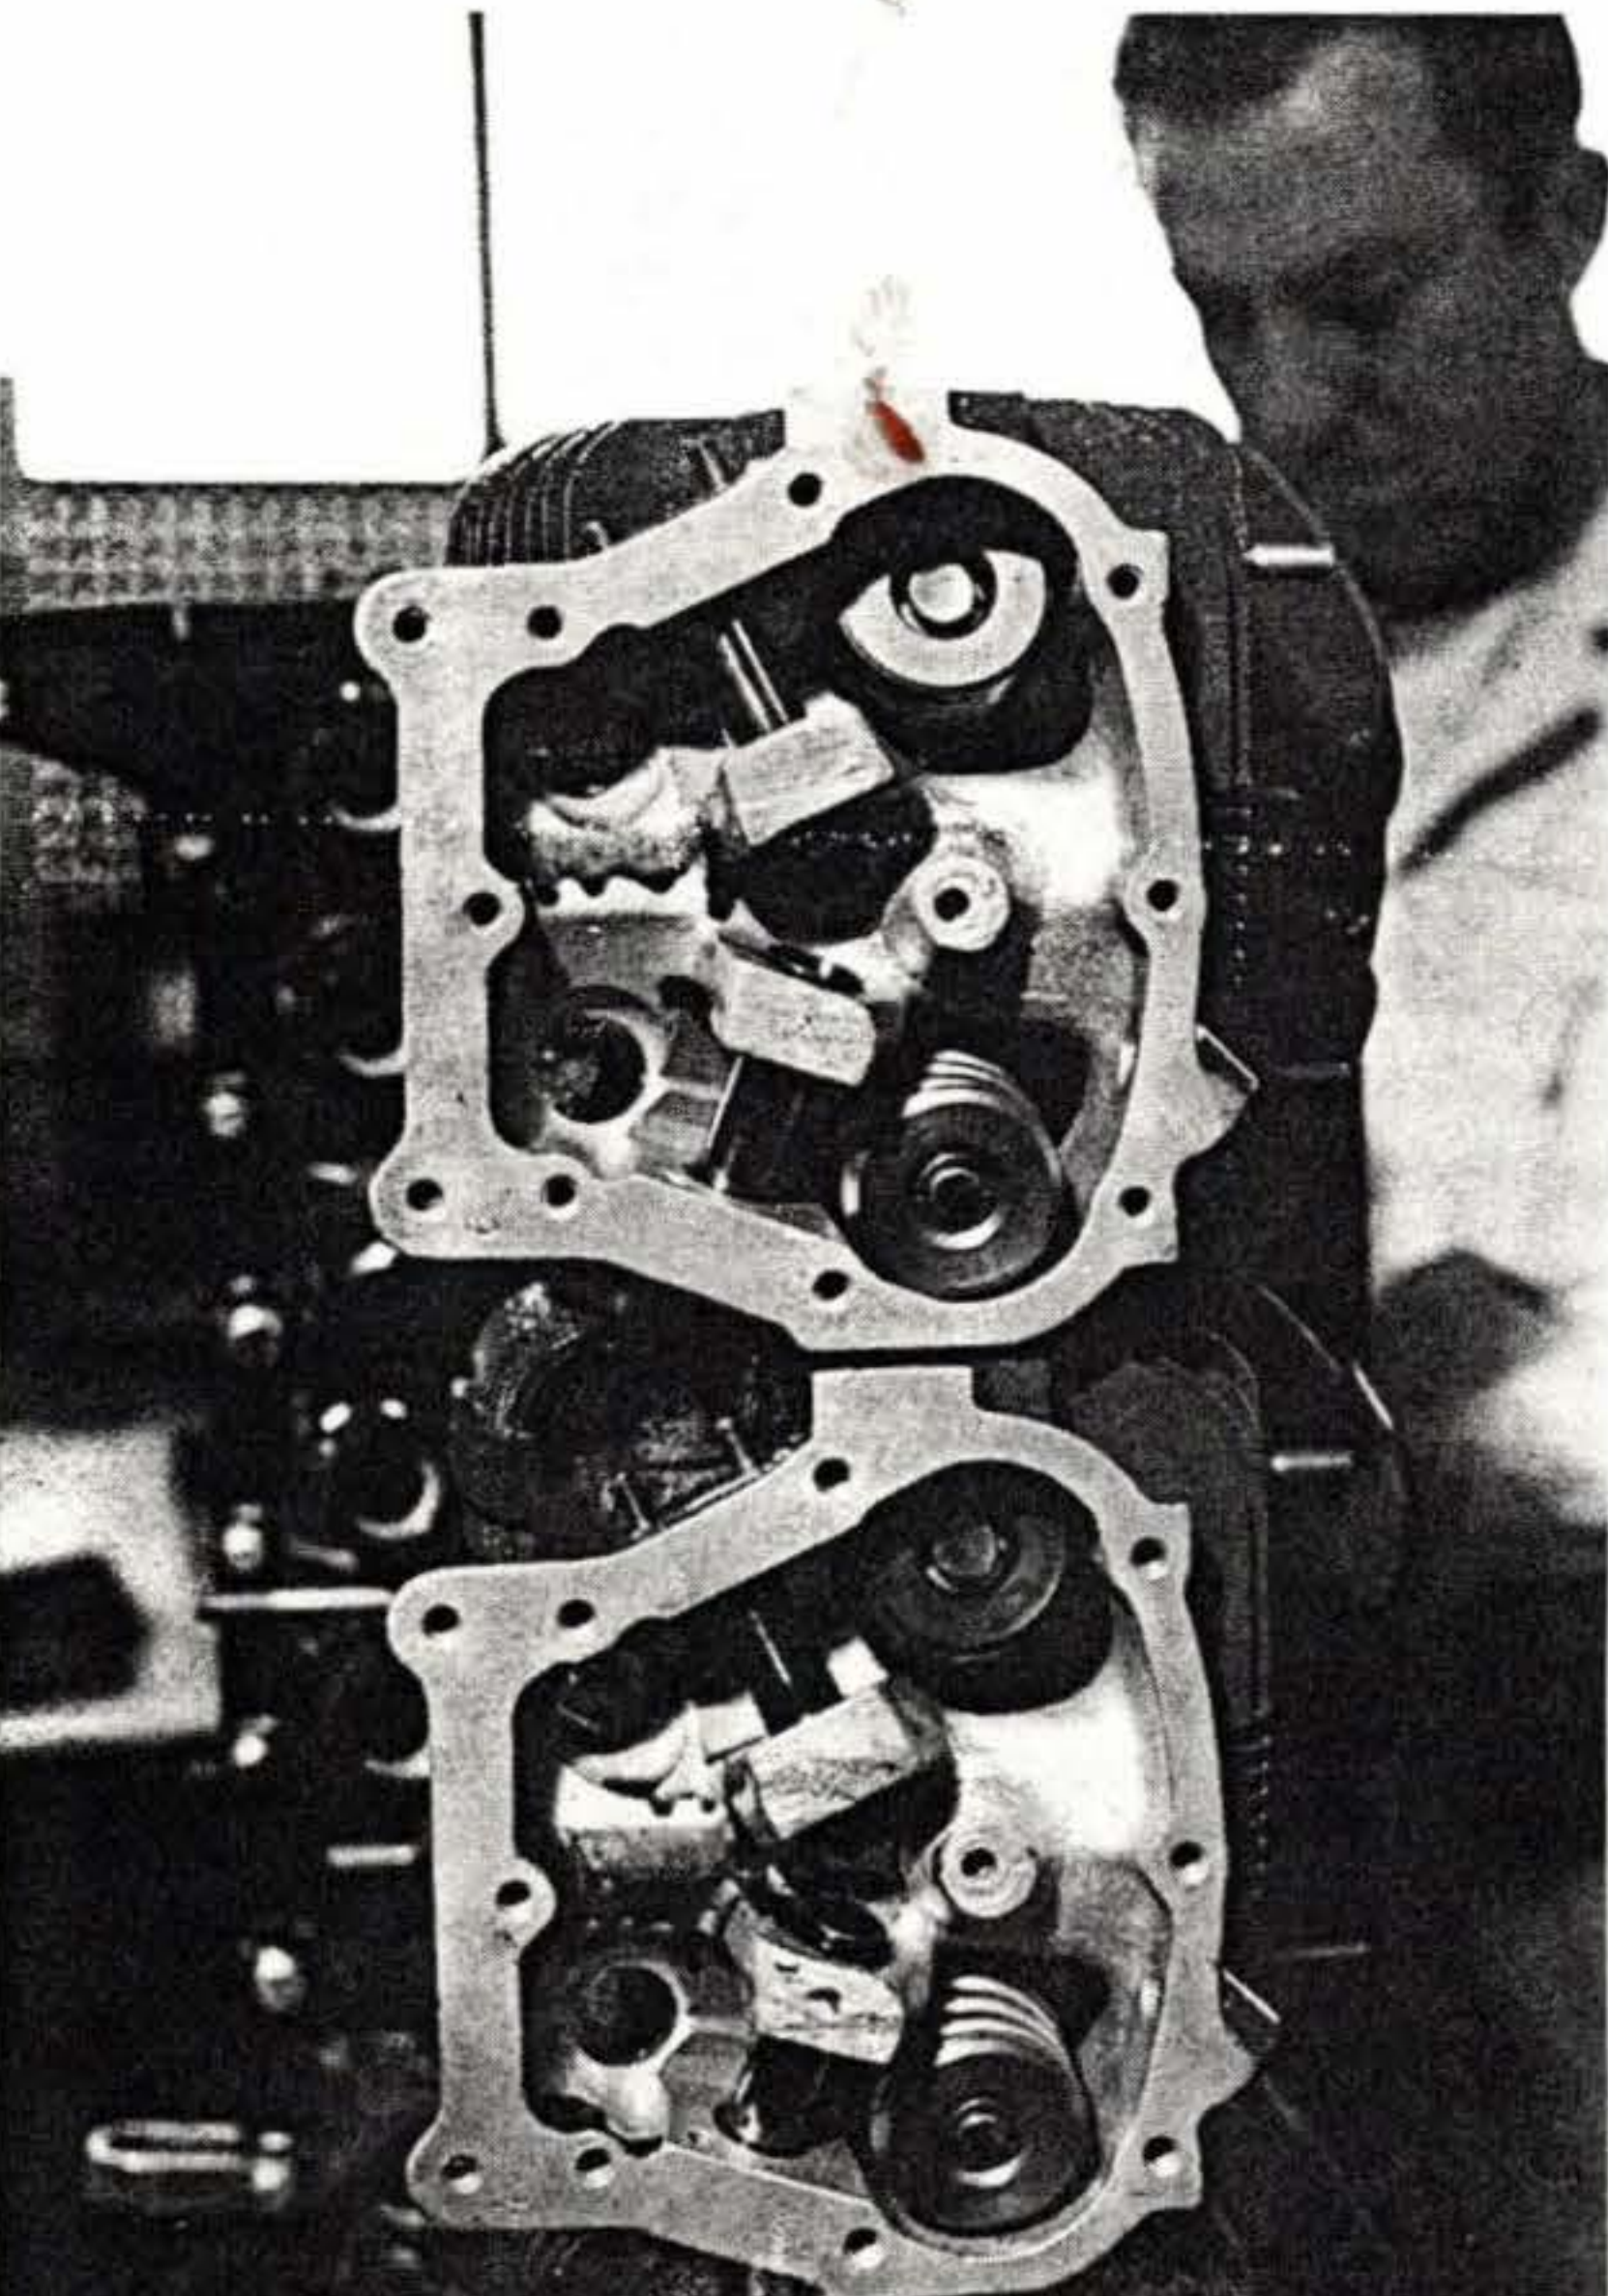
*Lycoming engines come in parallel-valve and angle-valve cylinder head types. The IO-540 shown at left has angled valves.*

*Not only are the valves themselves different in the two engine types, but the guides they use are different—and easy to mix up, with potentially disastrous results (see story on page 16).*

It turns out that Lycoming *angle-head* valve guides, P/N 75838, had been put in the cylinder instead of the parallel-valve P/N 74230 guide. (The TIO-540-C1A uses parallel-valve cylinder heads.) The difference between these two parts? The angle-head guide is a quarter-inch longer on the rocker arm (top) side than the parallel-valve counterpart. What this means (if you get them reversed, as I did) is that each time the valve is depressed, the

spring keeper bangs against the too-tall guide lip, creating stresses that feed back into the pushrod and rocker ears. Eventually, something's got to give: either the pushrod bends, or the rocker ears crack. Or both.

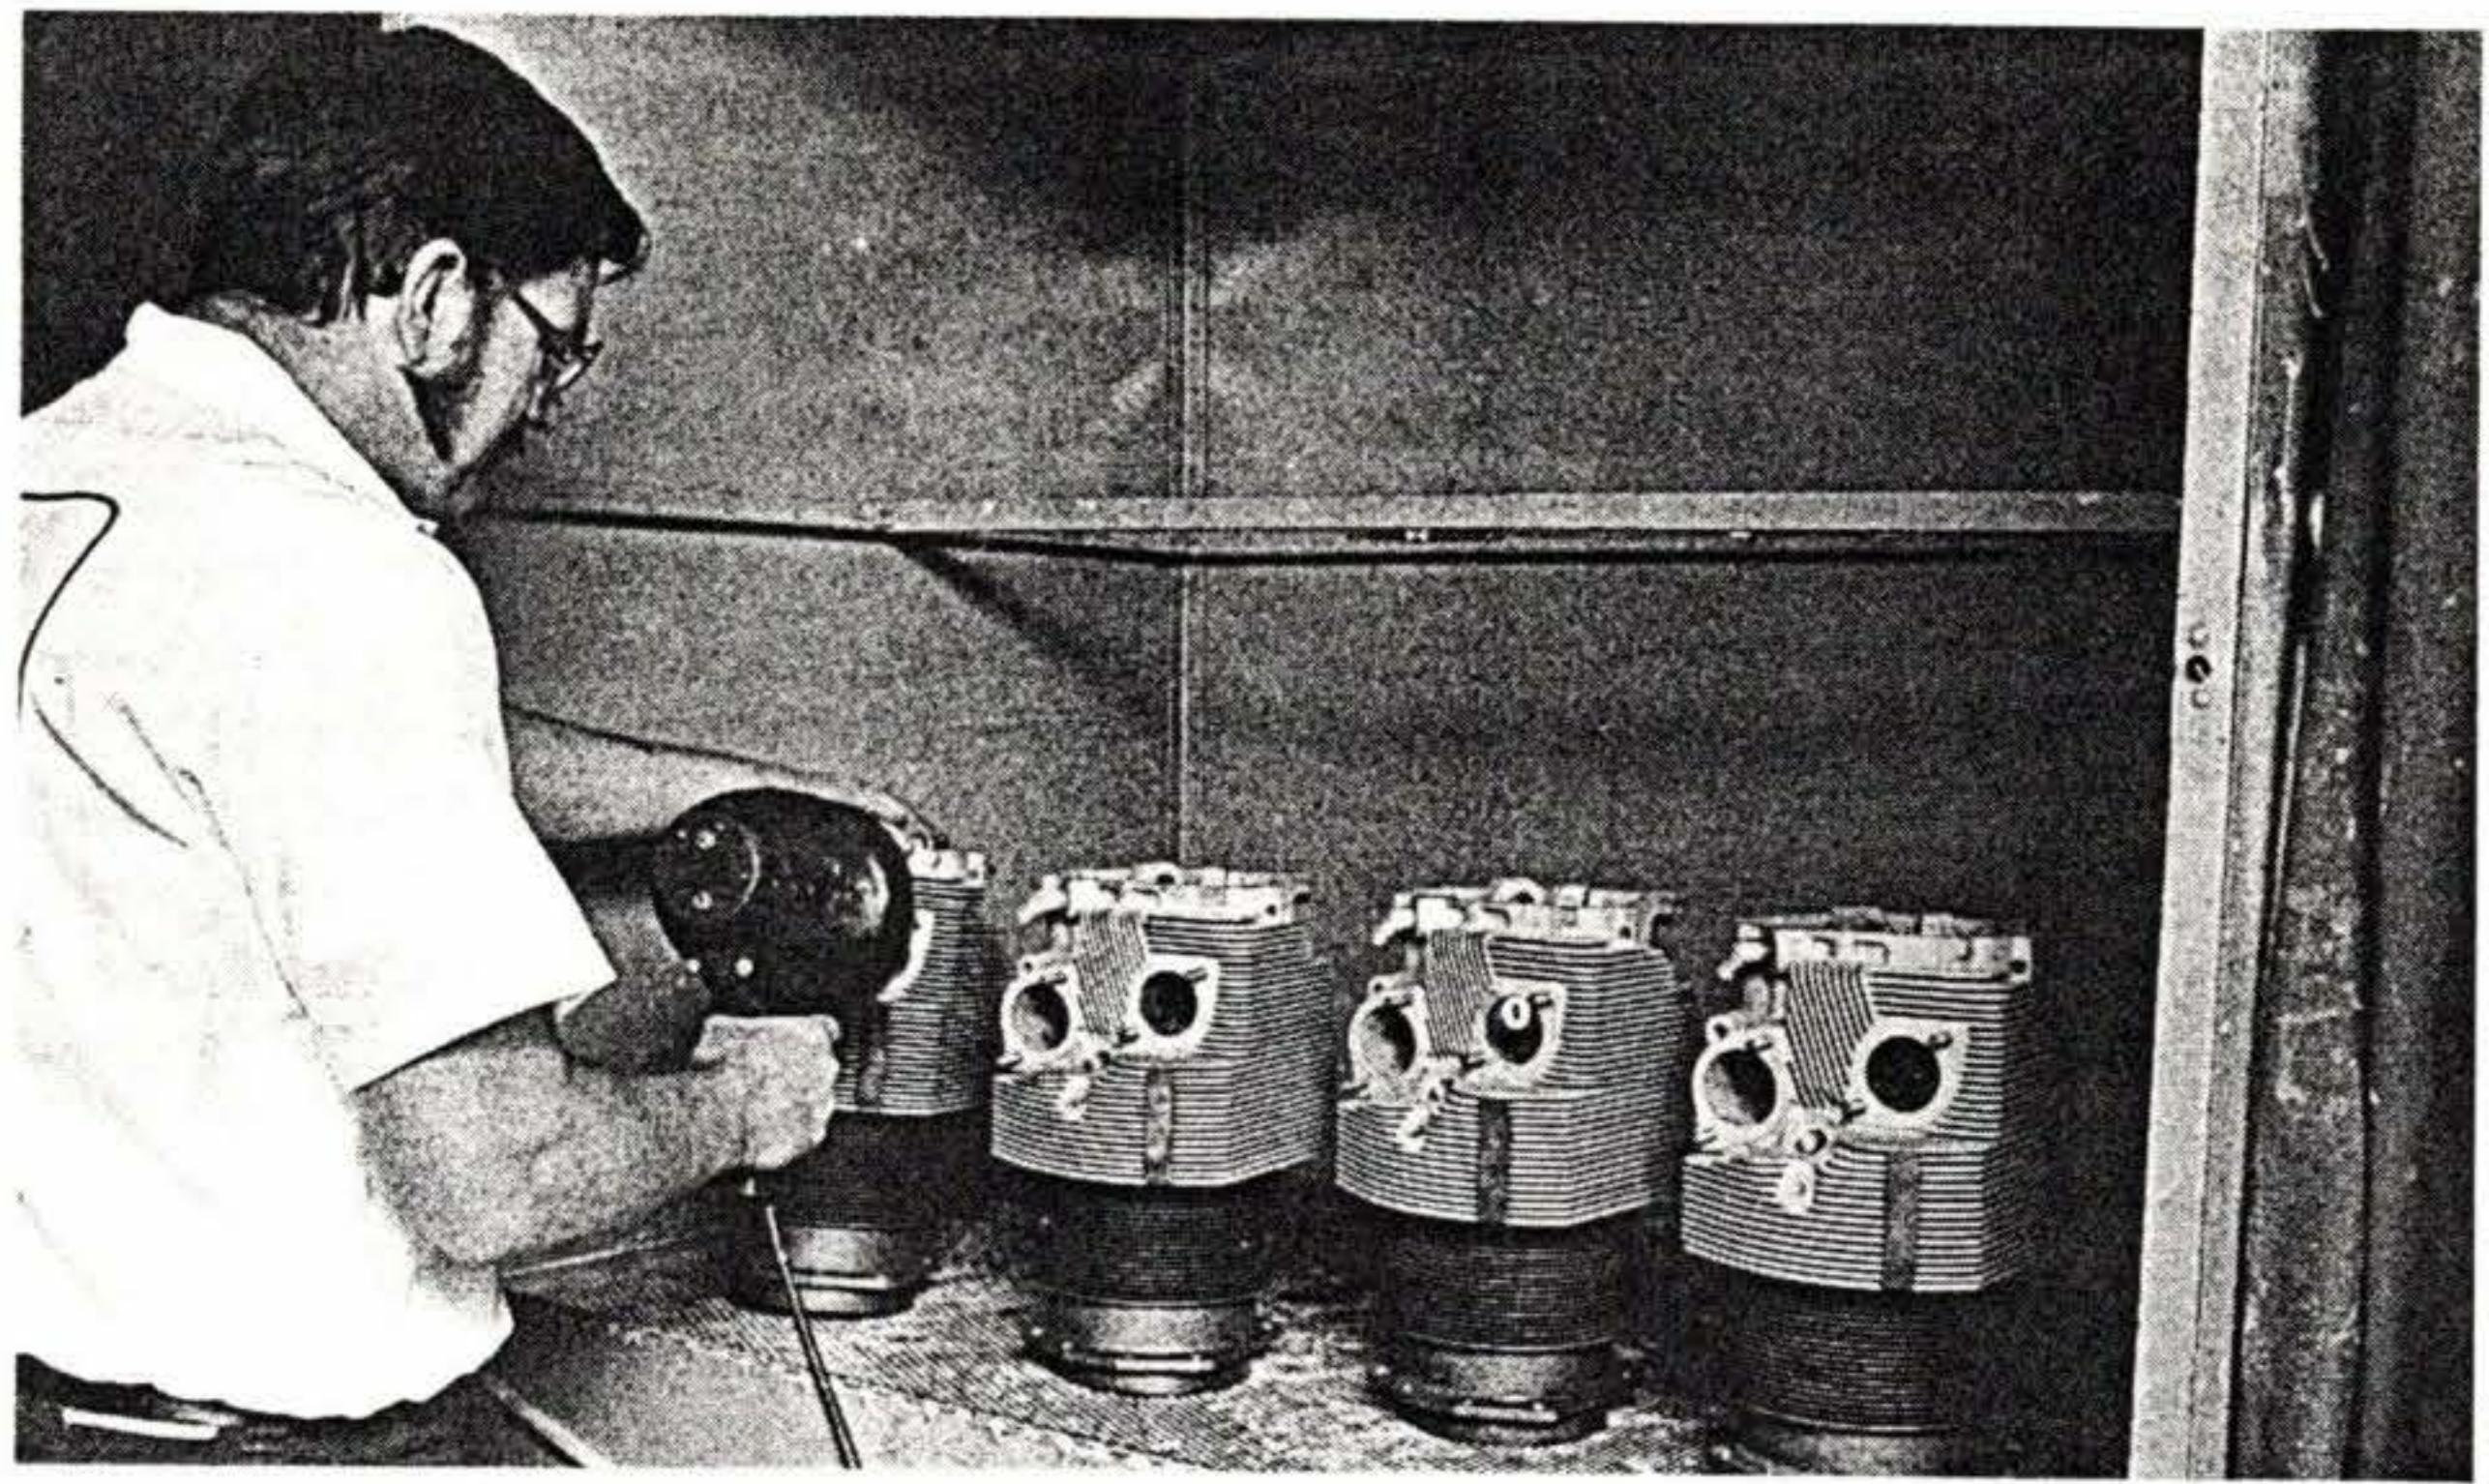
*Fortunately, most overhaul errors are top-end or cylinder related and do not involve safety of flight. Sloppy honing, grinding, and chroming are common.*

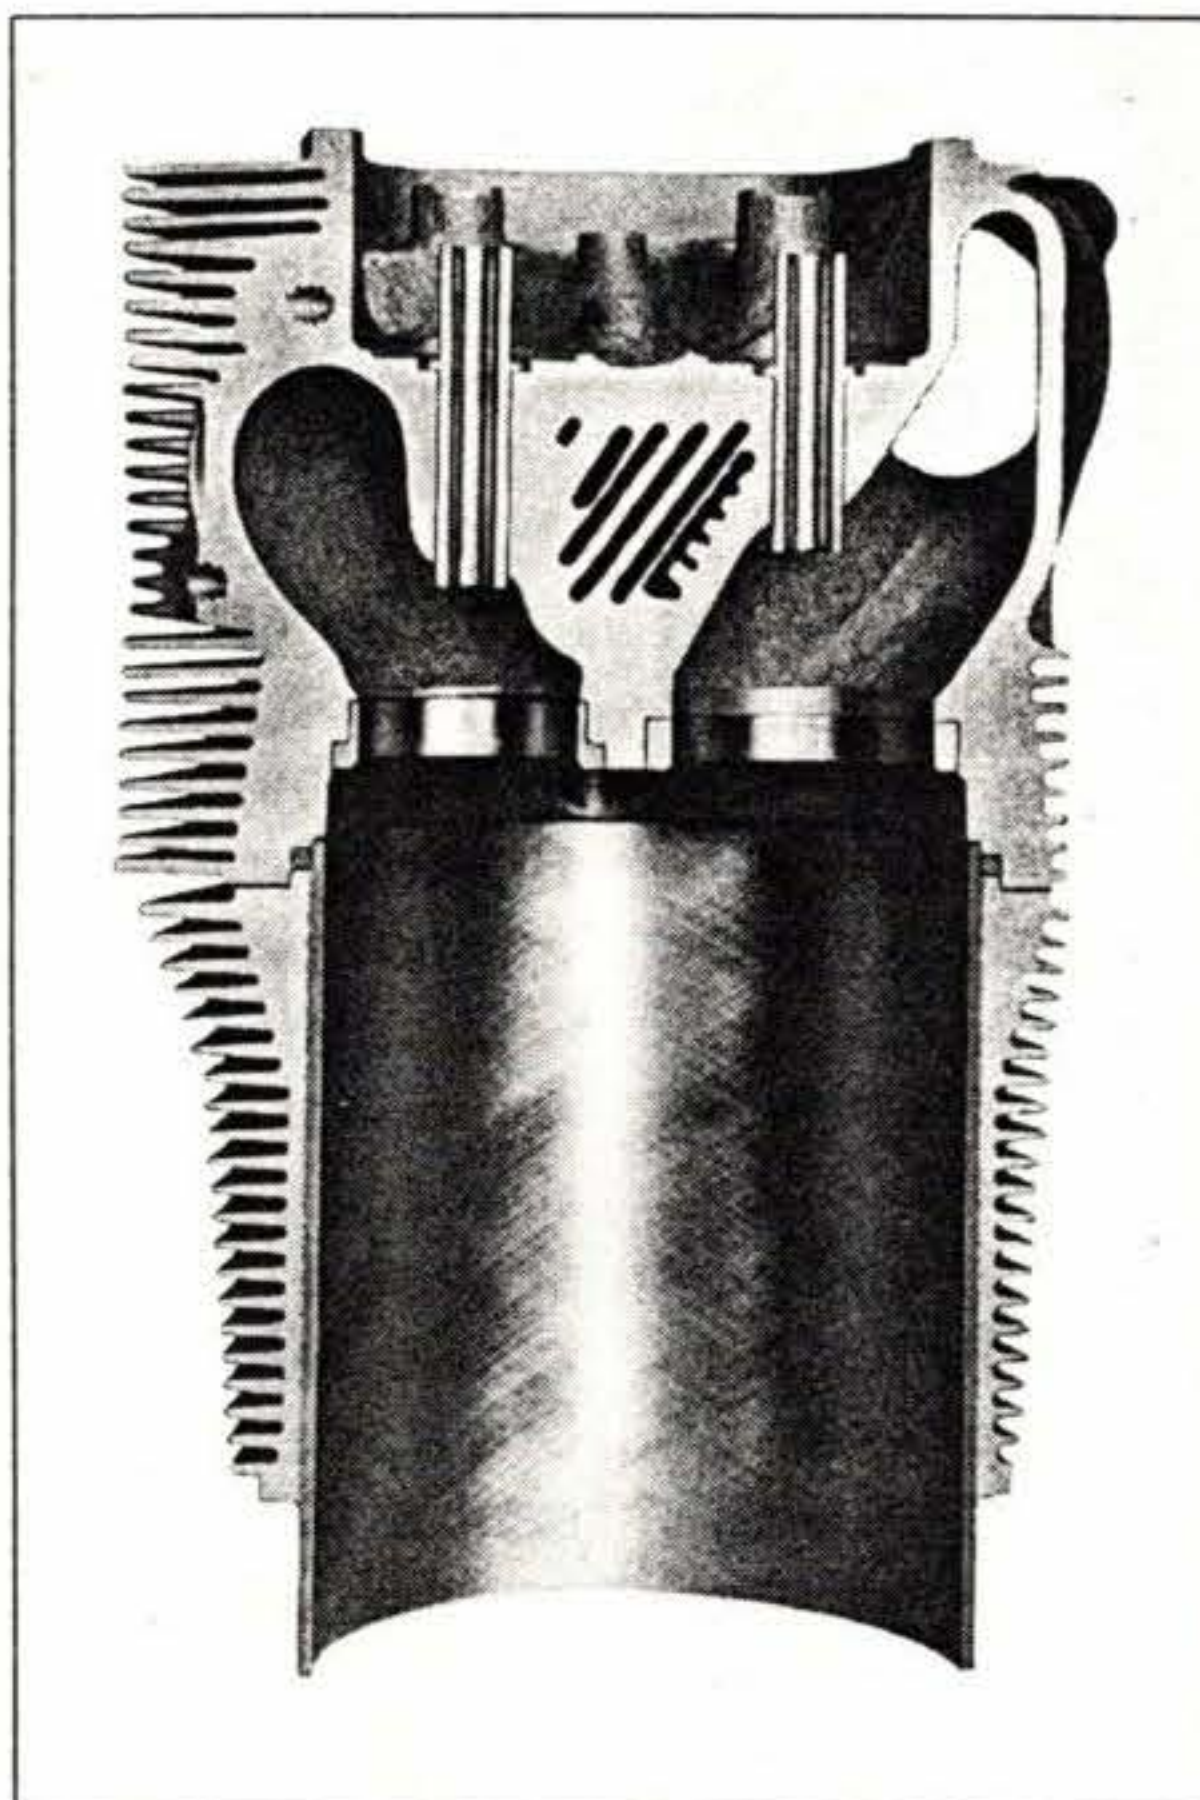
*A properly honed jug will have obvious 30- to 45-degree crosshatching, as on this parallel-valve TCM jug.*
