Exhaust Valve Failures

Part 2: Preventing failures by early detection

MIKE BUSCH

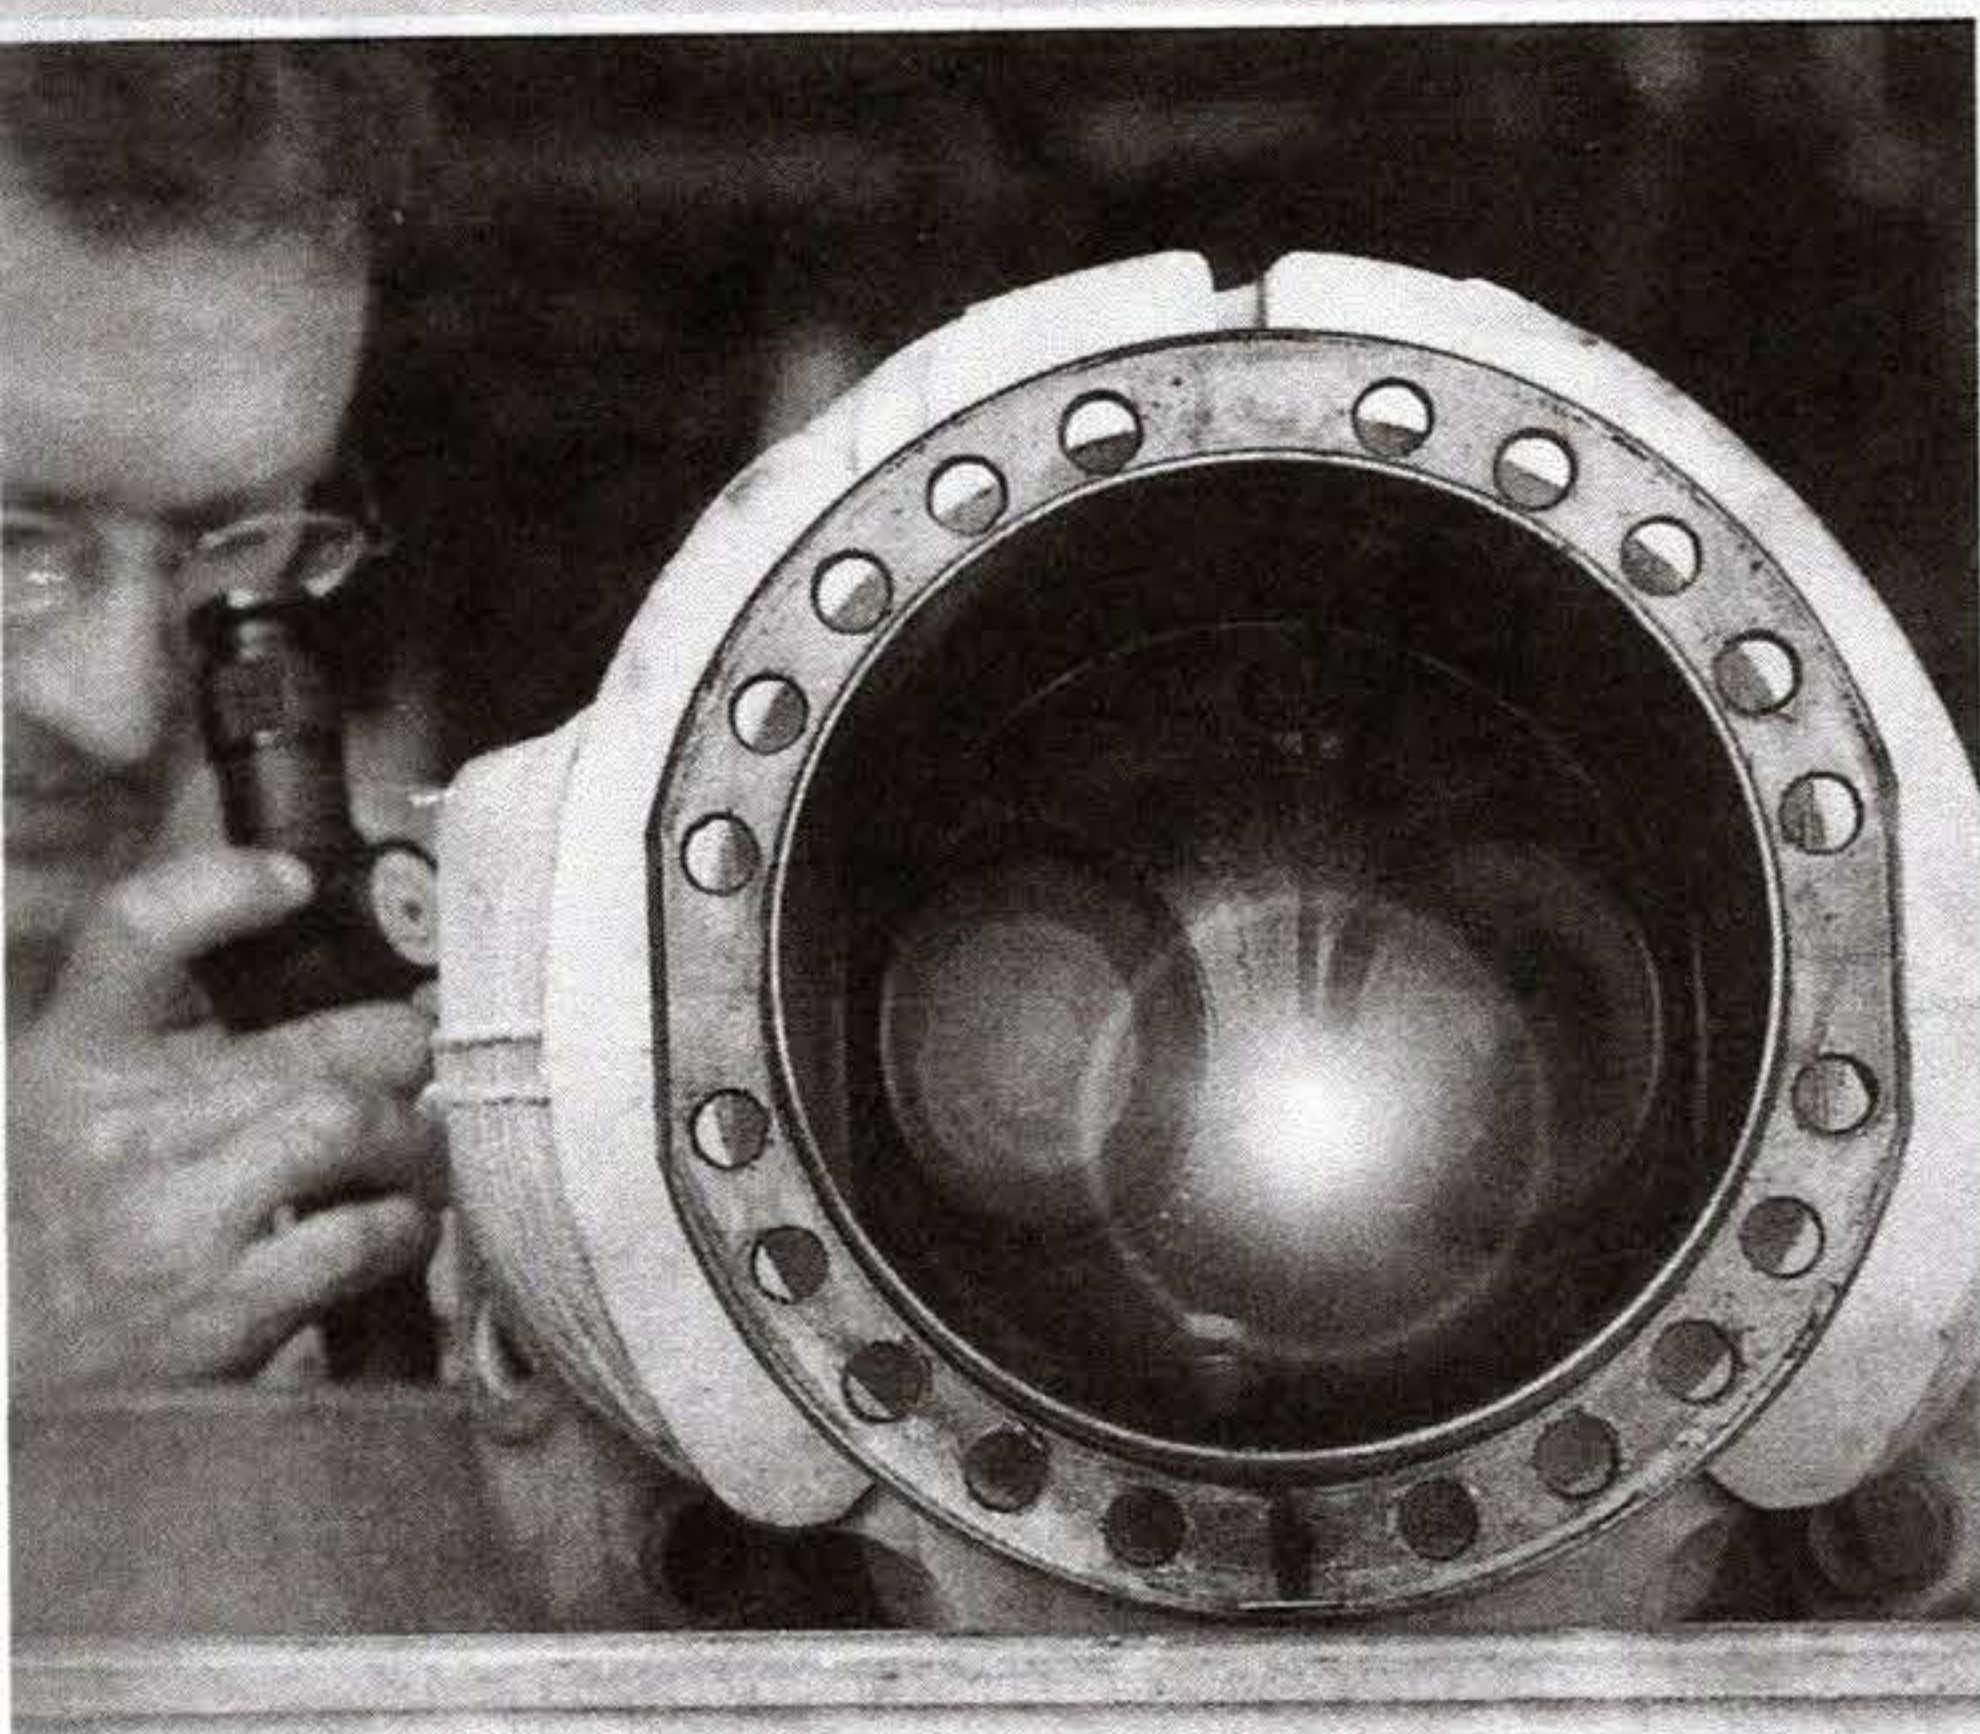
FIGURE 1

A close-up view of what a borescope inspection reveals.

In my opinion, regular borescope inspections should be the first line of defense against exhaust valve failure. The borescope is an optical tube (see Figure 1, next page) or a subminiature digital camera, depending on which model is used, that can be inserted through a spark plug boss (usually the top one). It is used to perform a direct visual inspection of the combustion chamber, including the valves, cylinder head, cylinder barrel, and piston crown. The borescope permits a quick, inexpensive, unambiguous determination of whether

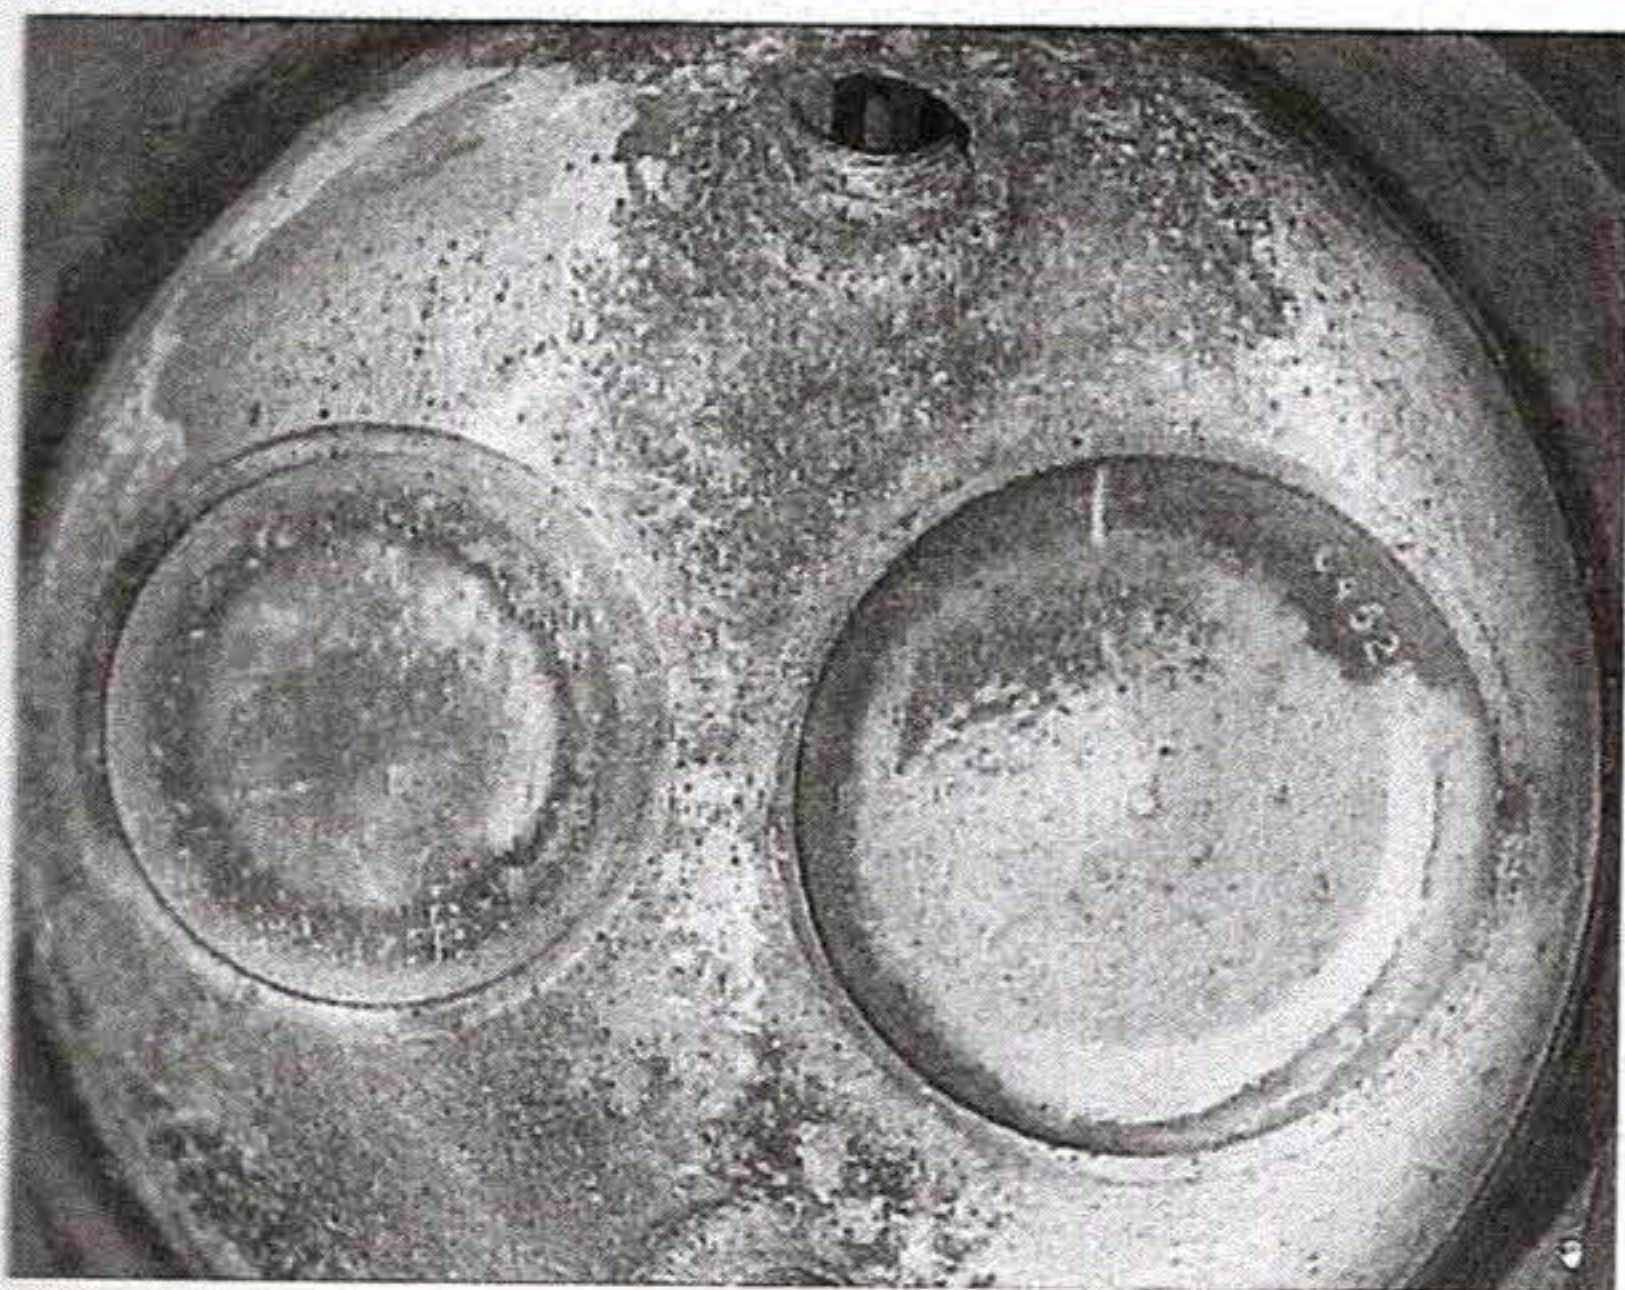
**FIGURE 2**

Note the symmetrical appearance of the exhaust valve (left), showing the valve is operating normally.

Figure 2 shows the appearance of normal valves in a TCM cylinder. The smaller valve on the left is the exhaust valve. Note the reddish pattern of exhaust deposits on the face of the valve. The deposits are quite minimal, indicating that this cylinder has been running a nice, lean, clean-burning mixture that produces relatively few deposits. More importantly, the deposit pattern is almost perfectly symmetrical, similar to a bull's-eye, showing that this valve is operating at the same temperature all the way around the circumference of its face with no hot spots—exactly the way a healthy exhaust valve should look.

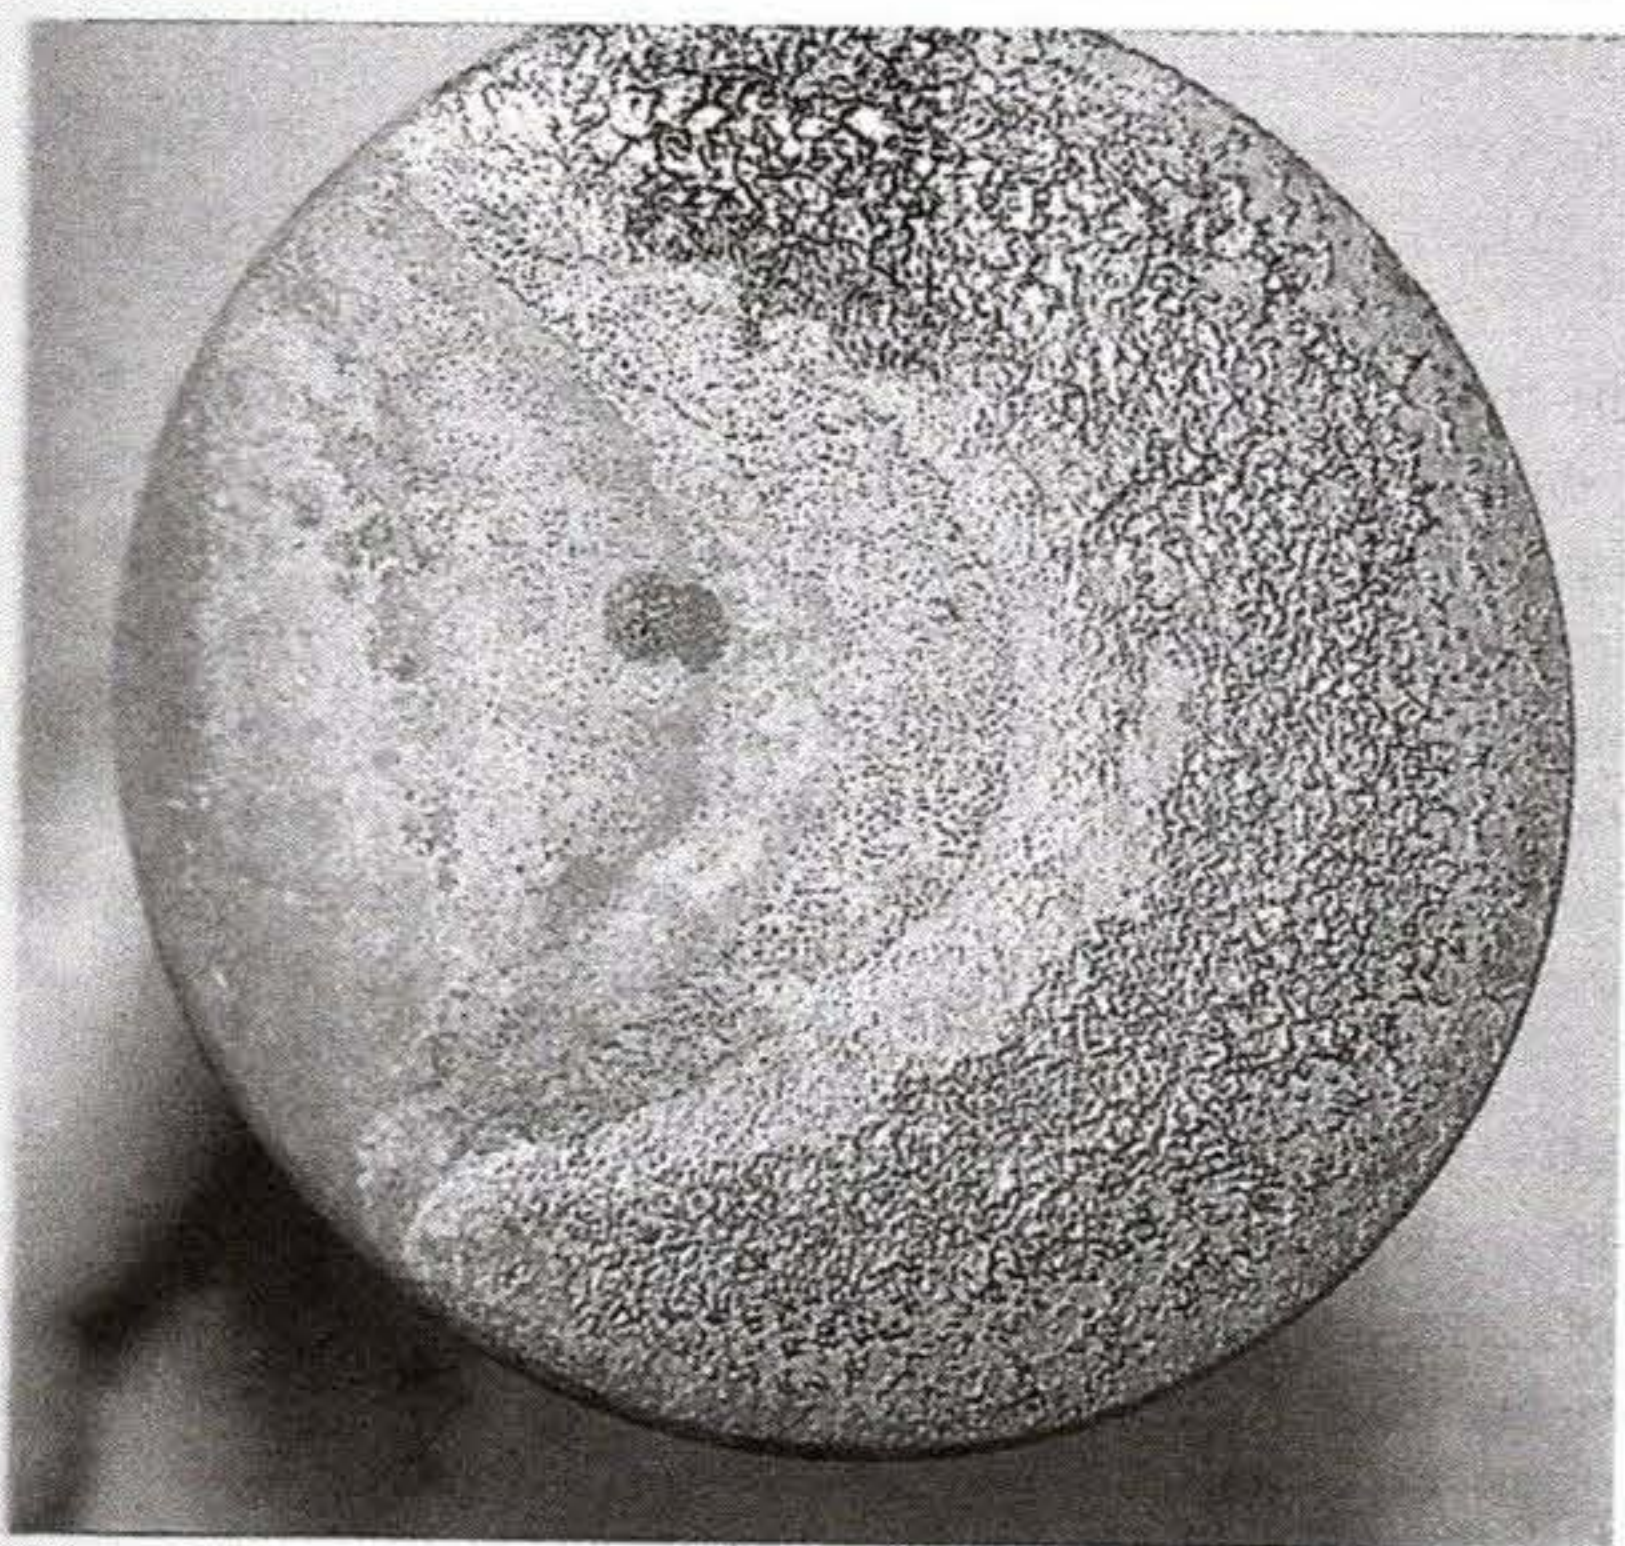
**FIGURE 3**

This exhaust valve is in serious trouble and doesn't have much longer to live. There's an obvious hot spot in the 8 to 10 o'clock position.

Compare that with the exhaust valve in Figure 3. Look at the highly asymmetrical pattern of exhaust deposits on the face of this valve. The cylinder has been running rather rich, causing thick deposits to form around most of the circumference of the valve face. The valve has an extreme hot spot in the 8 to 10 o'clock position, so hot that it has burned off almost all the exhaust deposits in this area. This wouldn't have survived many more hours without failing.

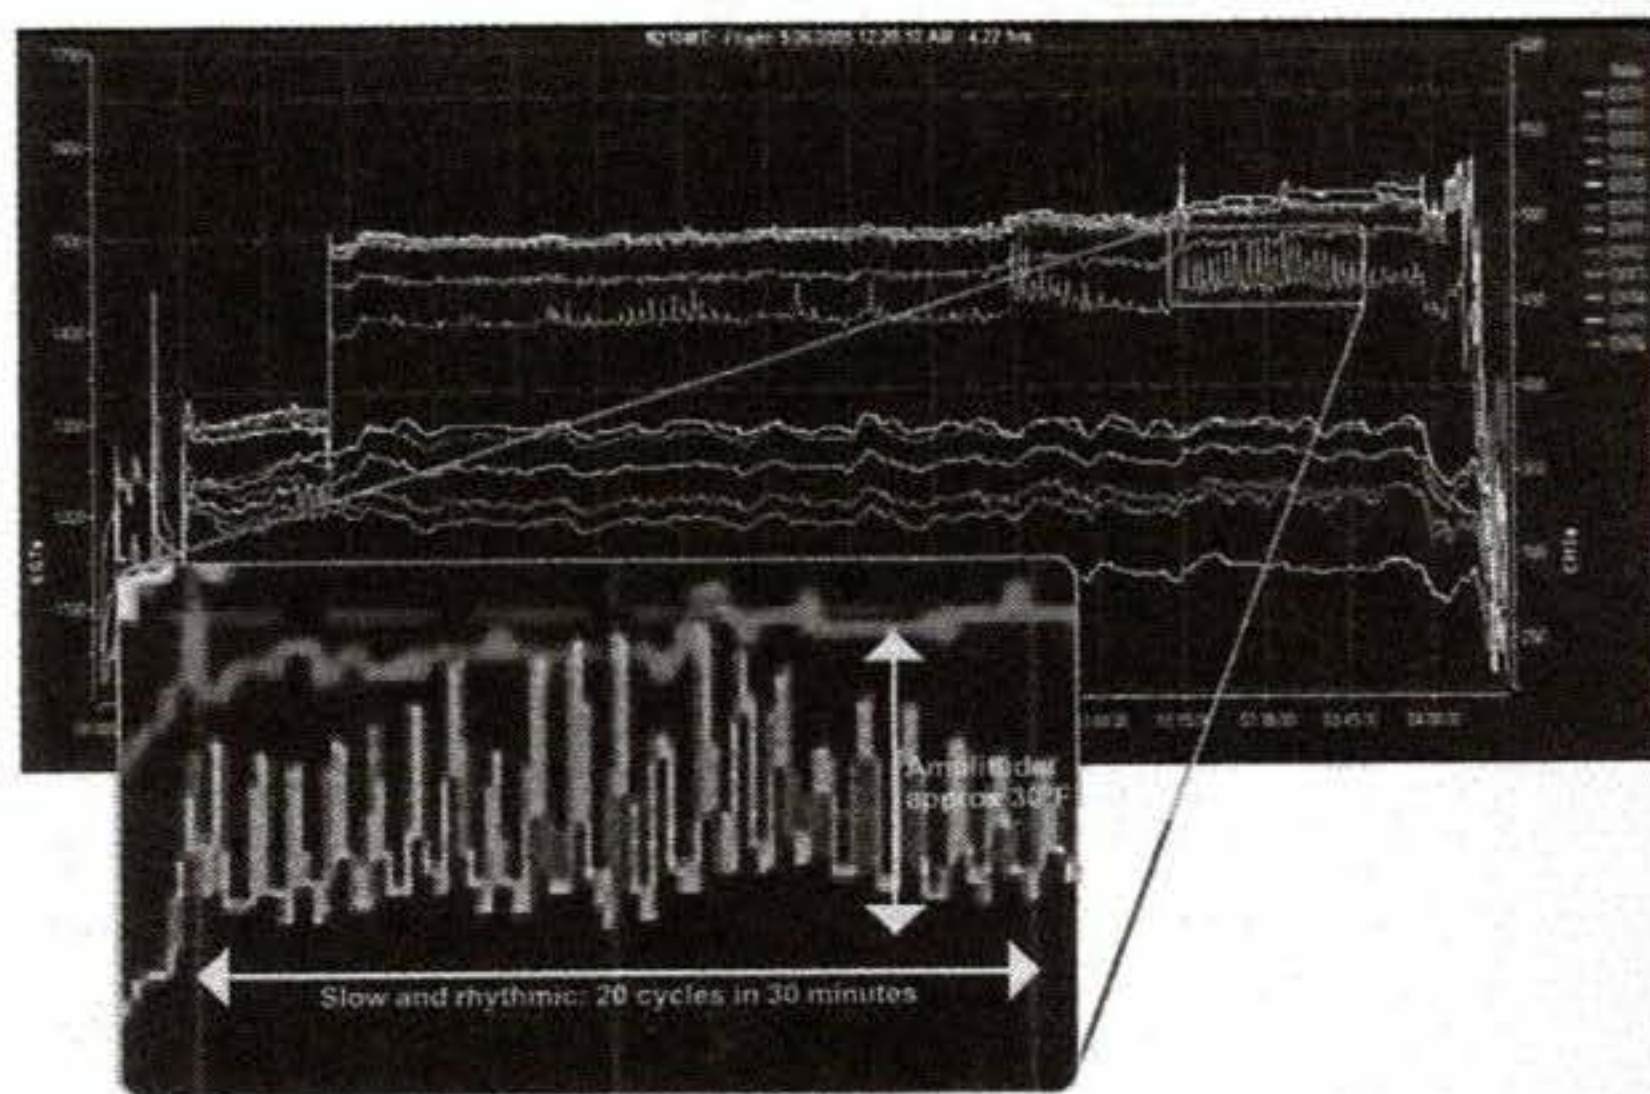
FIGURE 4

A slow, rhythmic EGT oscillation (often on the order of one cycle per minute) is the unique signature of a failing exhaust valve.

Look at the engine monitor data dump in Figure 4, and focus on the anomalous appearance of the EGT trace for cylinder No. 3 (light gray trace). At first glance, this might seem like it's coming from a failing probe or a loose connection. But closer examination reveals that the EGT oscillations are not rapid and random (as one would expect from a bad probe or connection), but rather very slow and almost perfectly rhythmic. As the inset shows, the EGT oscillated exactly 10 times in each 15-minute period, and for a total of exactly 20 cycles in 30 minutes—a bit less than one cycle per minute. A failing probe or connection can't do that. In fact, there's only one thing that can do that: a failing exhaust valve.

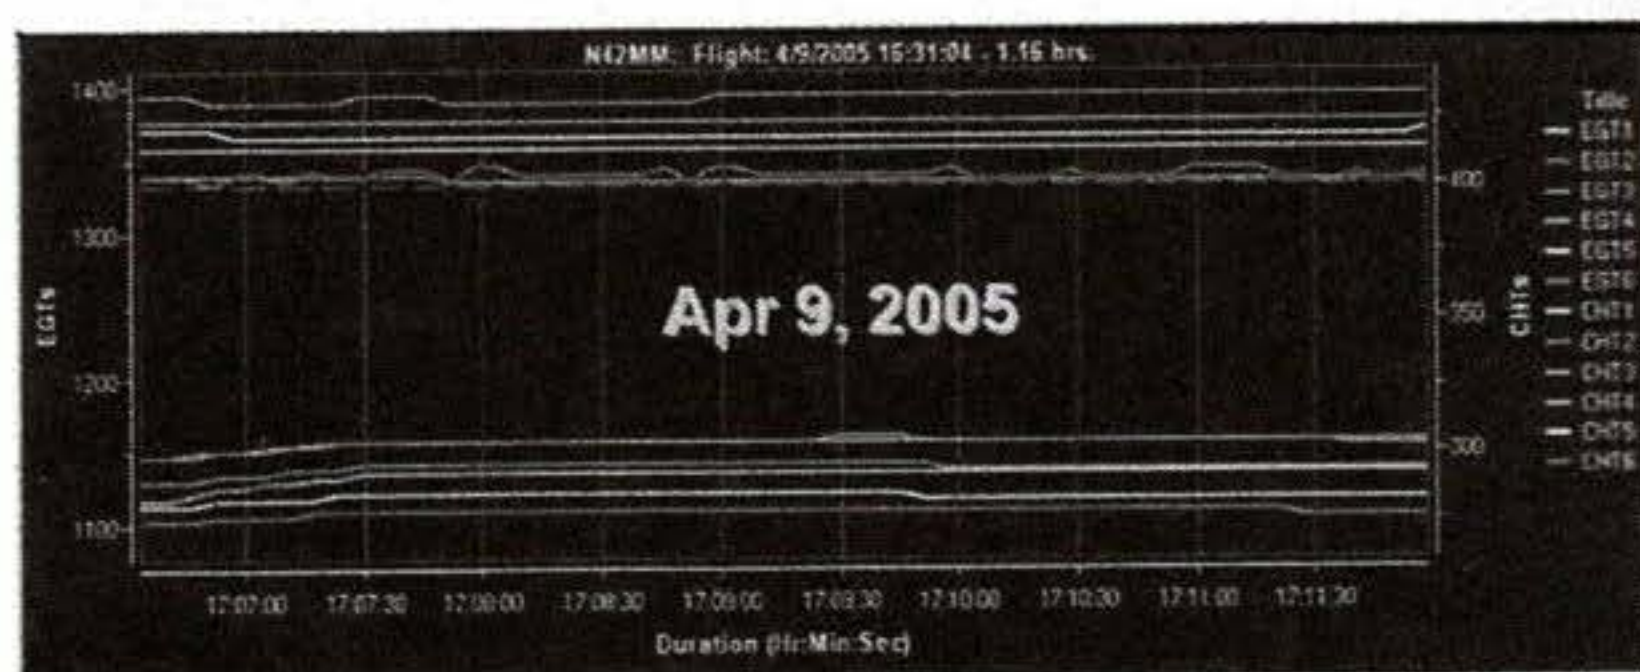
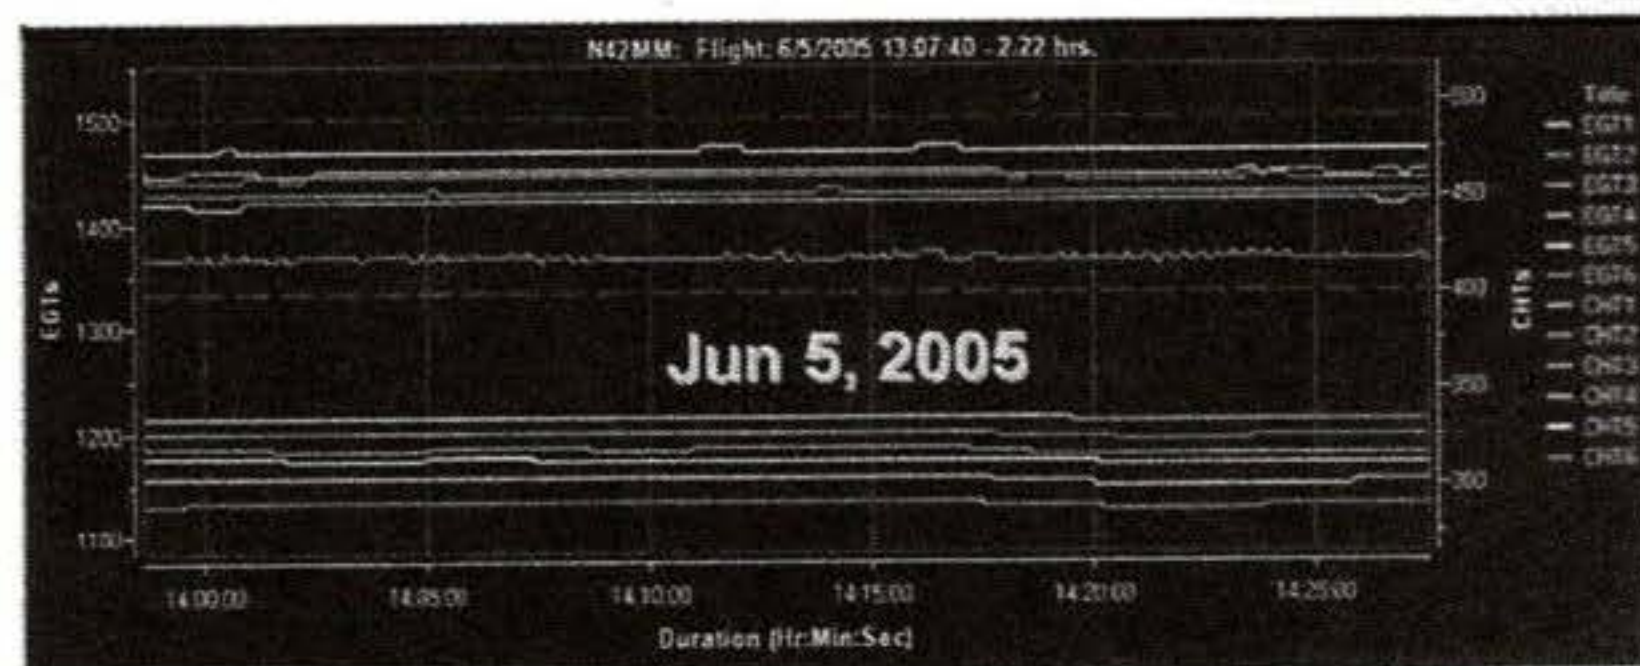
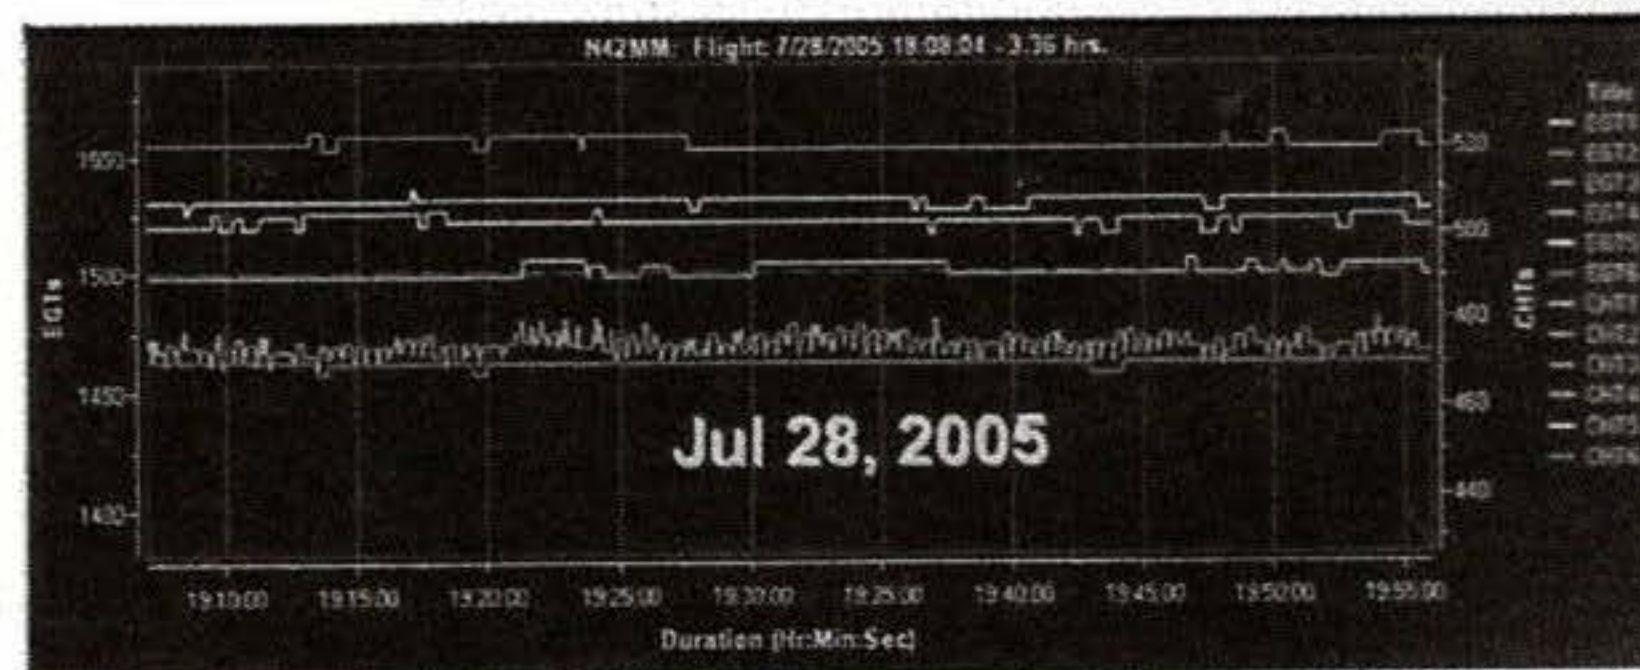
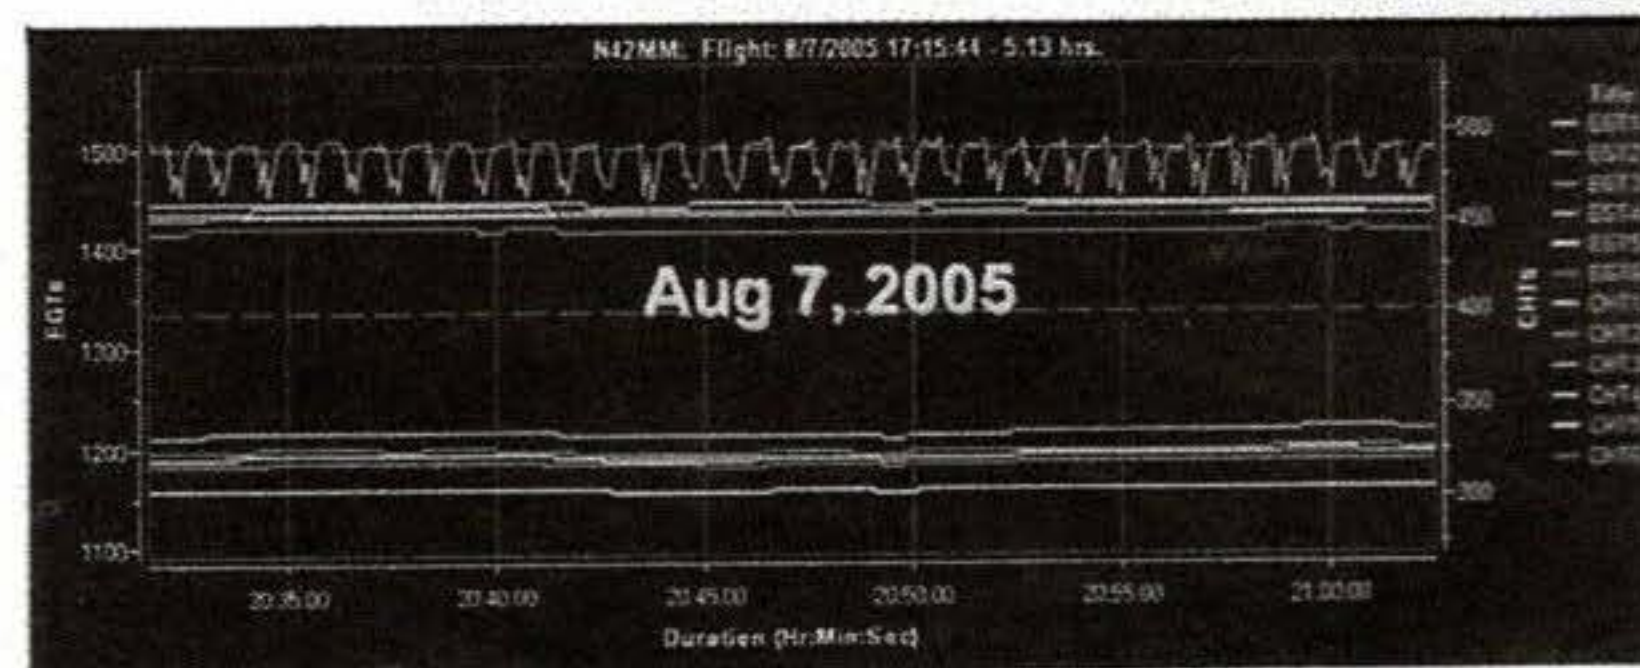
FIGURE 5

Successive data dumps show progressive deterioration of the No. 2 exhaust valve (top red trace) over a five-month period. Note the precisely rhythmic EGT variation at almost exactly one cycle per minute.

Figure 5 shows the progressive deterioration of the No. 2 exhaust valve (top red trace) in a Bonanza's TCM IO-520 engine over a period of five months. Note how the EGT variation becomes increasingly obvious, regular and rhythmic as the exhaust valve deteriorates. Also note the frequency: almost precisely one cycle per minute. The valve was crying out for attention. Ultimately, the owner noticed the problem and pulled the cylinder before the valve failed in-flight.

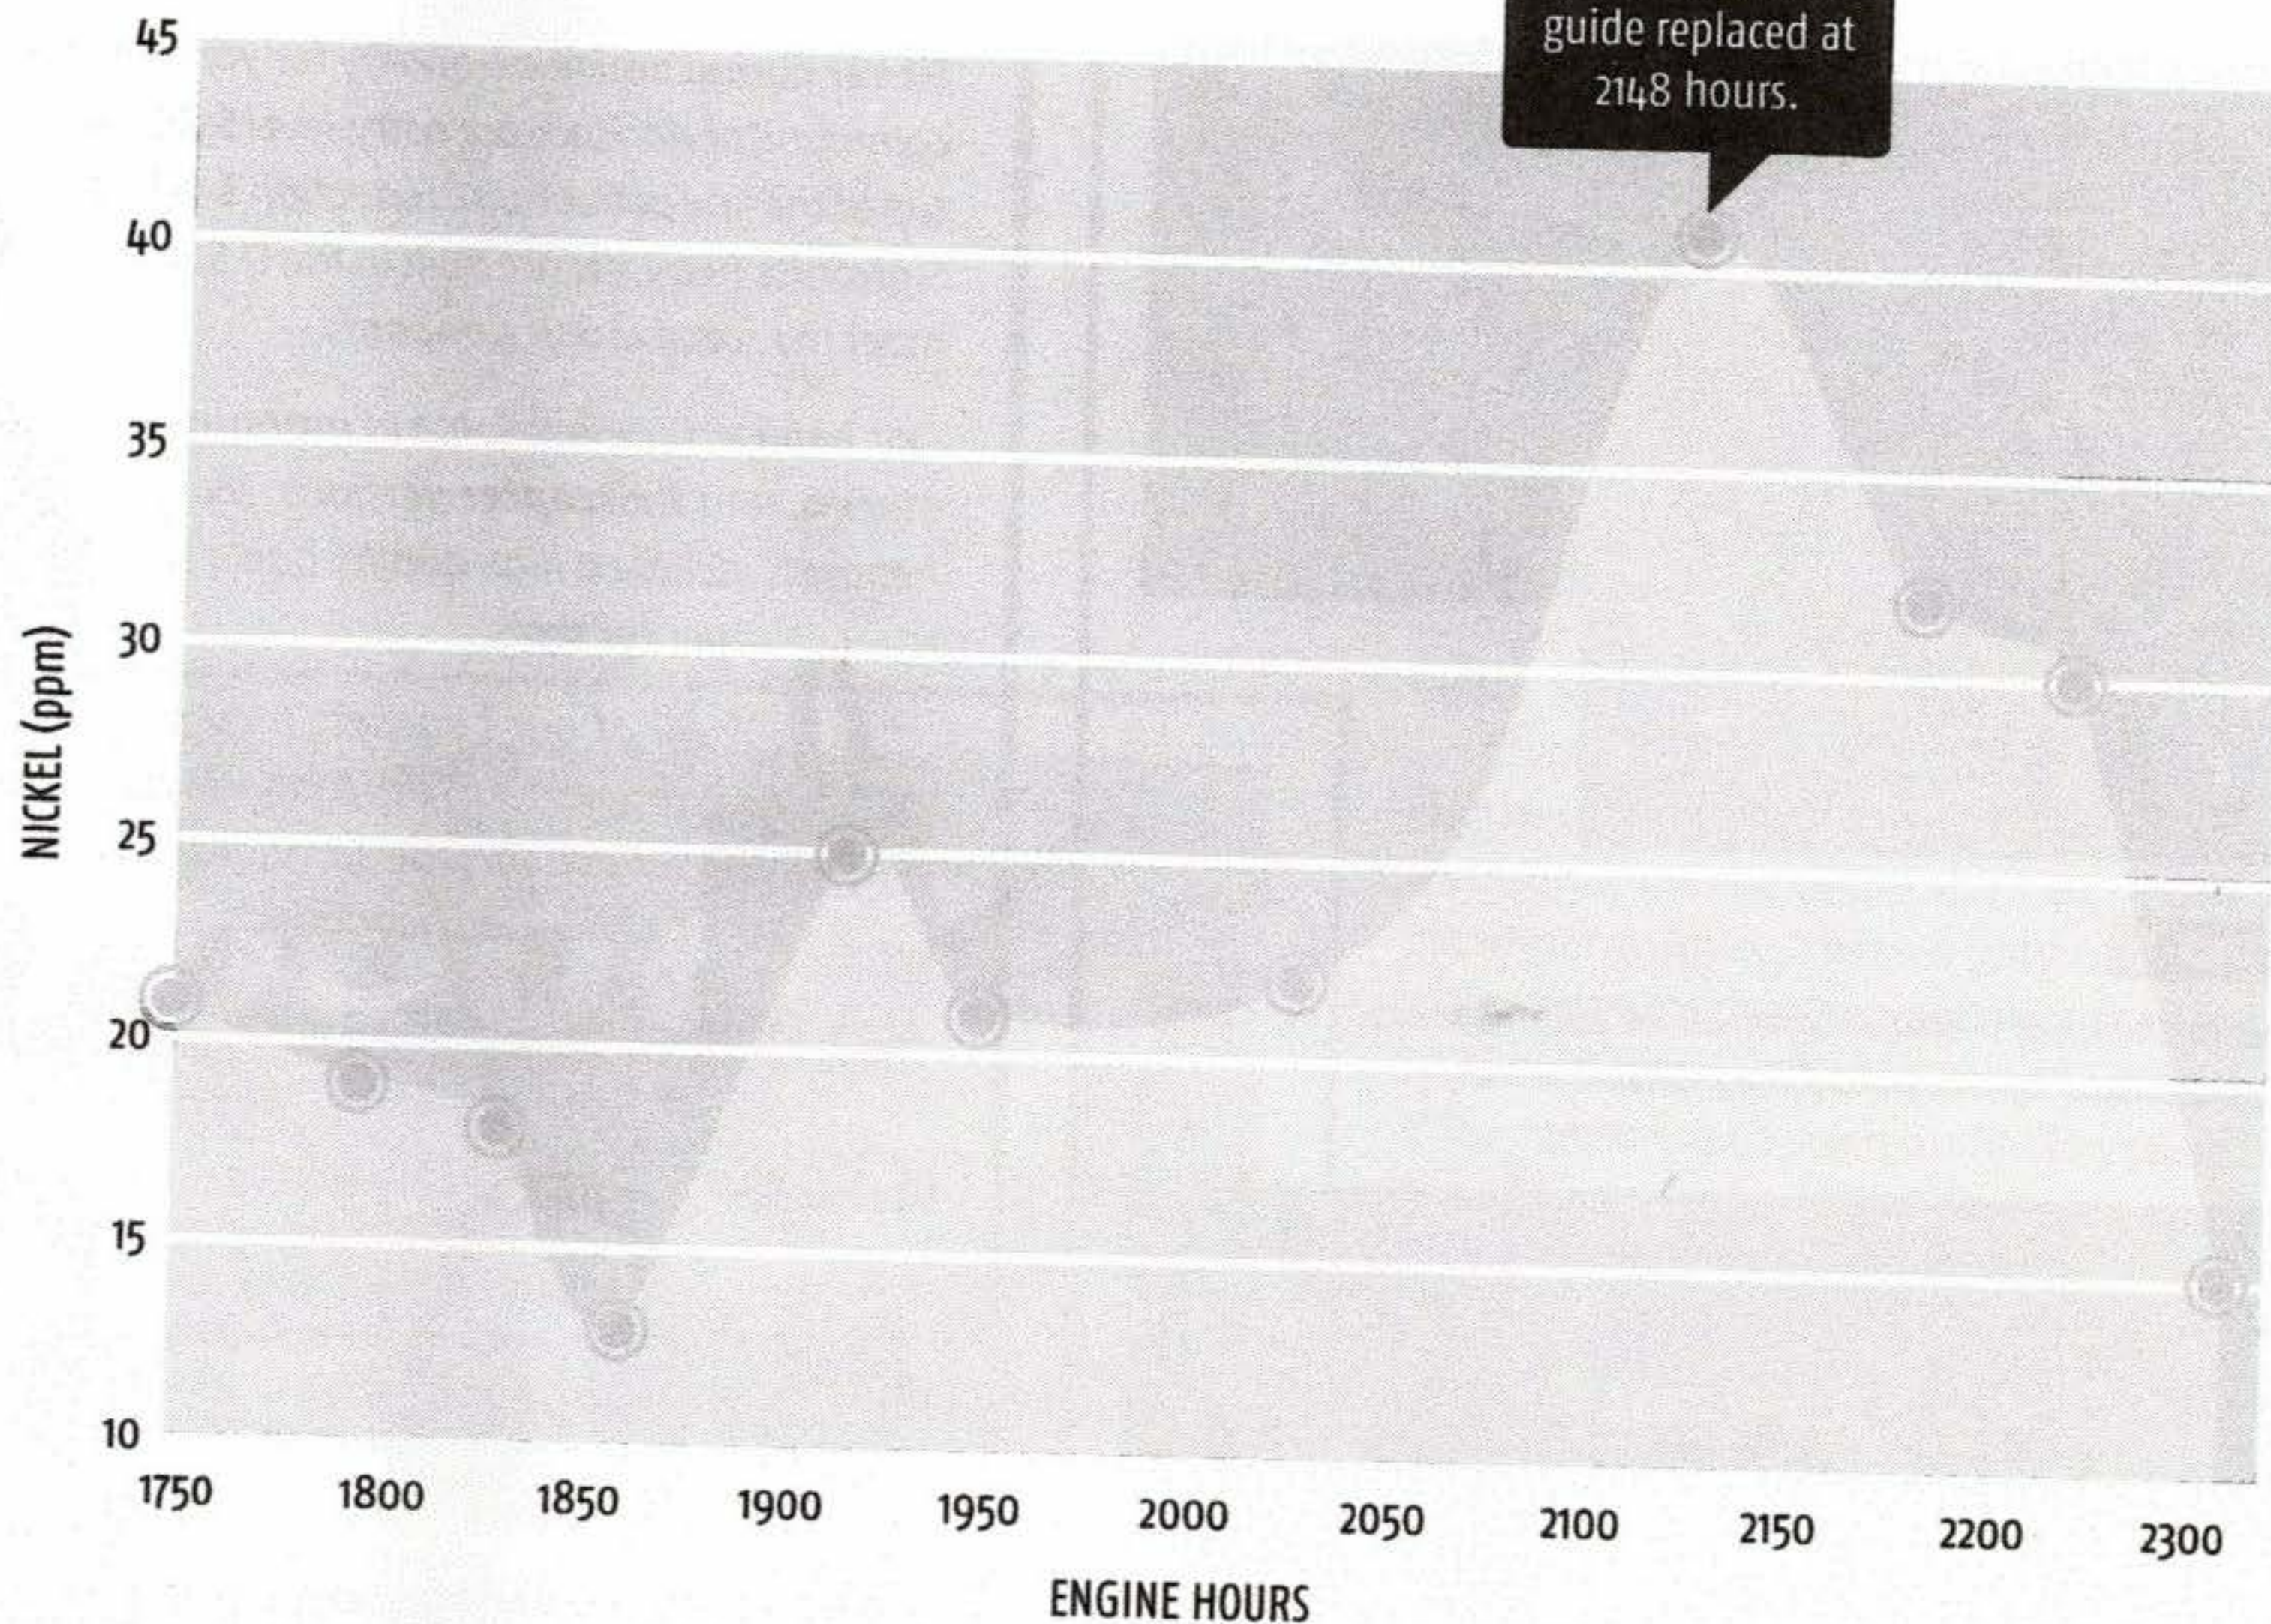
FIGURE 6

Oil analysis started showing elevated nickel (exhaust valve guide material) long before the failing exhaust valve was detectable by other means.

Figure 6 shows 550 hours' worth of history of nickel readings in the left engine of my Cessna T310R. This engine had traditionally "made" about 14 parts per million (ppm) of nickel during the first 1,500 hours since major overhaul (SMOH), which is about average for a six-cylinder TCM engine. Then the nickel readings started acting strange, rising into the low 20s, then the high 20s, giving warning of accelerated exhaust valve guide wear.

Unfortunately, oil analysis cannot identify which cylinder is the culprit. But the increasing nickel readings put me on notice that there was likely to be a failing exhaust valve in my future. Consequently, I started watching the engine monitor carefully, and started doing more frequent borescope inspections. Eventually, the No. 3 exhaust valve was found to be developing a hot spot. At 2,148 hours SMOH, the No. 3 cylinder came off and the exhaust valve and guide were replaced. Nickel then started to decline as the new valve
