Gary Hertzler's Vari-Eze

Carl Denk - Cosy Classic

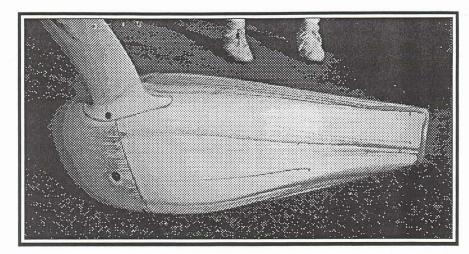
I was most pleased with the flow around the gear leg fairing. There does not seem to be any significant disturbance downstream. I was most concerned with this because of the non-perpendicular intersection between the gear leg and fuselage sides.

oil flow shows no disturbance from gear leg

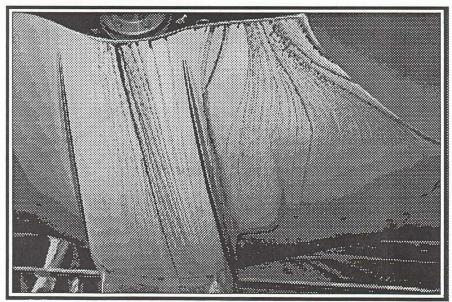
I don't understand the winglet flow. The upswept flow at the lower portion of the rudder is a well known problem (not sure what to do about it) but the local areas of separation about 60-70% chord directly above this is a mystery. I think there is something to be had with a different lower cambered airfoil for winglets.

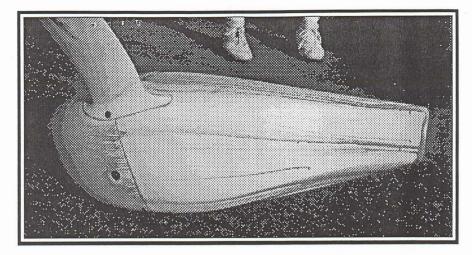
I was most pleased with the flow around the gear leg fairing. There does not seem to be any significant disturbance downstream. I was most concerned with this because of the non-perpendicular intersection between the gear leg and fuselage sides.

oil flow shows no disturbance from gear leg

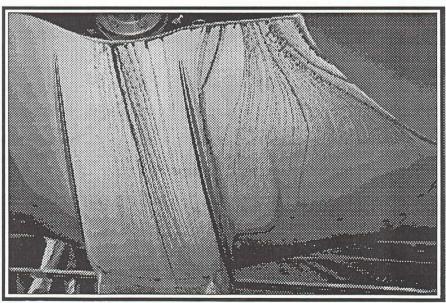
I don't understand the winglet flow. The upswept flow at the lower portion of the rudder is a well known problem (not sure what to do about it) but the local areas of separation about 60-70% chord directly above this is a mystery. I think there is something to be had with a different lower cambered airfoil for winglets.

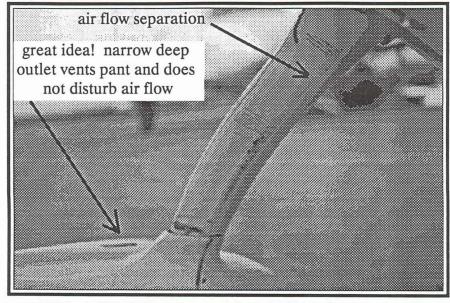
Oil flow and earlier tuft testing showed why. Note the air flow curves down the side of the fuselage between the gear leg and the arm pit inlet. It avoids entering the cowl. I guess you can't blame it. The temperature is pretty high in there. This is a test. What do you think should be done to get the air into the cowl?

cool air by passes cowl inlet

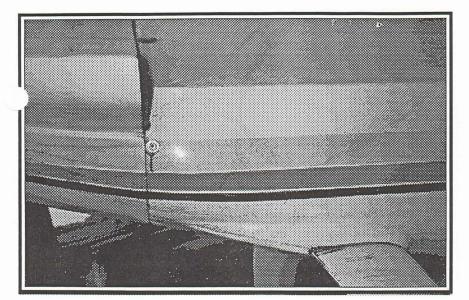
air goes straight back into inlet and is not affected by gear leg

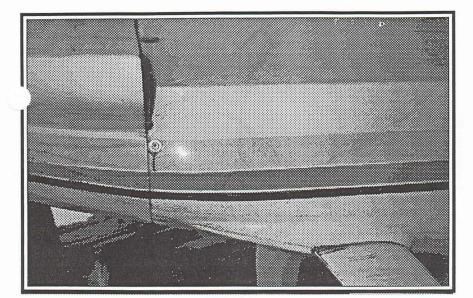
air goes straight back into inlet and is not affected by gear leg
