Overhauling the S-1200 Magneto

by Fred Mackerodt

Light Plane Maintenance

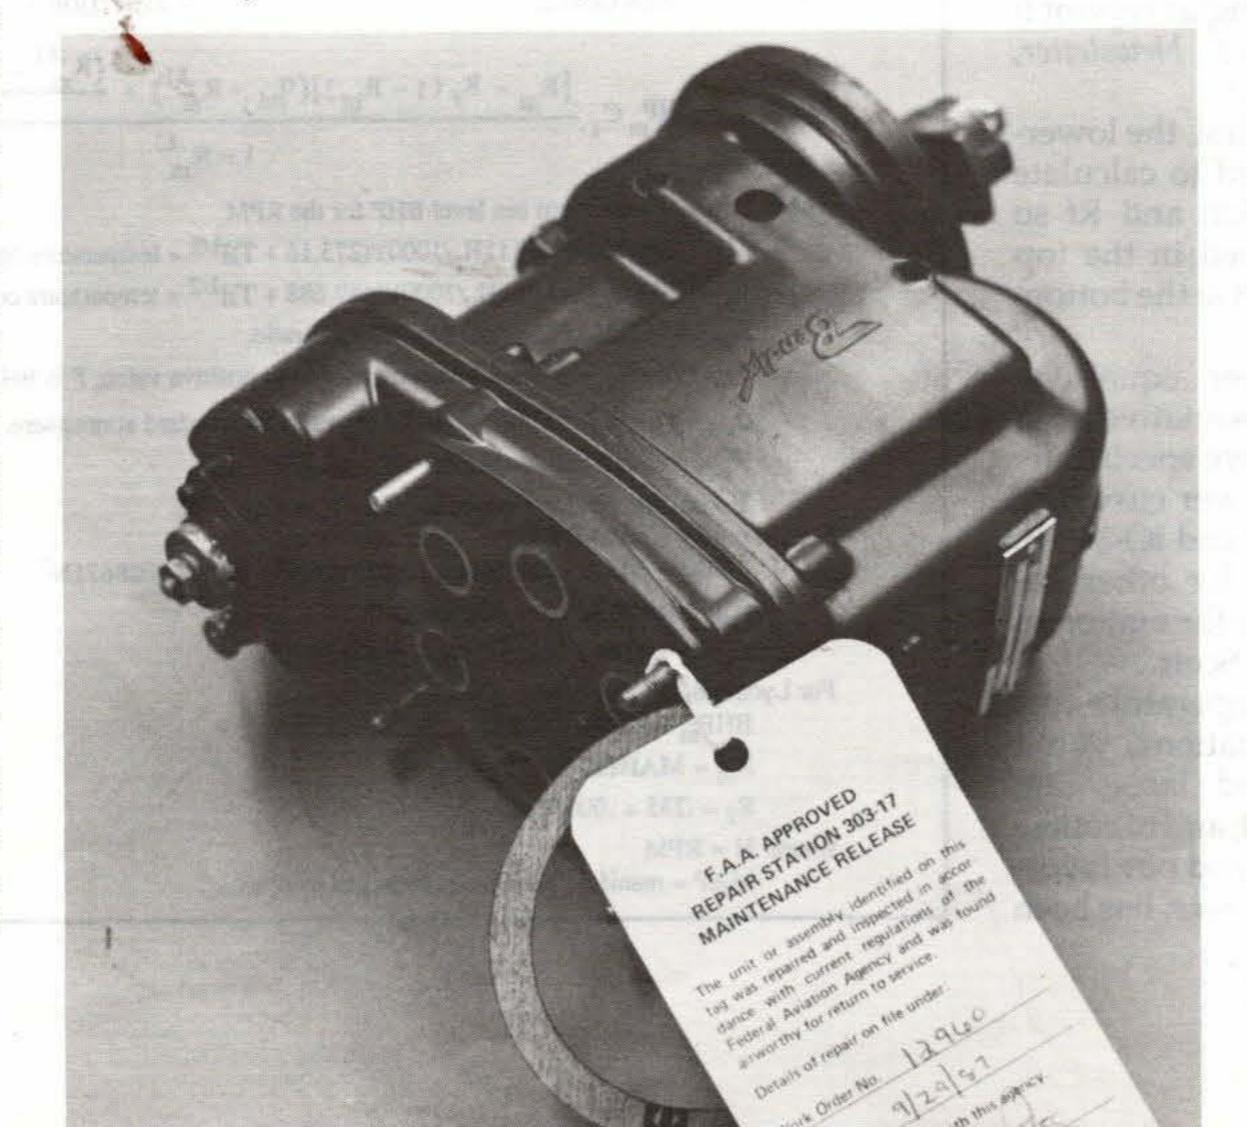
Clockwise from top left: Housing cracks are a rarity in most mags, but the Bendix S-1200 series is prone to cracks of the castmagnesium housing, as shown here. Distributor end removed, it's obvious this mag has accumulated considerable oil and carbon dust inside. (A 500-hour housecleaning is needed if for no other reason than to keep this sort of contamination under control.) If you look carefully at six o'clock on the distributor gear, you can see that a tooth is gone; this was probably caused when a mechanic used a timing lock to install the mag. In the final picture, severe erosion of the distributor finger is evident. The erosion was caused by the distributor gear being installed one tooth off.
