COMMENTARY / SAVVY AVIATOR

Cylinder Work: Be Afraid

It is nearly impossible to install a cylinder properly when the engine is on the airplane

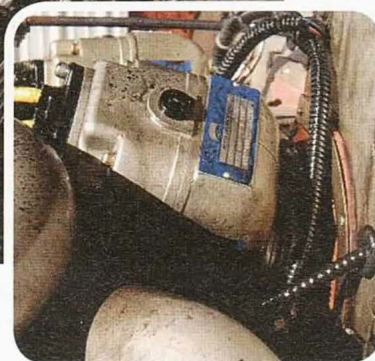
This Continental IO-550 threw the No. 2 rod through the top of the case less than 10 hours after the No. 2 and No. 4 cylinders were replaced at annual.

In short, Fuchs contends that there's a significant risk that an engine might come apart after cylinder work (especially a top overhaul) even when the work is performed exactly as directed by the manufacturer. How can that be? According to Fuchs, the root cause of spun bearings, thrown rods, and separated cylinders is simply "failure to achieve sufficient preload in the assembled fasteners."
