Service Letter SL 32 Rev.1

DOA - No.
 EASA.21J.020

All MT-; MTE- and MTV- Propellers with Natural Composite Blades

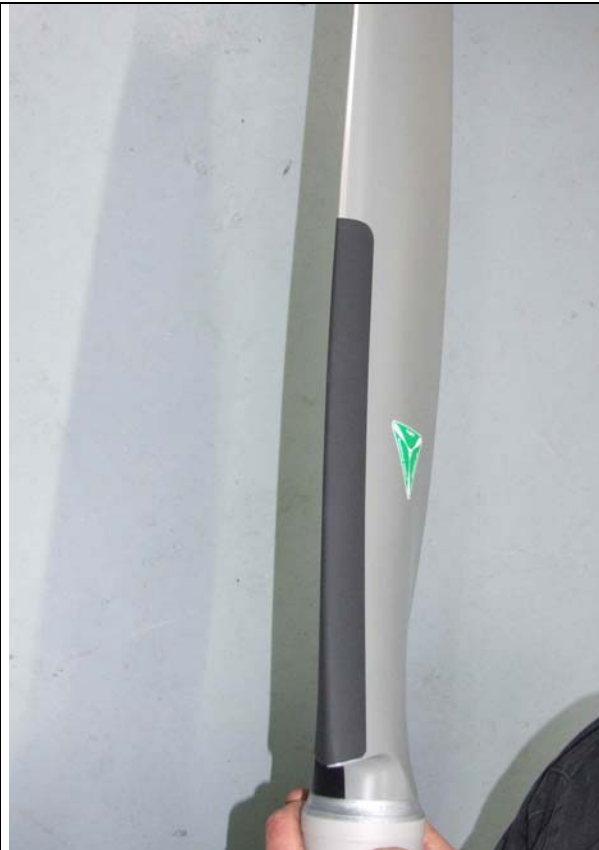
Undamaged PU-Erosion Sheath.

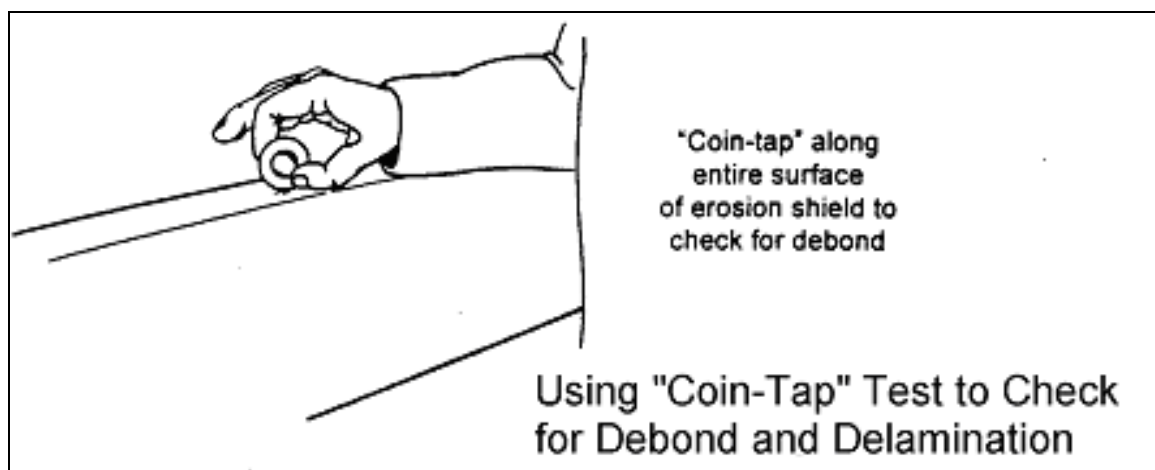
In case of debonding only very limited repair is possible. However the extent of debonding where repair is required is defined and not every debonding requires repair.

If any hollow and debonded spots exist, mark them. Whenever performing pre-flight inspection, monitor whether there are further delamination and/or whether the already existing delamination has become worse. The inspection can be executed by using an appropriate coin (Tab-Test).

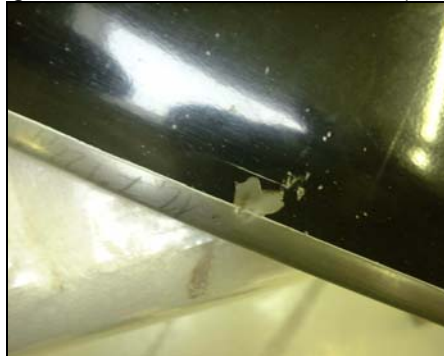
- ✓ The hollow and debonded spots must not exceed 30% of the surface of the erosion sheath at all (lengthwise only 1 inch allowed).
- ✓ Hollow and debonded spots (max. 0,39 square inch* 2,5cm²), no two spots may occur within 5,5 inch =13cm of each other.
- ✓ Debonded areas which result in an open bonding crack must be sealed in order to prevent water from penetrating.
- ✓ The length of open bonding cracks must not exceed 1 inch (2.5cm)

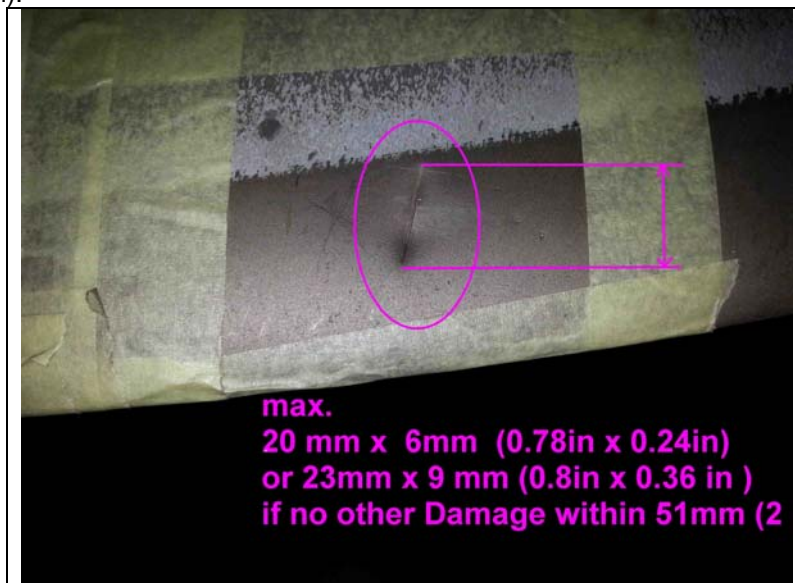
Due to the wider boning area the allowable dents in nickel erosion sheaths are bigger than in steel erosion sheaths.

- ✓ Longitudinal dents not more than 0,78 inch x 0,24 inch (20 mm x 6mm)
- ✓ If within 51 mm (2 inches) no other dents of that size are visible, the dent size may exceed the original maximum size by 3 mm (0,12 inch) to a maximum of 23 mm x 9 mm (0.9 inch x 0,36 inch).

Check whether the dent penetrates through the erosion sheath.
If the dent does not penetrate through the erosion sheath, the dent may be filled with Epoxy.
The Epoxy can be sanded flush until there is a smooth surface.

If the dent penetrates through the erosion sheath, check erosion sheath for possible cracks. If there are no cracks, the dent must be filled with Epoxy so that no moisture can enter into the blade body.
The Epoxy can be sanded flush until there is a smooth surface.

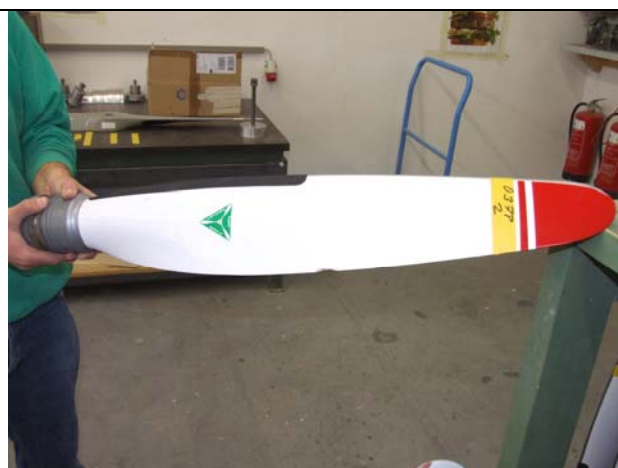
- Hangar Damage
- Tow Bar Damage
- Cowling Damage

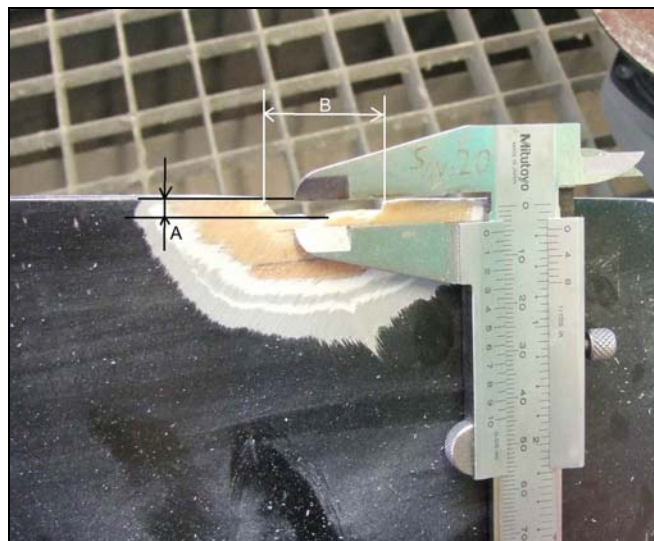
Crunched trailing edges can be sealed by using 5 minute Epoxy if the damage is not deeper (Dimension A) than 5 mm (0,20 inches) and not wider (Dimension B) than 15 mm (0,60 inches).

Crunched trailing edges can be repaired by replacing the fiber glass cover if the damage is not deeper (Dimension A) than 7.5 mm (0,30 inches) and not wider (Dimension B) than 25 mm (1 inch).

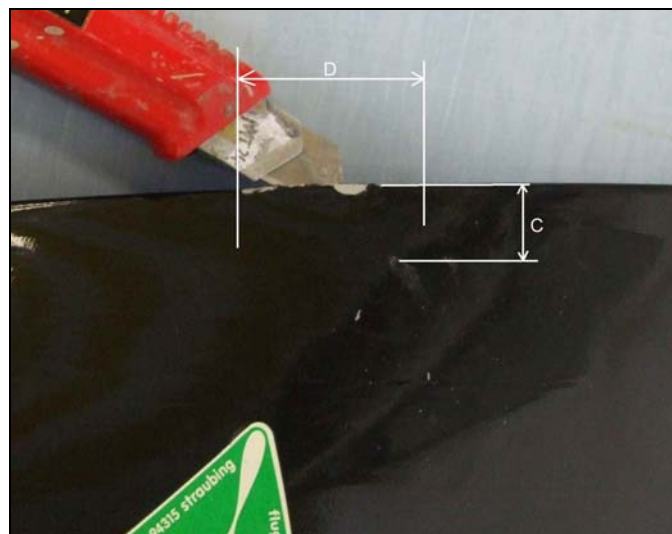
Delaminated fiber glass shell on the trailing edge may be rebonded if the debonding is not deeper (Dimension C) than 12,5mm (0,5 inch) measured from the trailing edge and not wider (Dimension D) than 25mm (1 inch).

Caution: Assure that any moisture cannot enter the load carrying blade body.

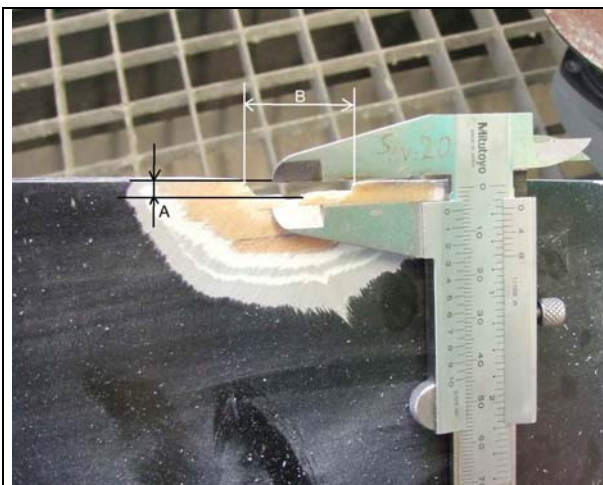
Measure the extent of damage
Max. 7.5mm from Trailing Edge and 25mm wide
allowed for Field Repair

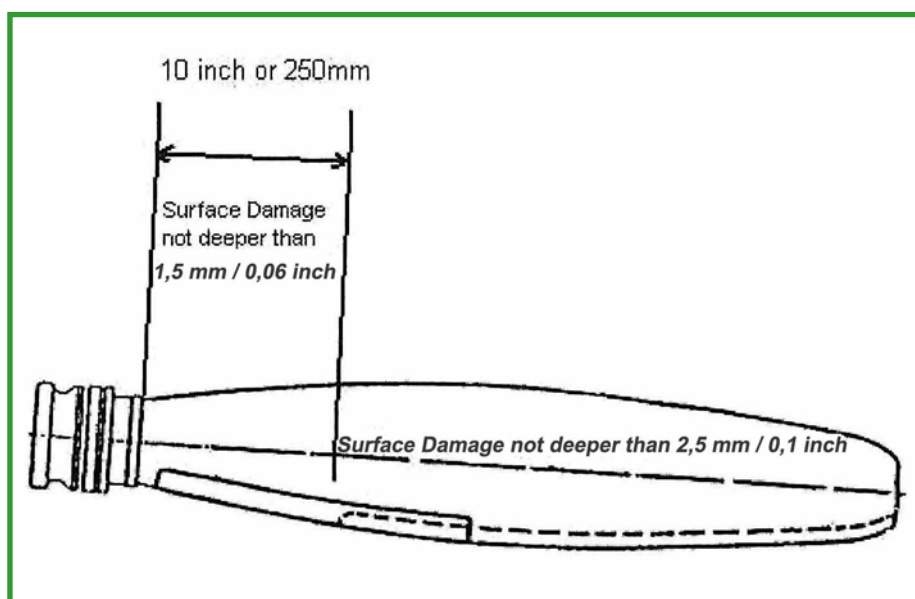
- ✓ There may be no crack in the load carrying natural composite structure beyond the following repair limits.
- ✓ All dimensions are measured after local removal of paint and filler.
- ✓ Blade Root: inside 25 cm (10 inch) from Blade Ferrule:
Damage may not be deeper than 1,5 mm (0,06 inch.)
- ✓ Blade outside Blade Root: Damage may not be deeper than 2,5 mm (0,01 inch)

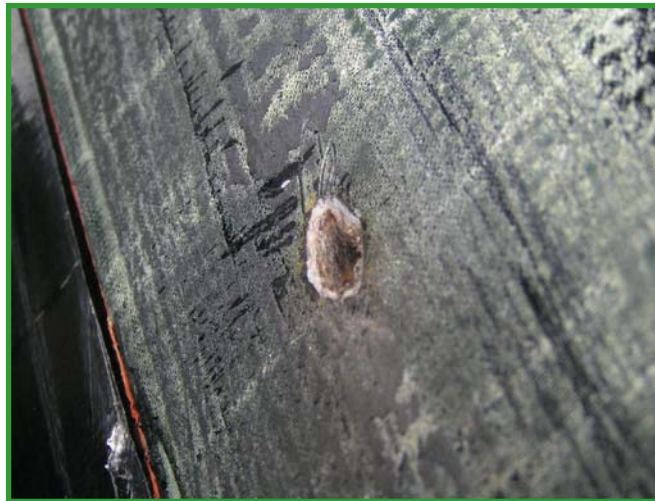
Surface damage whose size (E X E) is below 6 mm x 6 mm (0.2 inch x 0.2inch) may be sealed by filling the dent with 5 minute Epoxy.

Failed de-ice boots may cause damage to the blade surface structure behind the boot failure. Such damage may be repaired with 5 Minute Epoxy also.

14 mm x 8 mm x 1, 5 mm (0,55 inch x 0,31 inch x 0,06 inch)

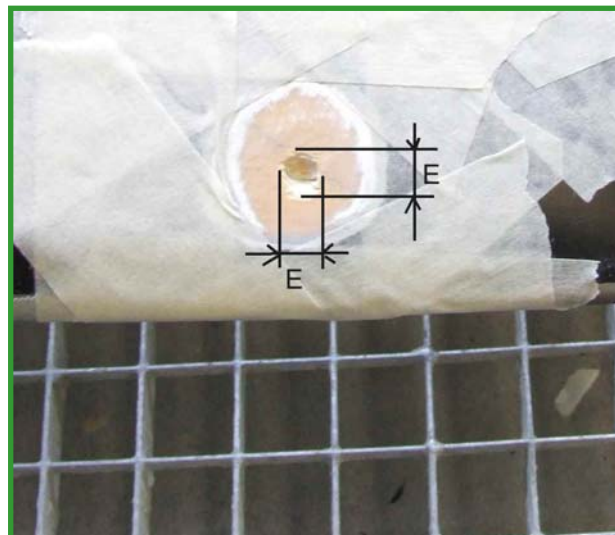
Surface damage whose size (E X E) is above 6mm x 6mm (0.2 inch x 0.2 inch) but below 12mm x 12mm (0.5 inch x 0.5 inch) must be field repaired by locally replacing the fiber glass shell.

Blades with surface damage above 12mm x 12mm (0.5in x 0.5in) must be must be sent to the manufacturer or to an authorized service station for repair as soon as possible.

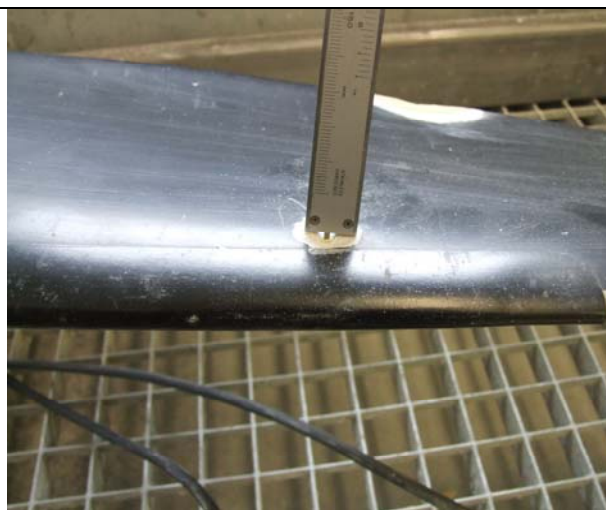
Field Repair Limits:
Blade Root: inside 25cm (10 inch) from Blade Ferrule:
Damage may not be deeper than 1.5 mm (0,06 inch)
Blade outside Blade Root: Damage may not be deeper
than 2,5 mm (0,1 inch)

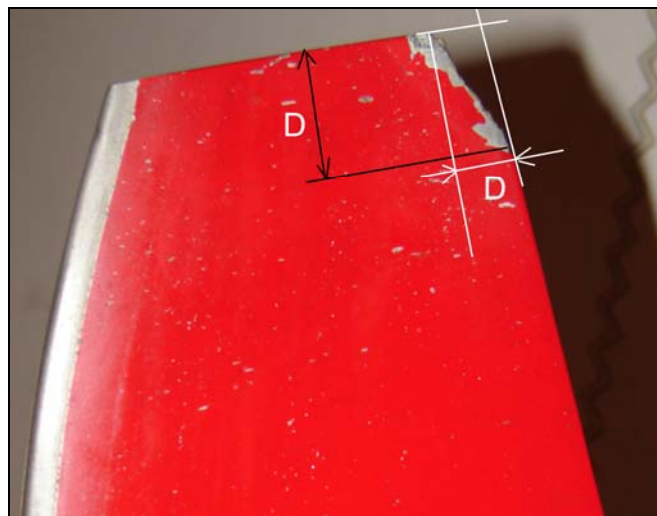
Maximum damage size measured from the blade tip trailing edge

Dimension "D" below 12mm (0.5 in) : Only sealing with 5 minute Epoxy required.

Dimension "D" above 12mm (0.5in) and below 25mm (1 in) local repair with fiber glass required

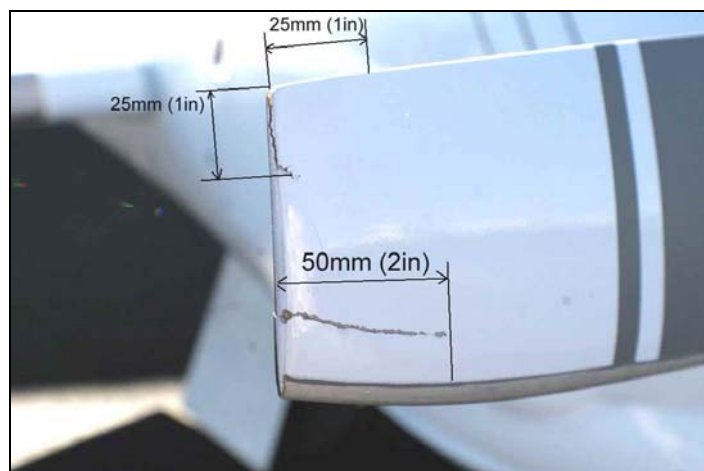
Split trailing edges may be field repaired if the crack length is below 50mm (2 in) . The fiber glass shell must be scarf repaired from both sides

Delaminated blade tip trailing edges can be field repaired if the length of delamination is Less than 25mm (1 in).
