Sony GPS Report

Davenport Shimmy Damper Update

Ellison Safety Consideration

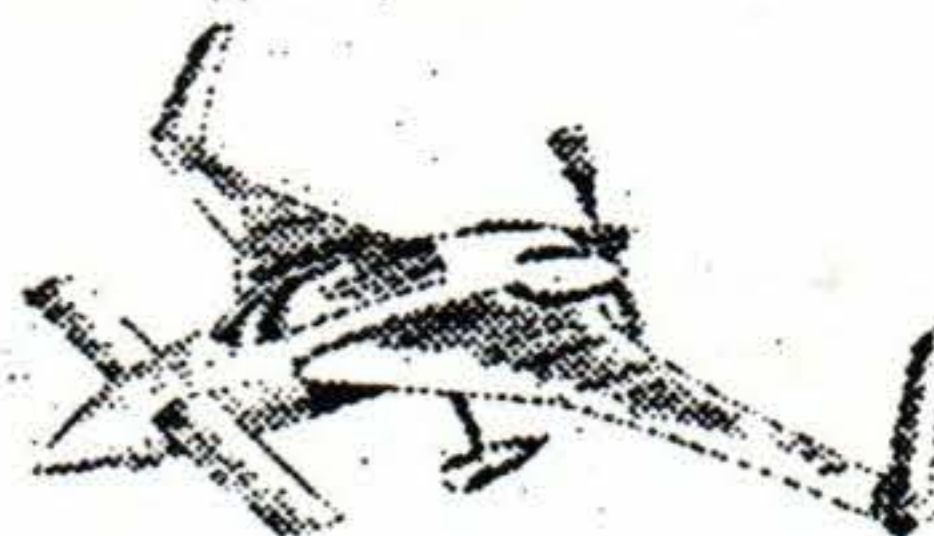
I do not have a machine shop and, therefore, subcontract all parts to a high quality shop. I keep no inventory of parts or complete assemblies. I hold all orders until a total of 25 accumulate. That quantity is required to keep the delivered sale price to \$71.48. All checks are kept until two weeks prior to shipping.

Save yourself a disappointment by ordering the unit when you can afford a waiting period that won't disrupt your schedule.

Bob Davenport (FL) - I'd like to report on a letter which was received from Mark Buxbaum of Richland, WA. It seems, after making a series of "not so good landings" last summer, he experienced catastrophic shimmy on landing at Dubois, WY. This occurred with the Super Shimmy Damper Installed !! After replacing the nose gear assembly with another complete assembly, including a Super Shimmy Damper, Mark continued on his way to OSH with no further problems.

On returning home and checking over the failed nose gear assembly Mark discovered he had bent the wheel disc on one of those "not so good landings". Run-out was found to be .020", which he believes drove the nose wheel in oscillation beyond the capacity of the shimmy damper.
