Oil Cooler Mount

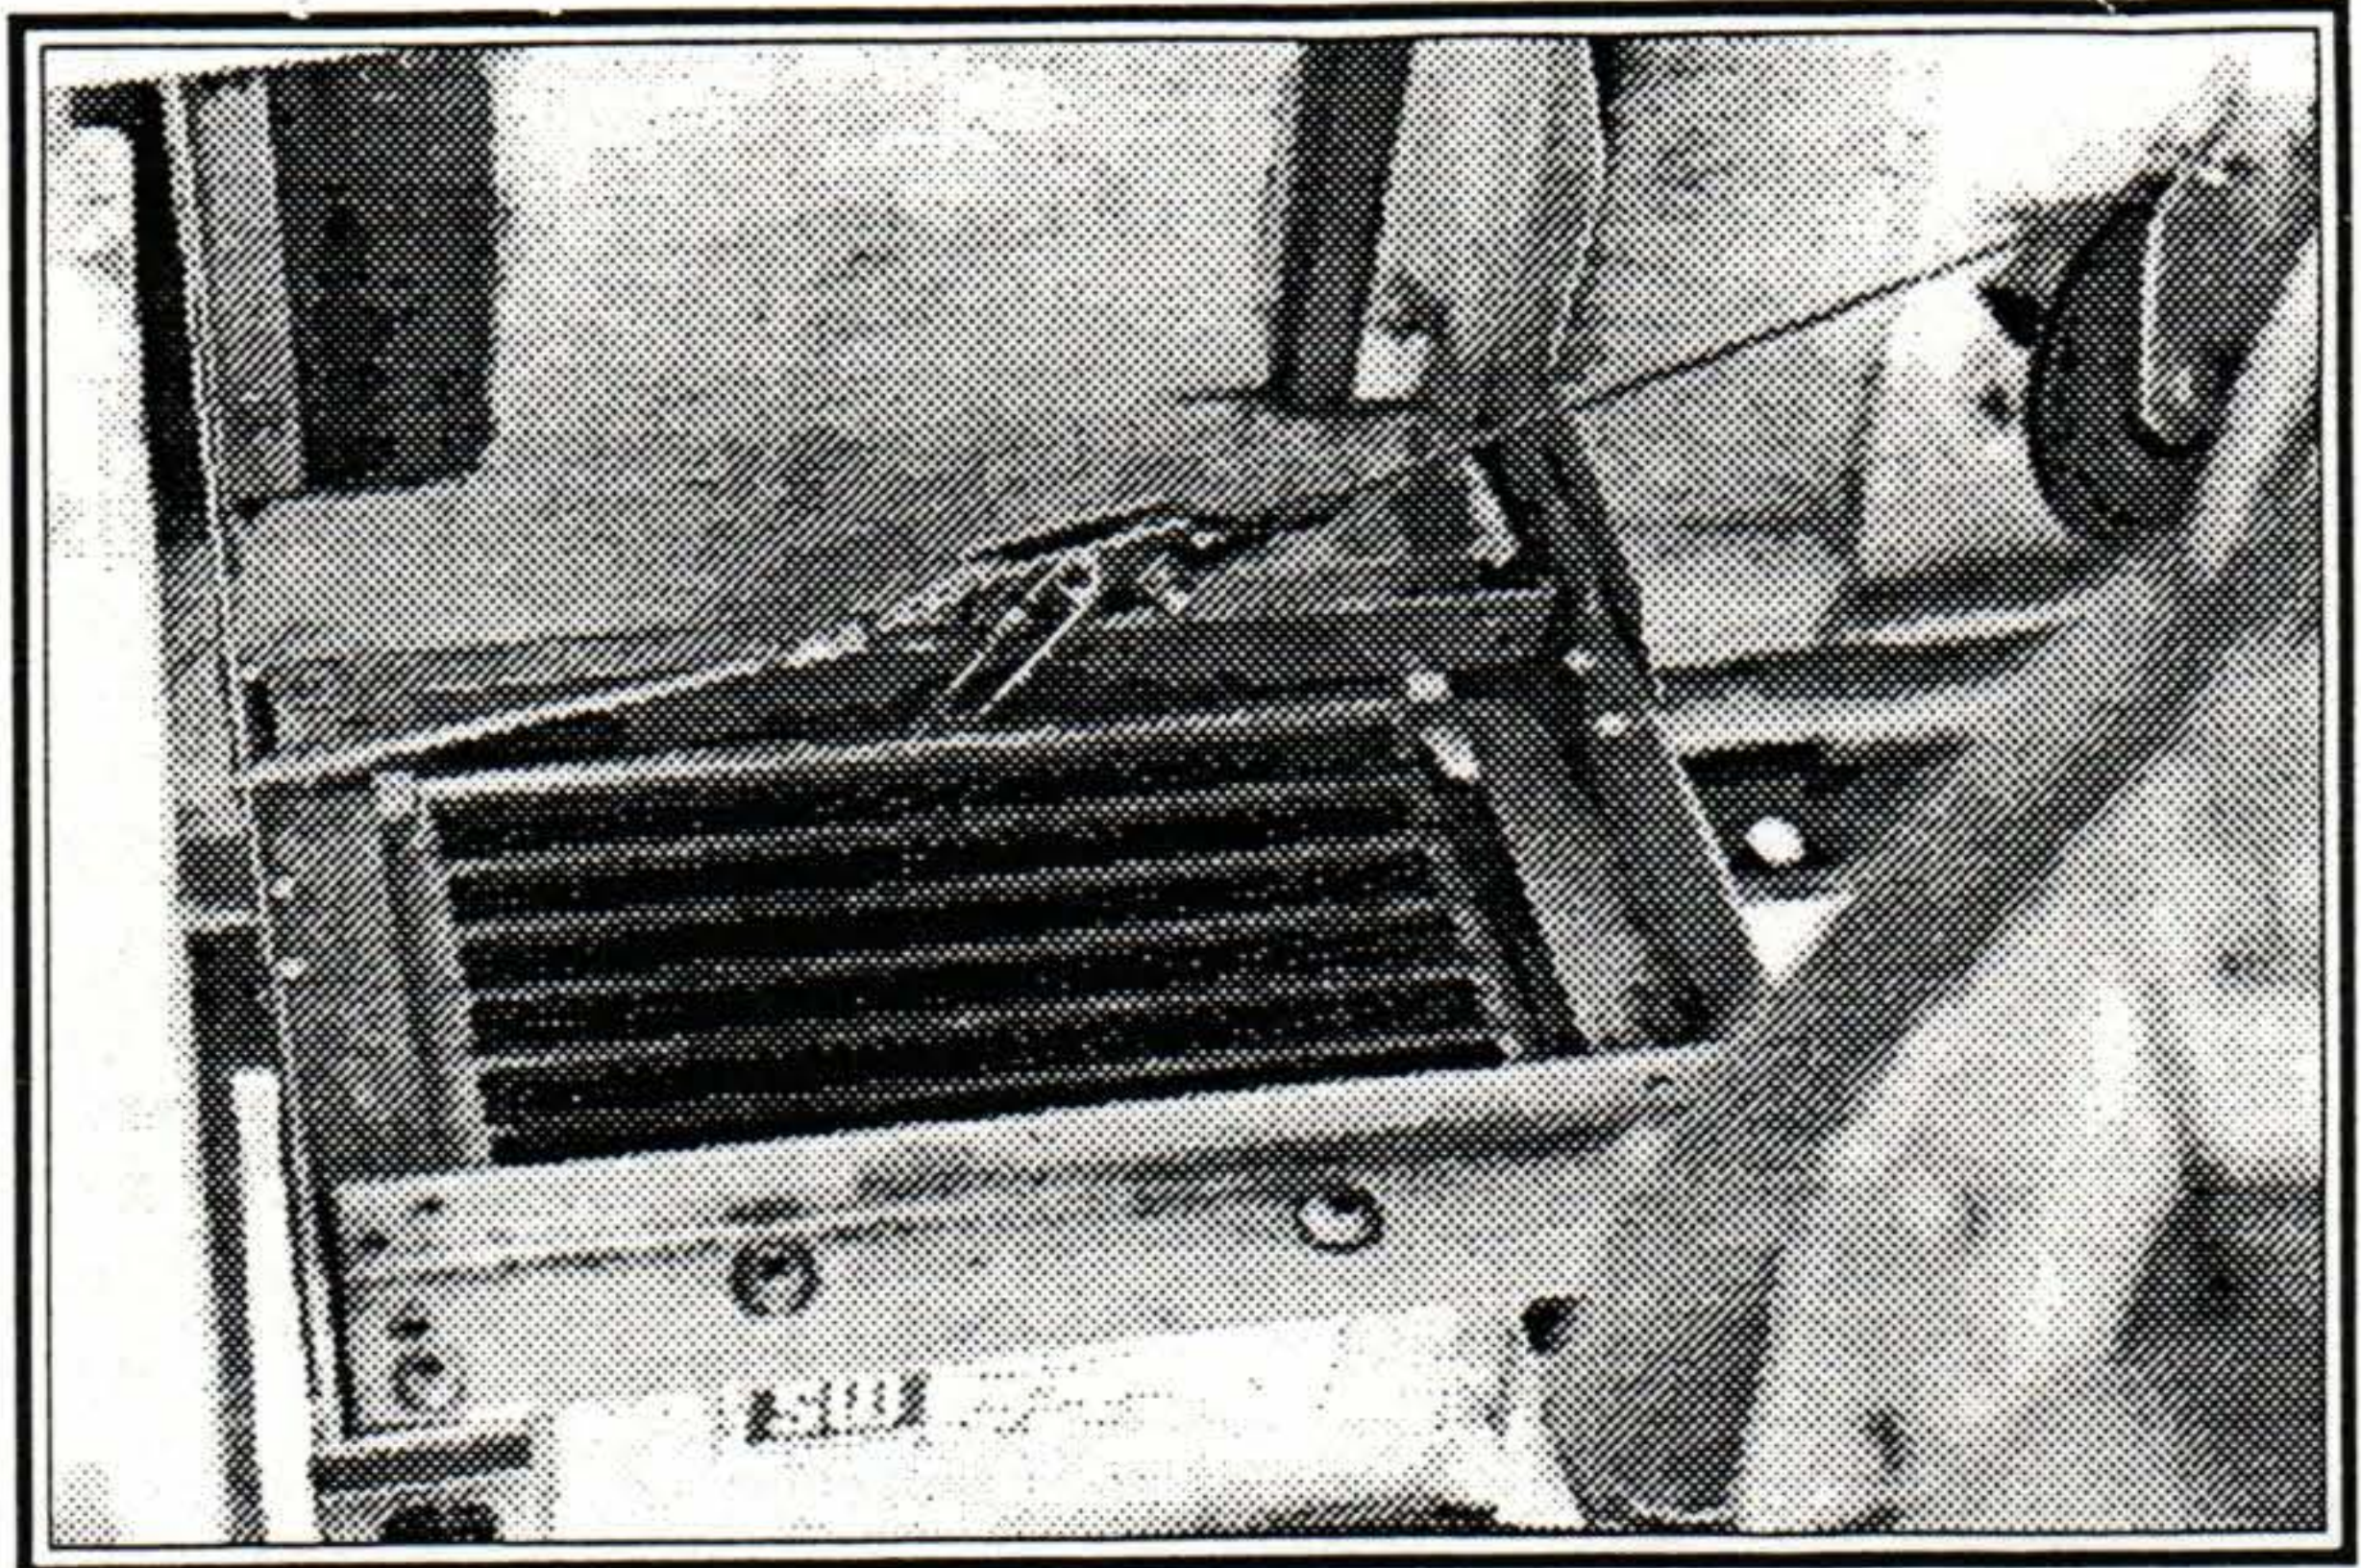
Dave Haggard (KS) - Are you tired of removing the oil cooler from the lower cowl every time you do maintenance? Wouldn't it be nice to have the thing permanently mounted? I've attached my oil cooler to the spar and it has worked well. It stays there and does not need to be disconnected when I remove the lower cowl.

The mounting brackets are bolted to pads that are glassed to the spar center section.
