Induction Icing

Ben Ellison (WA) - Thanks for inviting my input on carburetor icing. I have summarized what (we think) we know about the mechanism of carburetor ice formation.

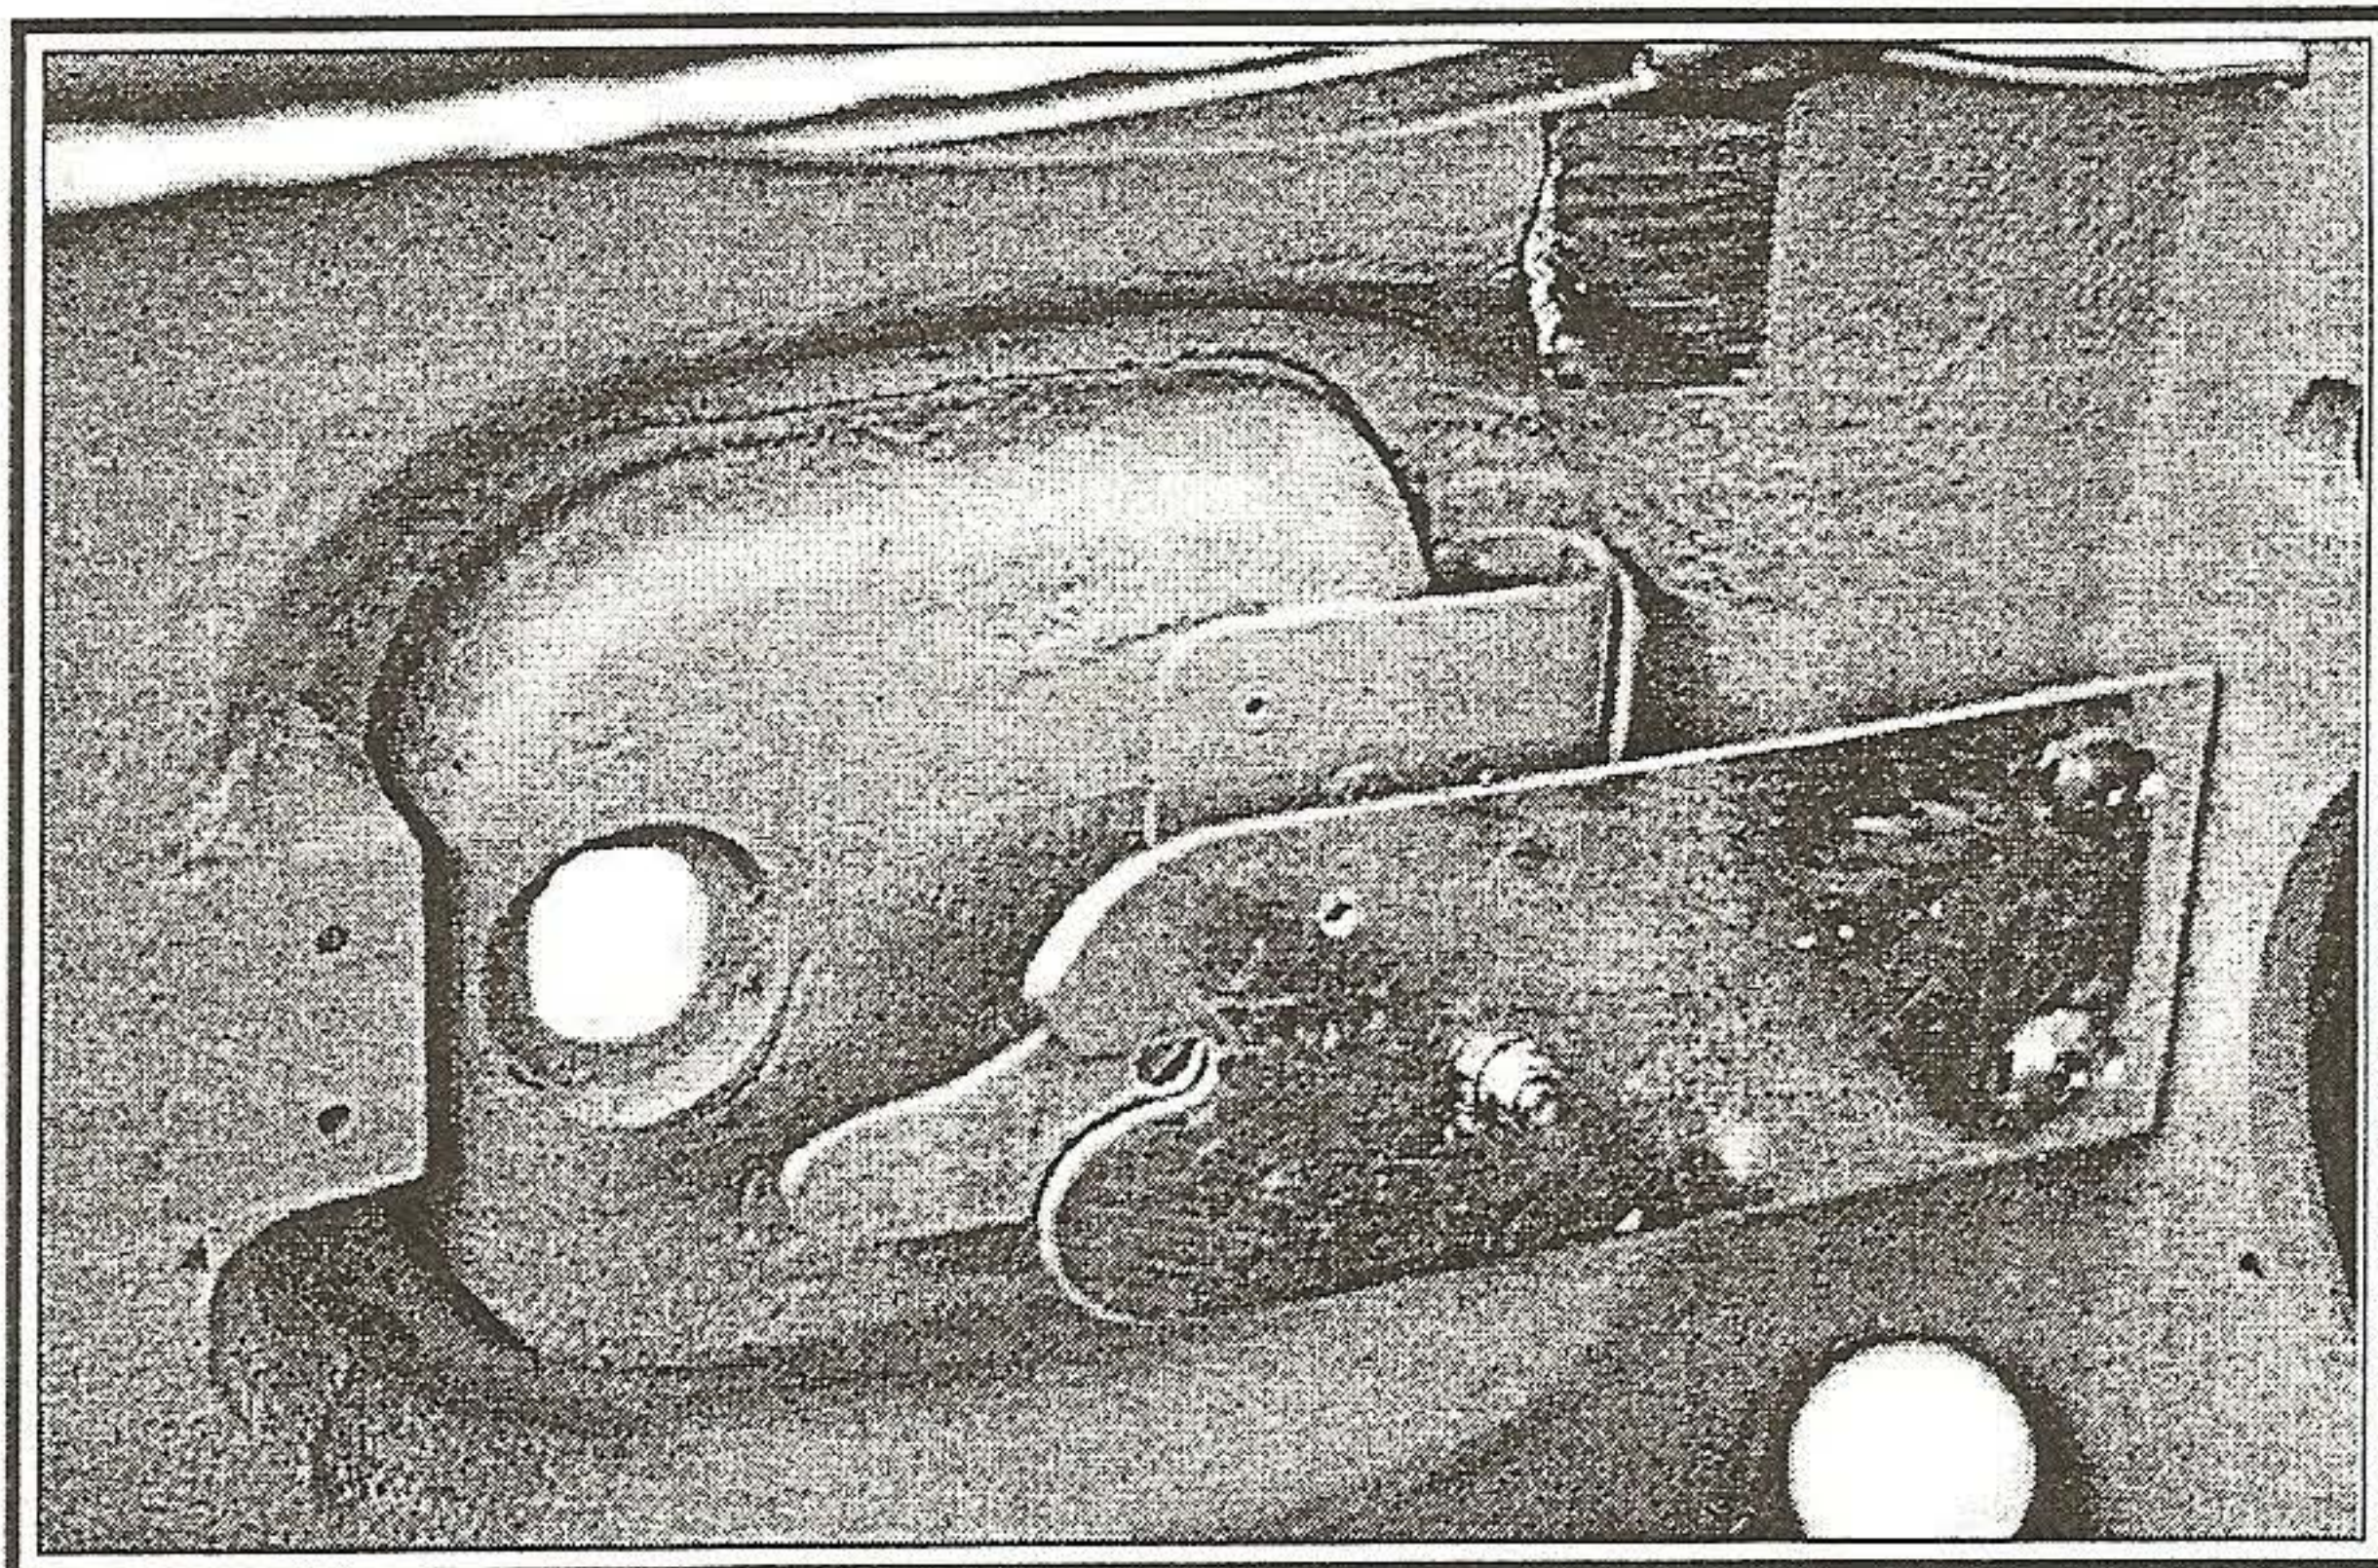
Canopy Access Door

During a recent trip, looking at EZ projects for new ideas, I came across Jim Leturgey's Long-EZ in Gasport, NY. Almost everyone, who has installed the canopy access door, has been bothered with air leaks from that flexible door. Jim's approach has been to increase the stiffness to achieve more reliable sealing and provide a more secure mounting for the door's lock. He has also changed the hinge geometry to reduce the possibility of leaks. That is important in NY's cold winters.
