### More Landing Gear Shake

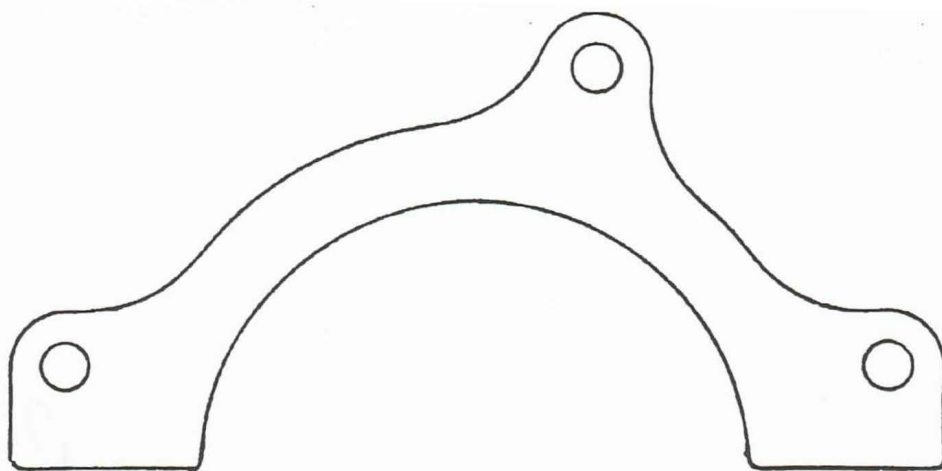
The most important thing I would like to pass on is that run-out is not necessarily only in the disc but may be in the two wheel halves. The wheel wobble causes the disc to also wobble. I find that just the paint between the two wheel halves makes a difference in run-out. You can also assemble each wheel in three differ-

ent positions - so pick the one with the least run-out.

On the new set I found run-out still over .010". I checked with Mike Melvill and discovered the run-out must be less than .010" to work satisfactorily. After much hassle I got a third wheel assembly from Cleveland that had less than .010" run-out. After that change I've had no further vibration problem.

Run-out on an automobile wheel is a problem when it exceeds .002". I fail to see how Cleveland expects us to accept ten times as much on their product. It's no wonder we are having problems with vibration.
