Upgrades for the Lycoming O-320

Overhauling the S-1200 Magneto

Slow Cranking: Causes and Cures

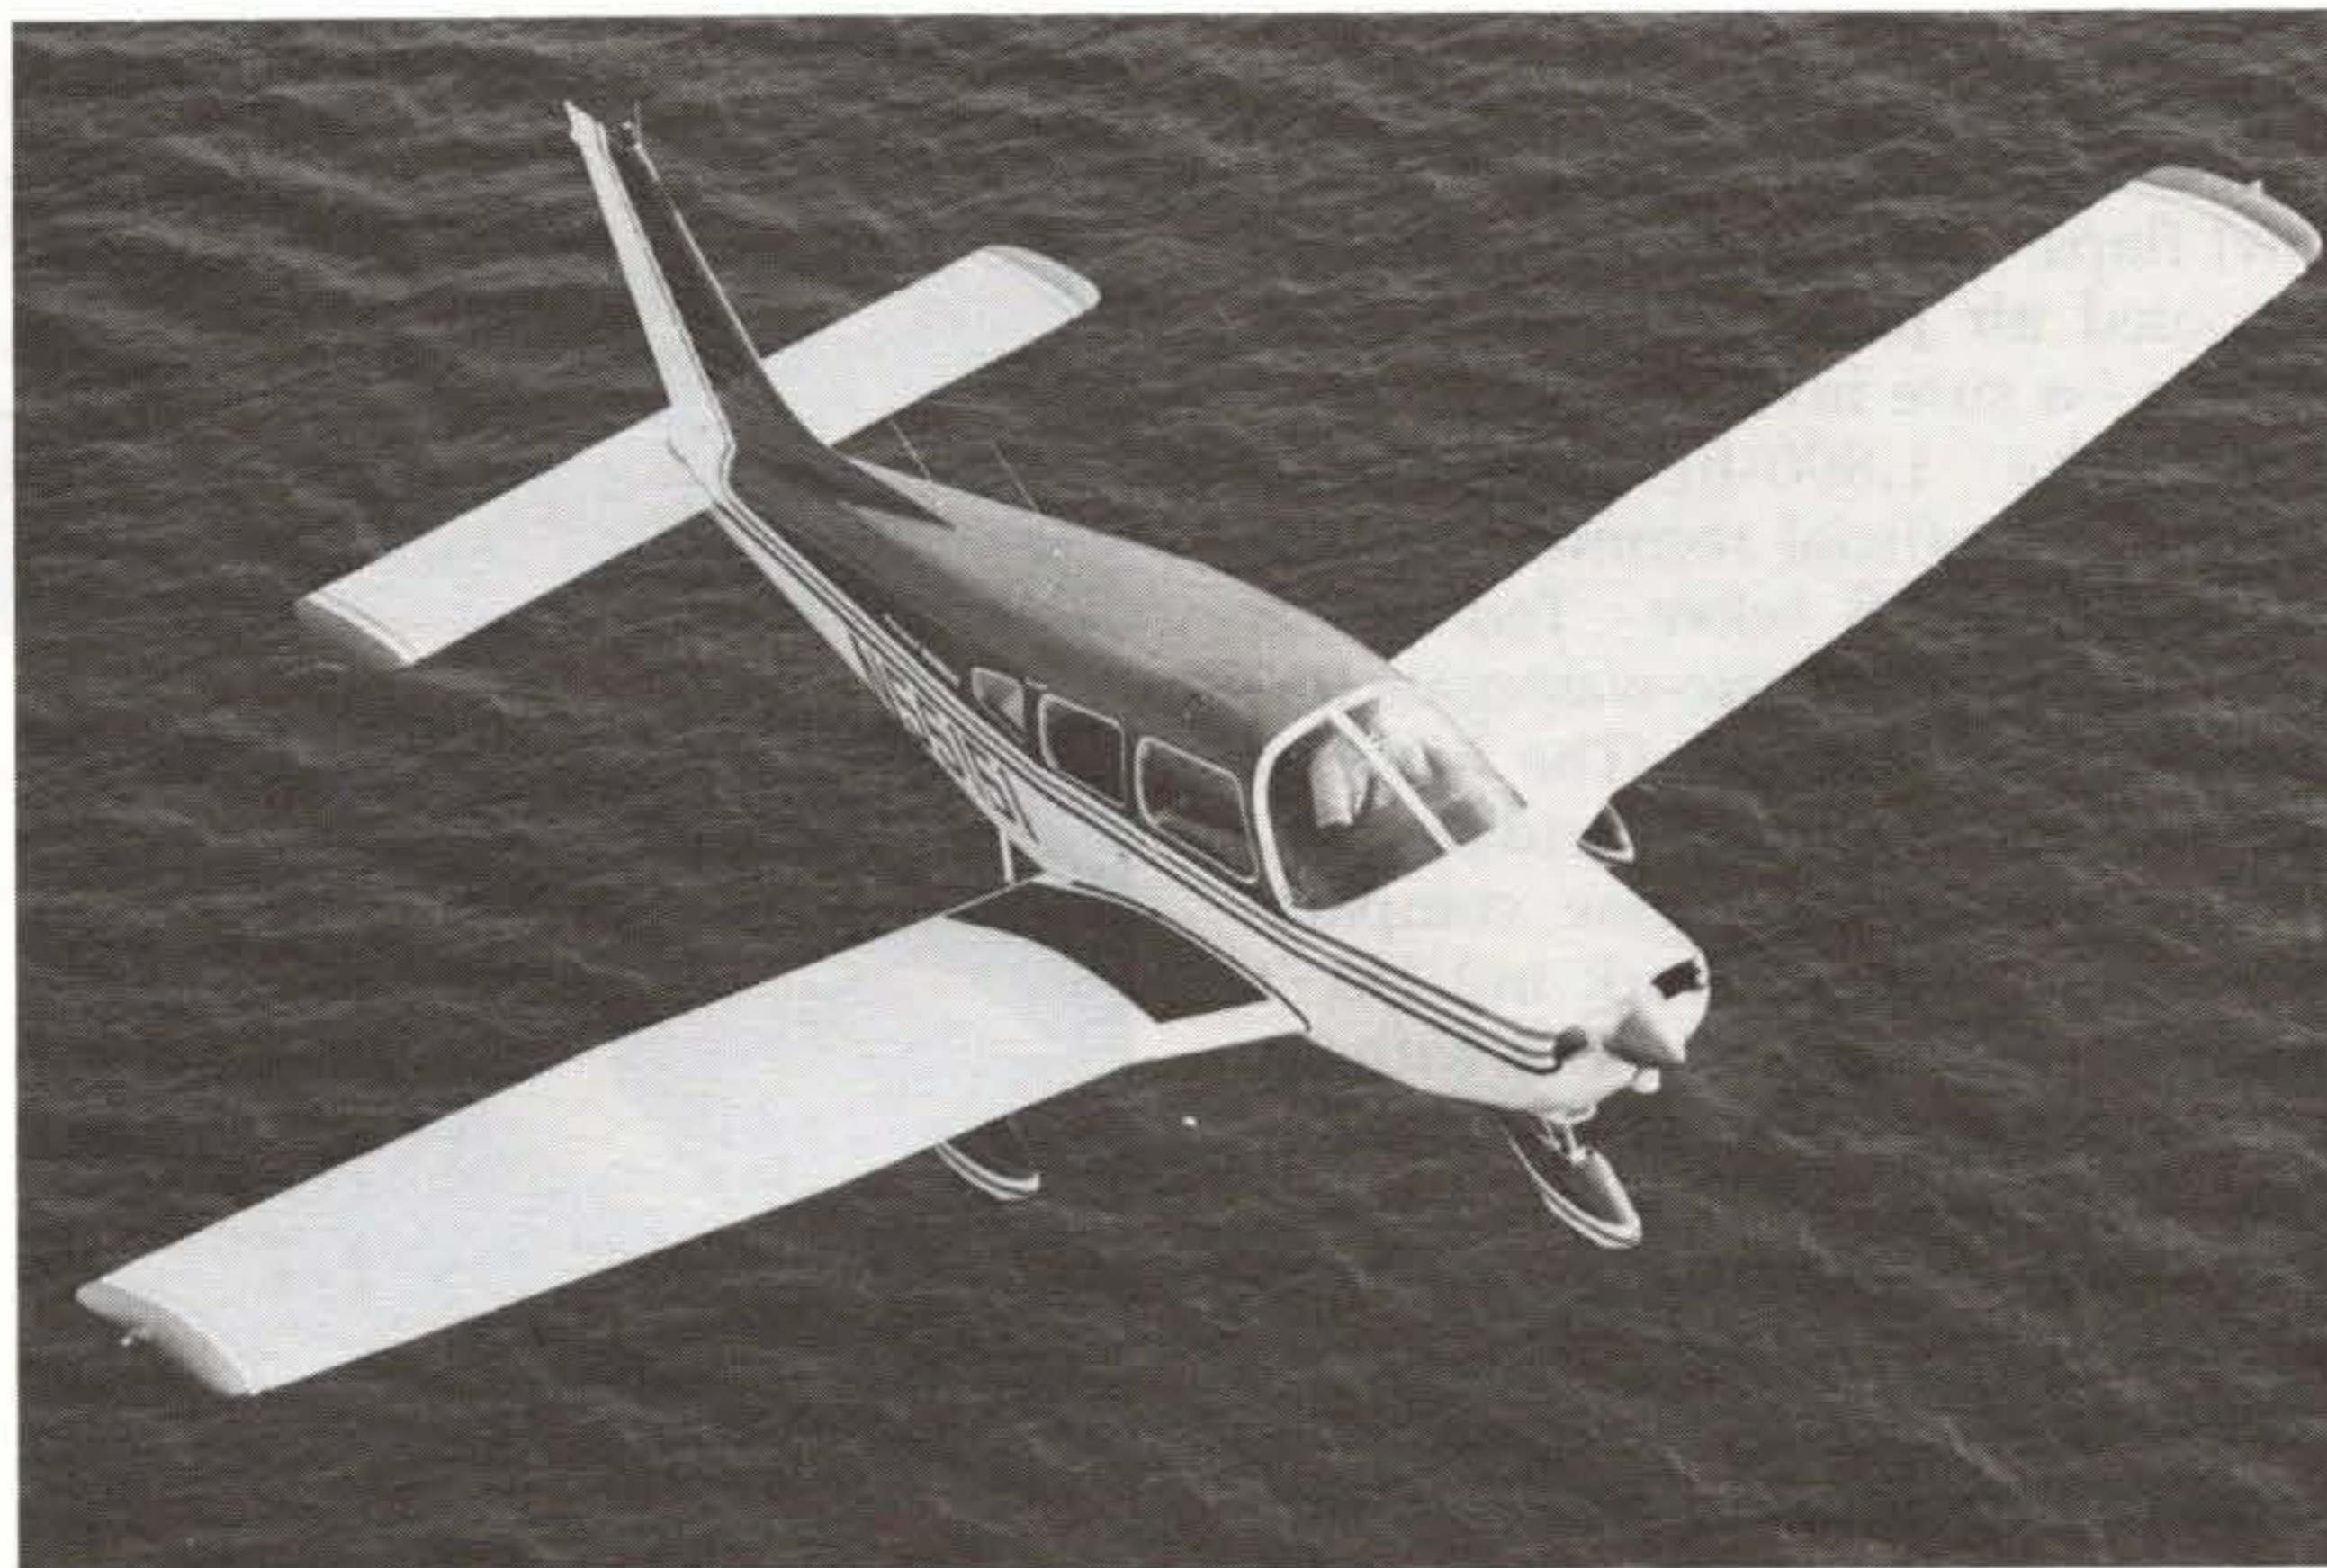
The 150-hp Piper Warrior can be converted to 160 horsepower by installation of a RAM-overhauled O-320. Piston swap cannot be done in the field in this case, however.

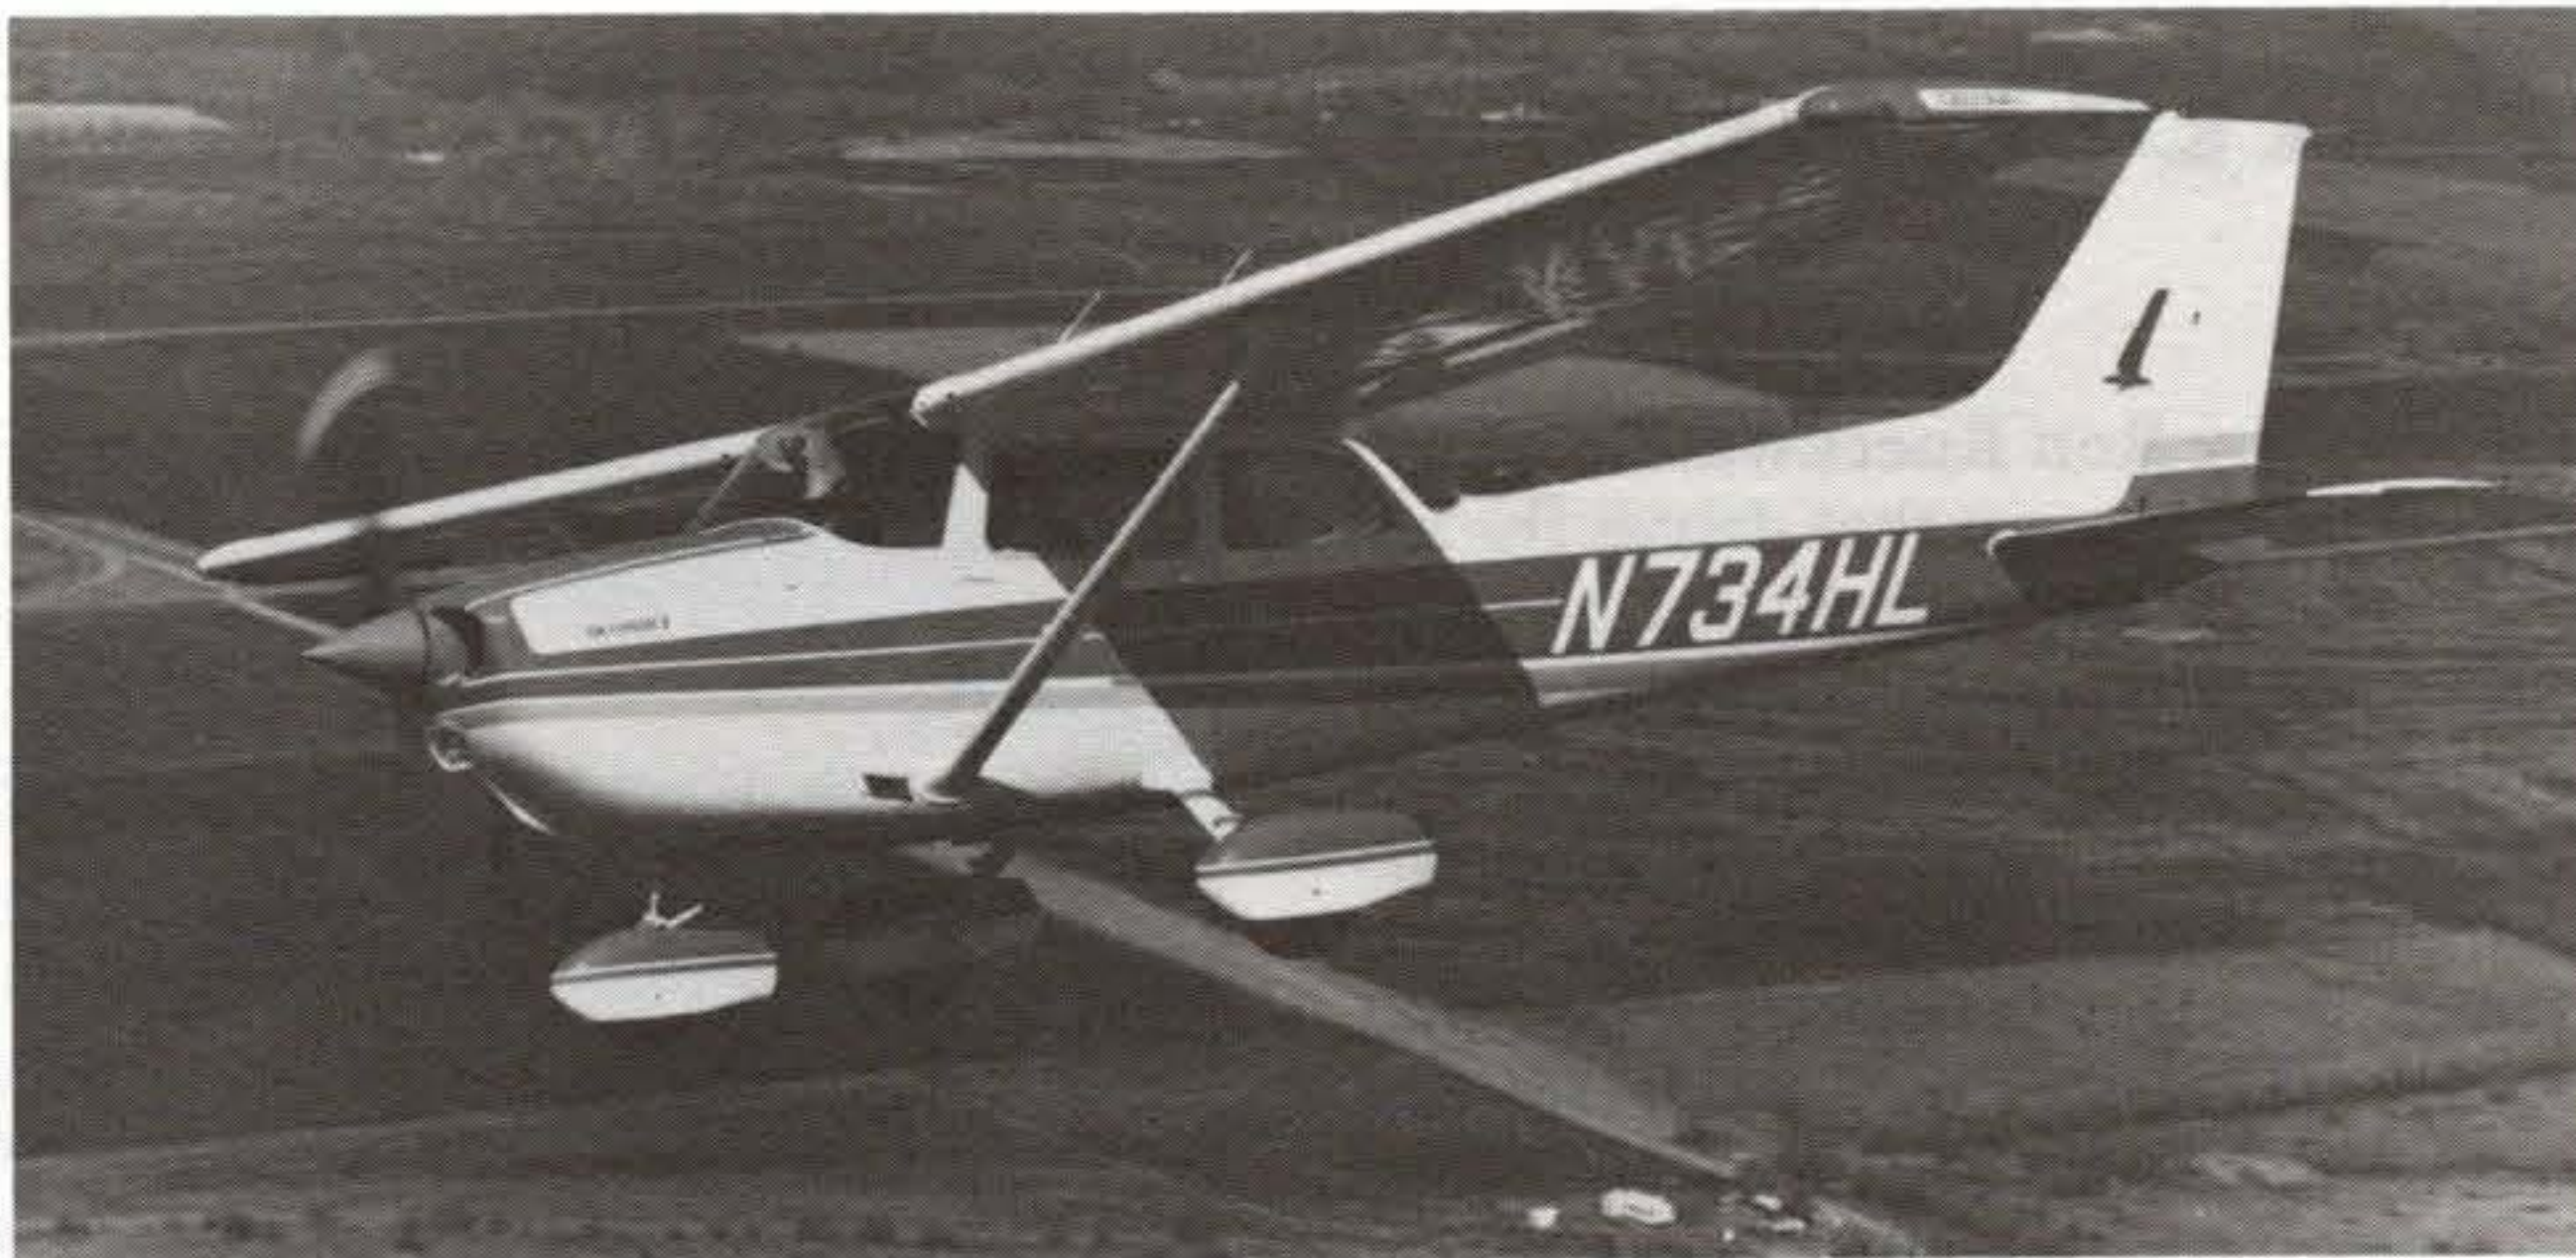
The Skyhawk's 150-hp Lycoming O-320-E2D can be converted to 160 horsepower relatively economically through RAM's piston-swap STC.

RAM's STC allows just that. As currently written, the RAM 160-hp STC allows the owner of an O-320-E2D to install P/N 75089 (half-wedge, 8.5:1) pistons in place of the old 7:1 pistons, and in so doing convert the engine to a 160-hp, 100-octane powerplant. Cost of the STC: \$400.

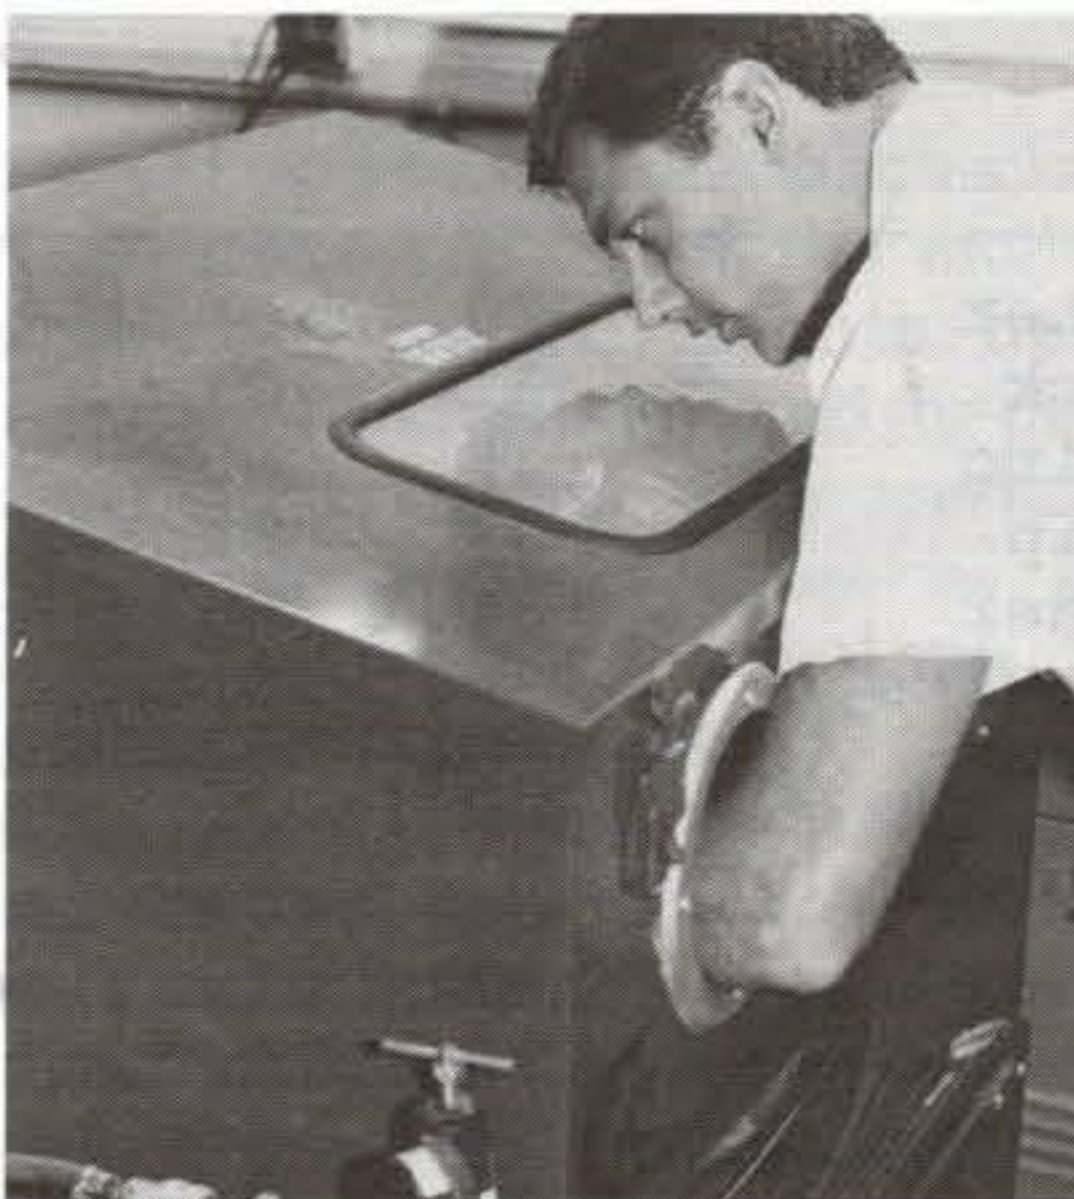
Clockwise from top left: Terry Norris subjects a distributor block to plastic-media blast-cleaning. Care must be taken not to damage the block (newer brown-colored blocks cannot be blast-cleaned). After cleaning, the block is checked carefully for cracks. Then one end is corked and the center cavity filled with special distributor-block lube, and the unit baked in an oven to get the oil to soak into the oilite bushing. Finally, the block gets a coat of special distributor sealant (which will insulate the block and cause moisture to bead up rather than wet the surface). If it needs it, the distributor gear timing marks are then repainted on.

After solvent cleaning, the distributor block is blasted with plastic media, carefully controlling the pressure so as not to allow the block to be damaged. This is done to completely clean the block so as to reveal even the smallest crack. (Norris cautions others not to attempt to clean the new brown-colored blocks under pressure, as it will erode them.) After this, the block is washed again in solvent and carefully examined under a 10X magnifying glass, after which it gets placed in an oven (briefly) to evaporate off any

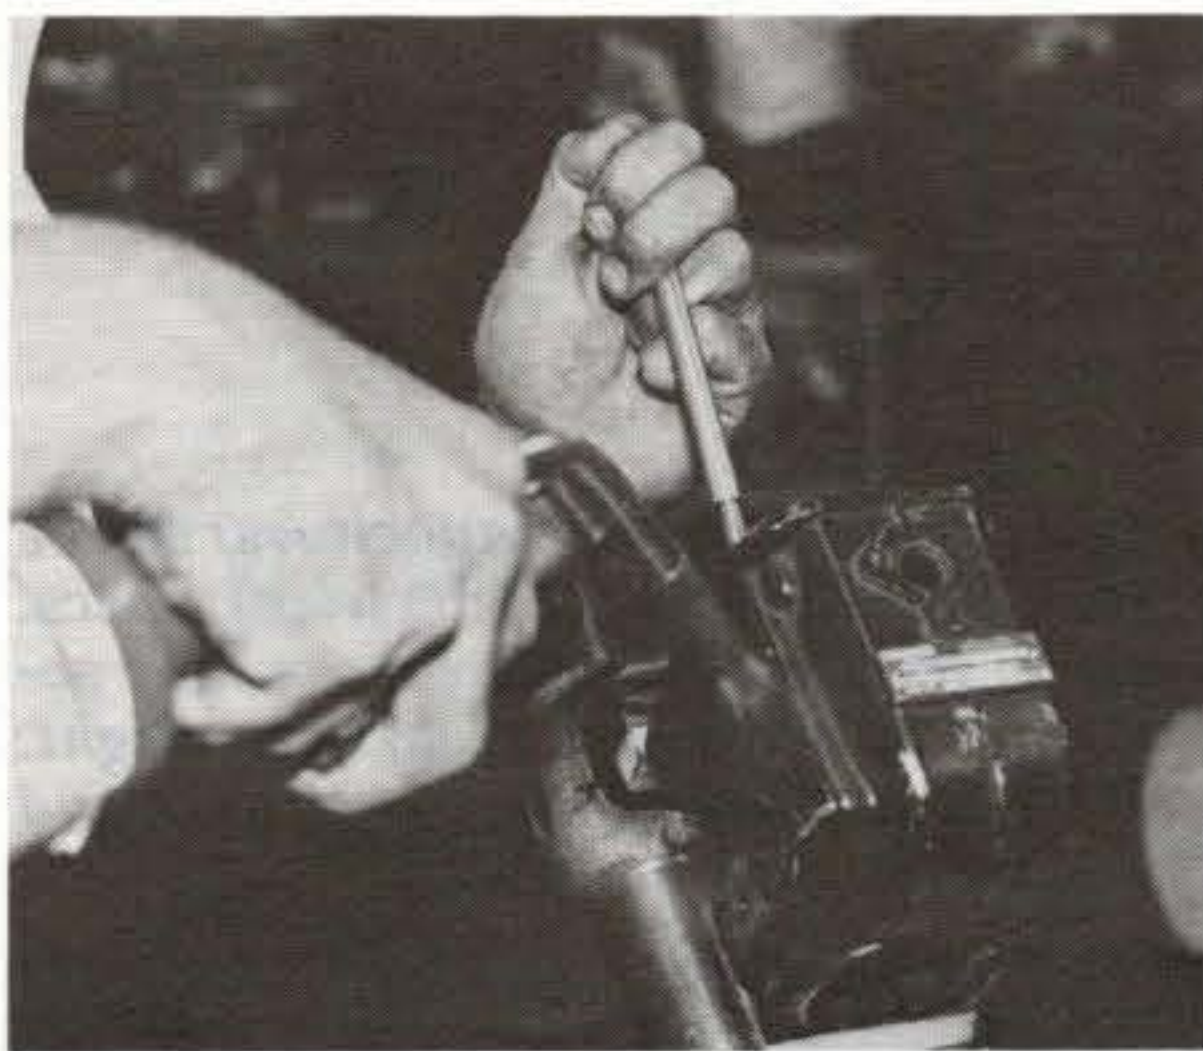
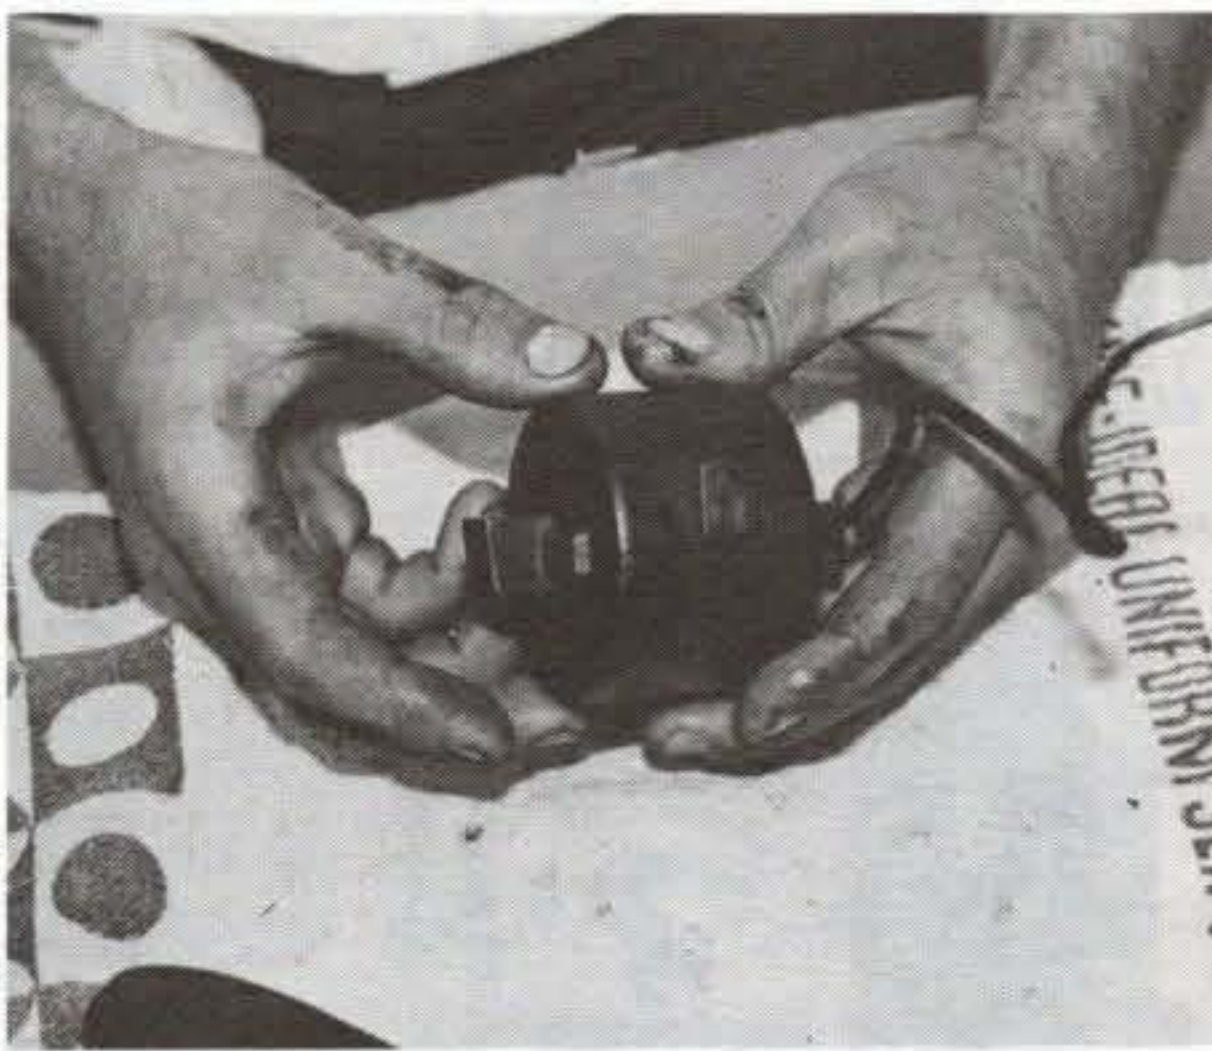
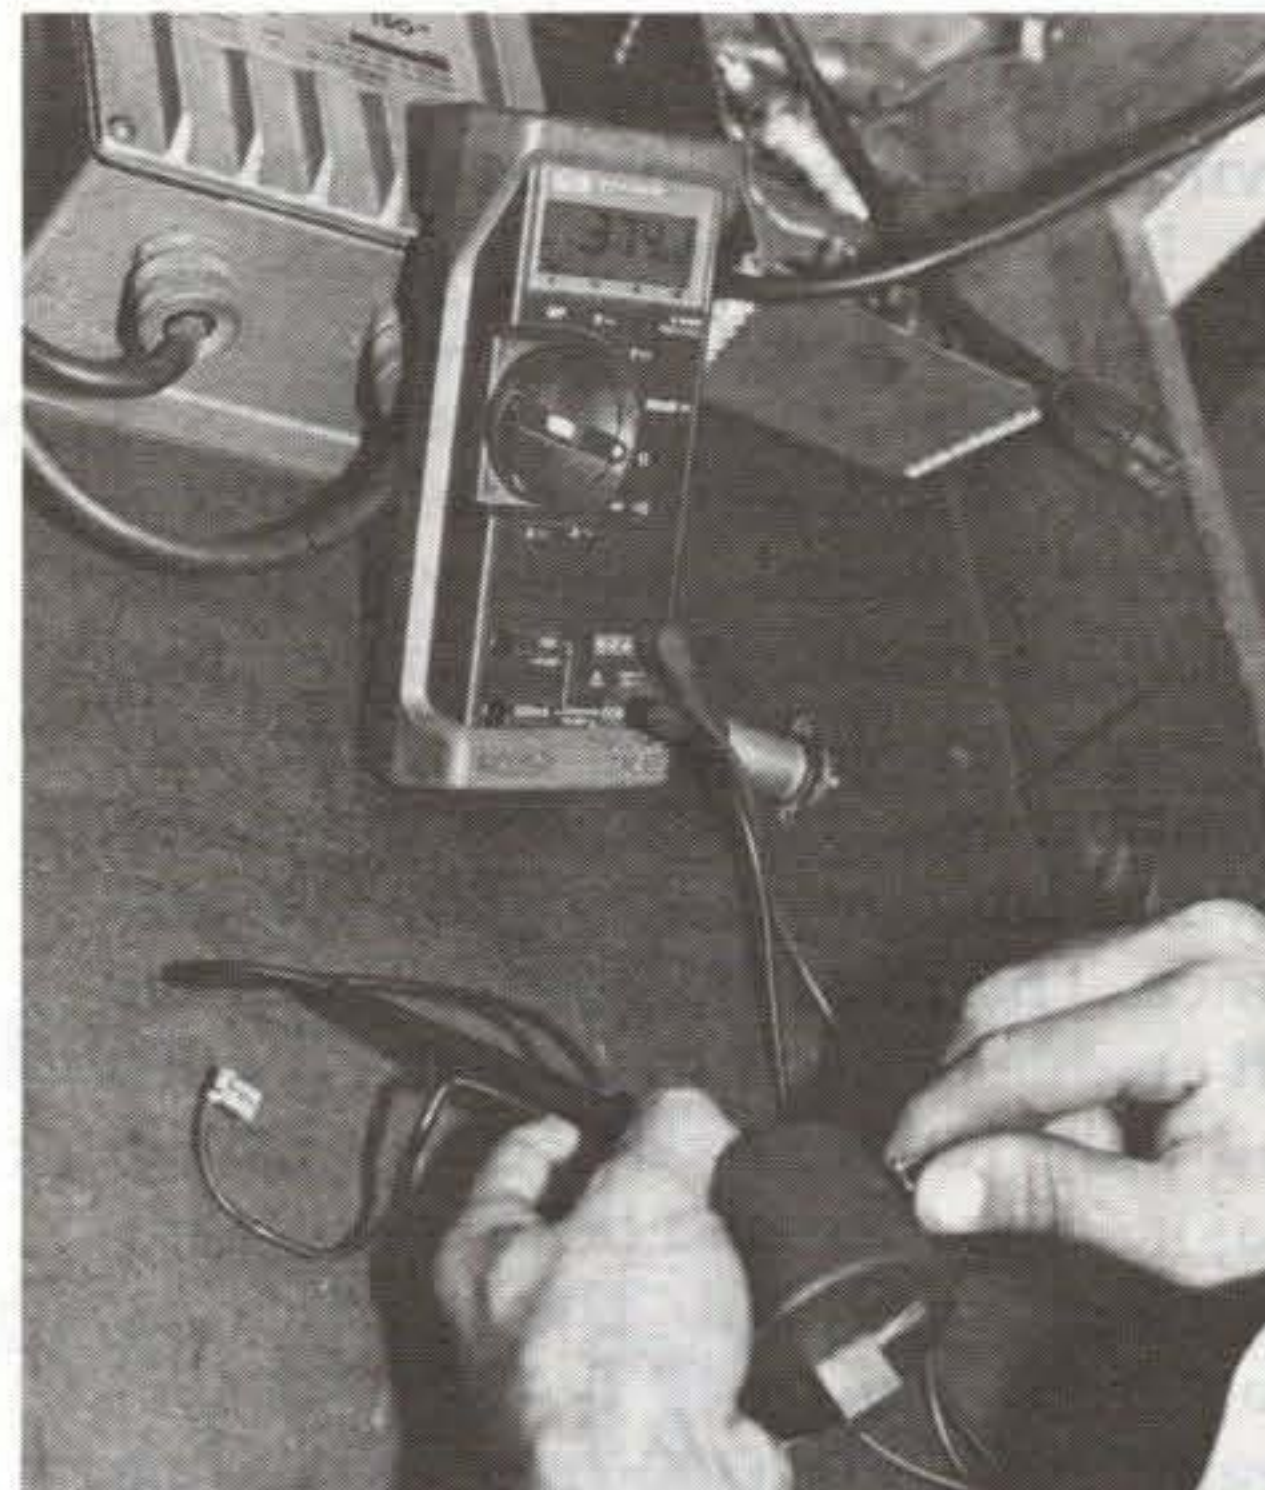
Clockwise from top left: In the S-1200, the coil is held in place by wedges. To remove the coil without damaging it or the magnesium housing, heat (from a torch) is applied very judiciously to expand the housing so the coil can be popped out. Once out, the coil gets a careful visual inspection for damage to the wires and/or cracking of the potting compound. Then checks are made of the primary and secondary coil resistances. (The primary and secondary coils are potted as a unit. So even though we speak of "a coil," we're really talking about two coils.) Fish paper is used to keep coil wires from chafing; and a hammer and drift are used to wedge the coil back into place in its housing.

Next, the coil is removed (see photos for explanation) and it and the capacitor are checked electrically—the coil for primary and secondary resistances (1.0 to 1.5 ohms for primary; 17-23,000 ohms for secondary), and the capacitor for series resistance, leakage, and capacitance (0.30 to 0.45 mfd).

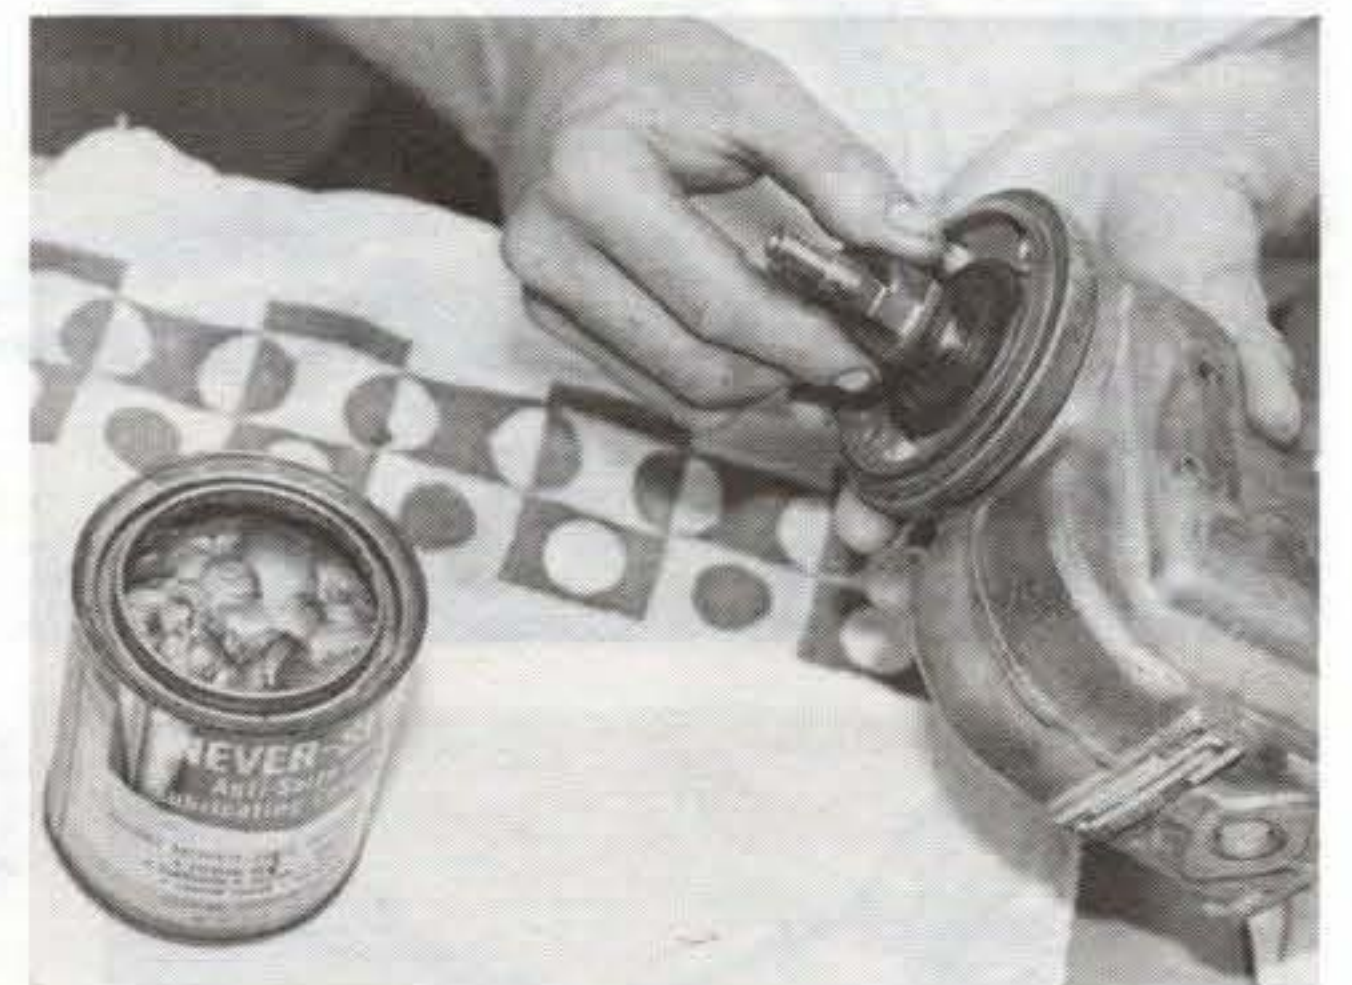
Clockwise from top left: The old rotor, if weak, is remagnetized using a special Bendix-Scintilla apparatus. Next, before final assembly of the mag, the breaker compartment is set up for proper internal timing (E-gap and point opening tolerances) using a special Bendix timing kit and feeler gauges. Anti-seize compound is used when installing the drive gear on the rotor shaft. Finally, the built-up mag is put on a test stand, where it is run up to 5,000 rpm. (On six-cylinder engines, the mag turns at one-and-a-half times crank speed.) Special electrodes are used to simulate spark plugs operating at high altitude. Low-rpm operation, which puts special stress on a mag's electrical components, is also tested. If weak output is noted, the mag gets torn down again.

it or not, magnets are found with low field strength from time to time.) If needed, the rotor can be remagnetized with a P/N 11-1362 Magnet Charger (Bendix-Scintilla) or a Weidenhoff Model D-818.

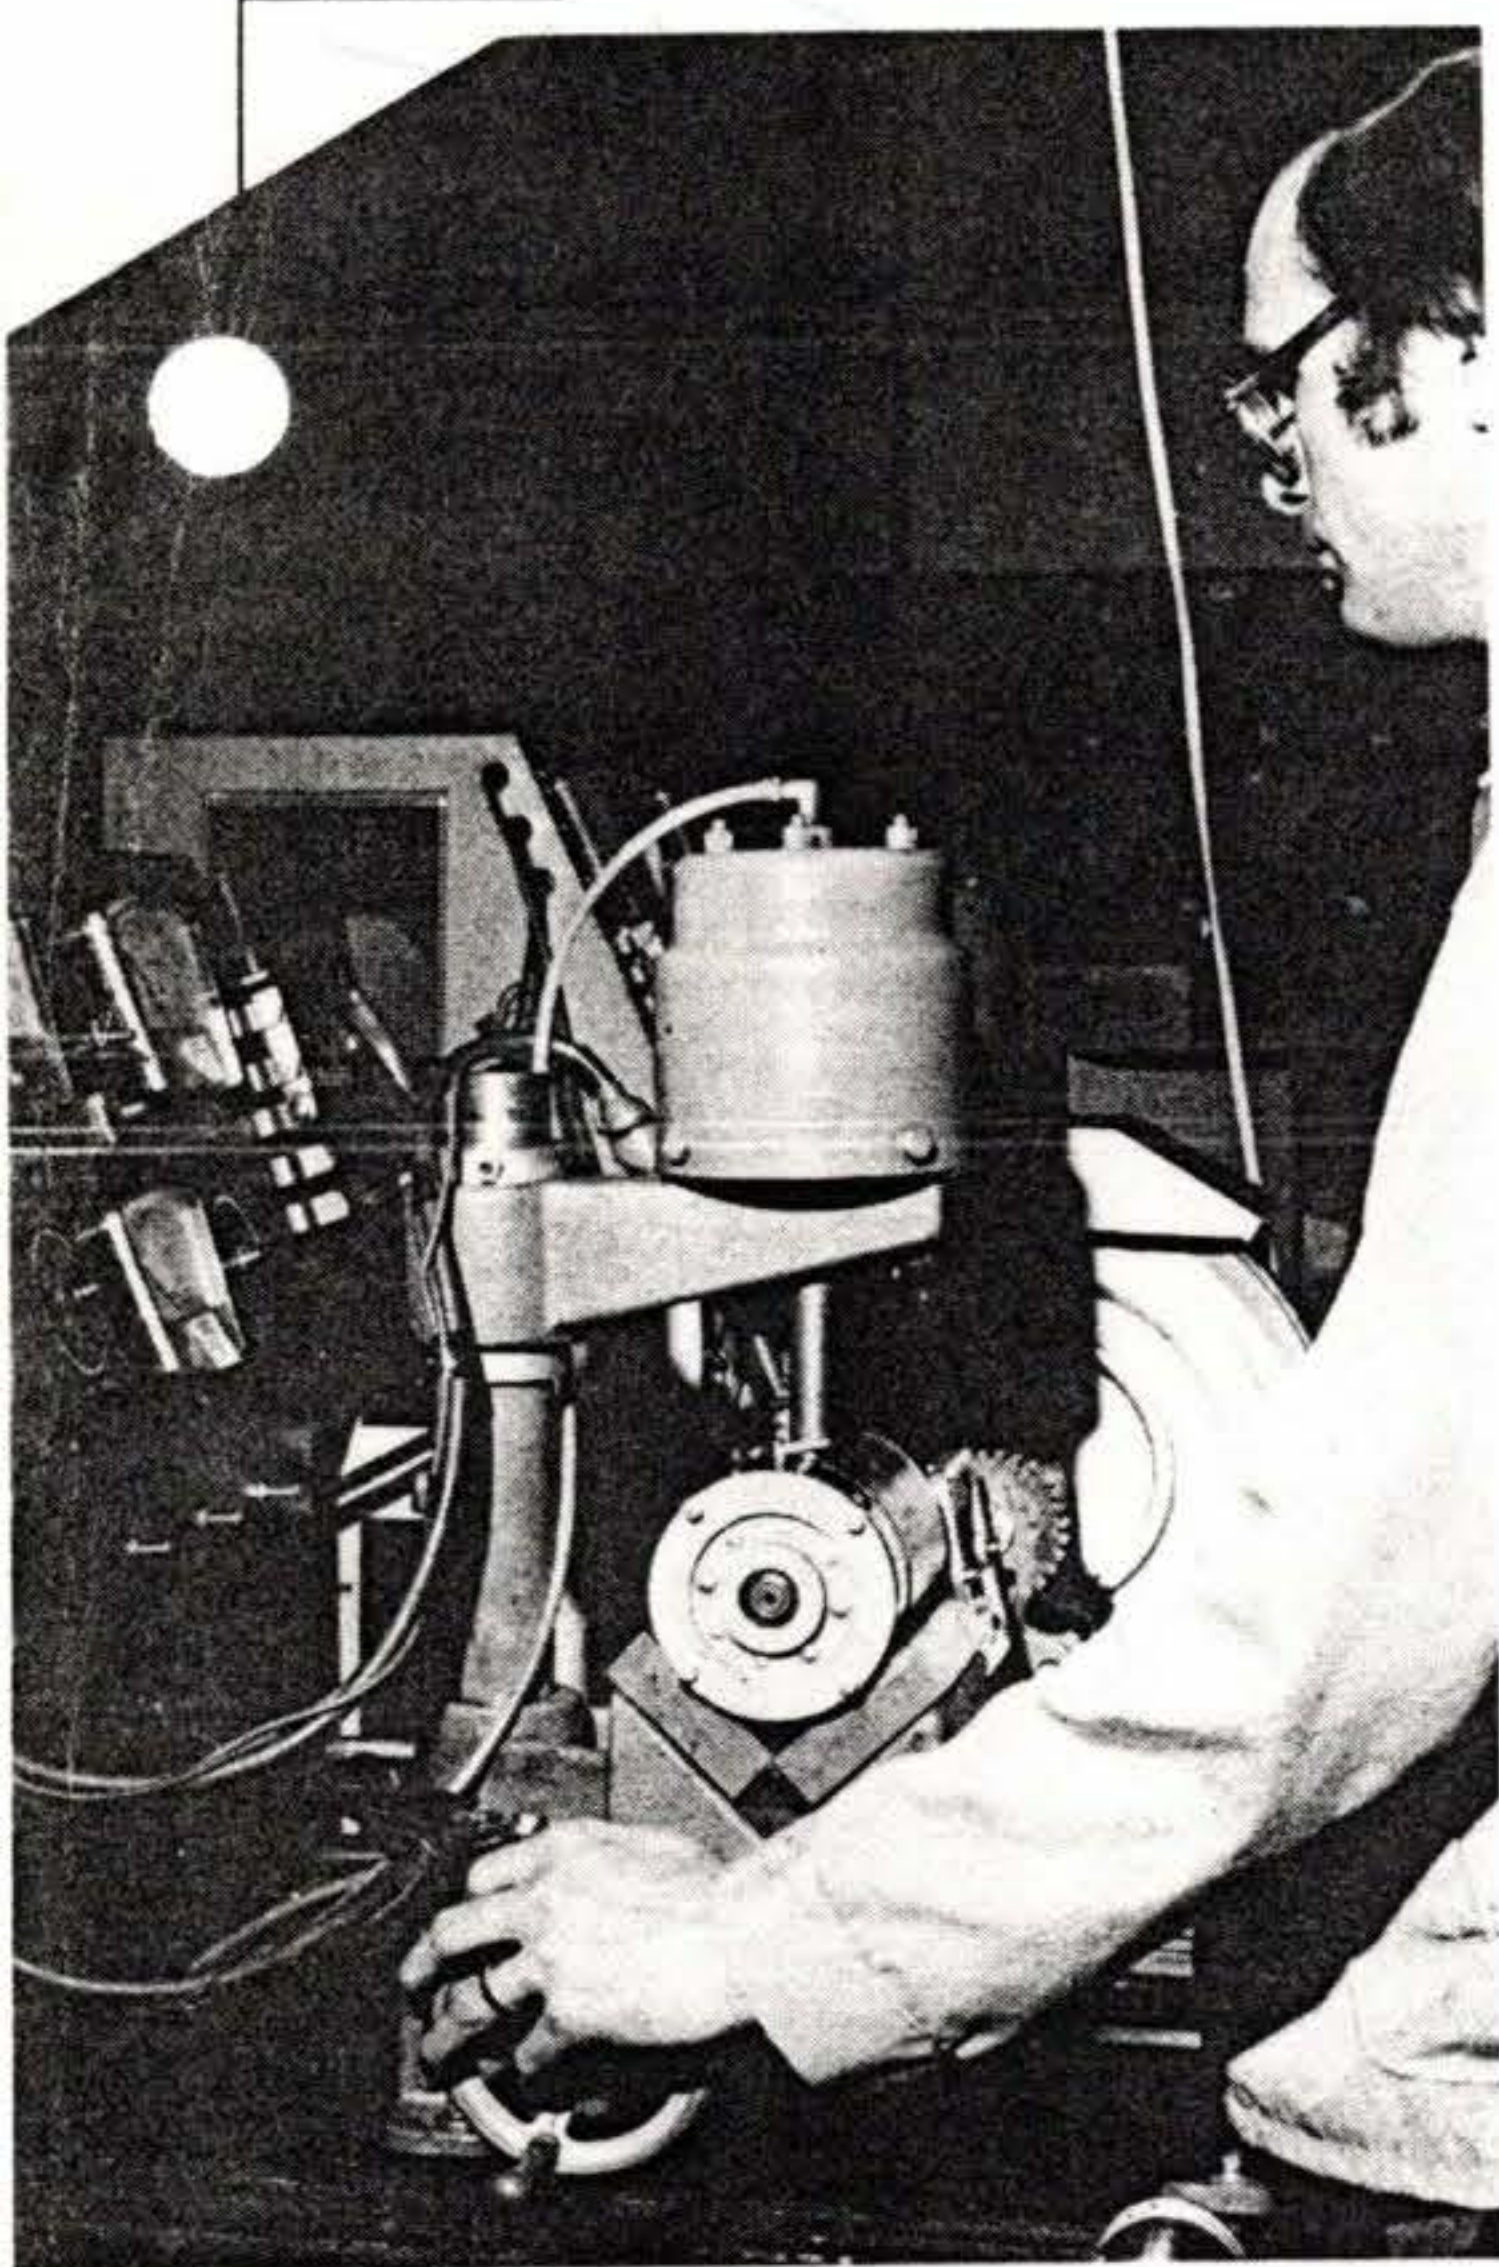
Proper testing of a starter motor includes a bench check of stall torque, stall amperage, and no-load rpm.

volts (or 24, on a 24-volt aircraft). In a total "lockup" condition—where the starter won't turn at all—a typical 12-volt Prestolite motor will draw 500 amps or more, producing 40 ft-lbs of torque.

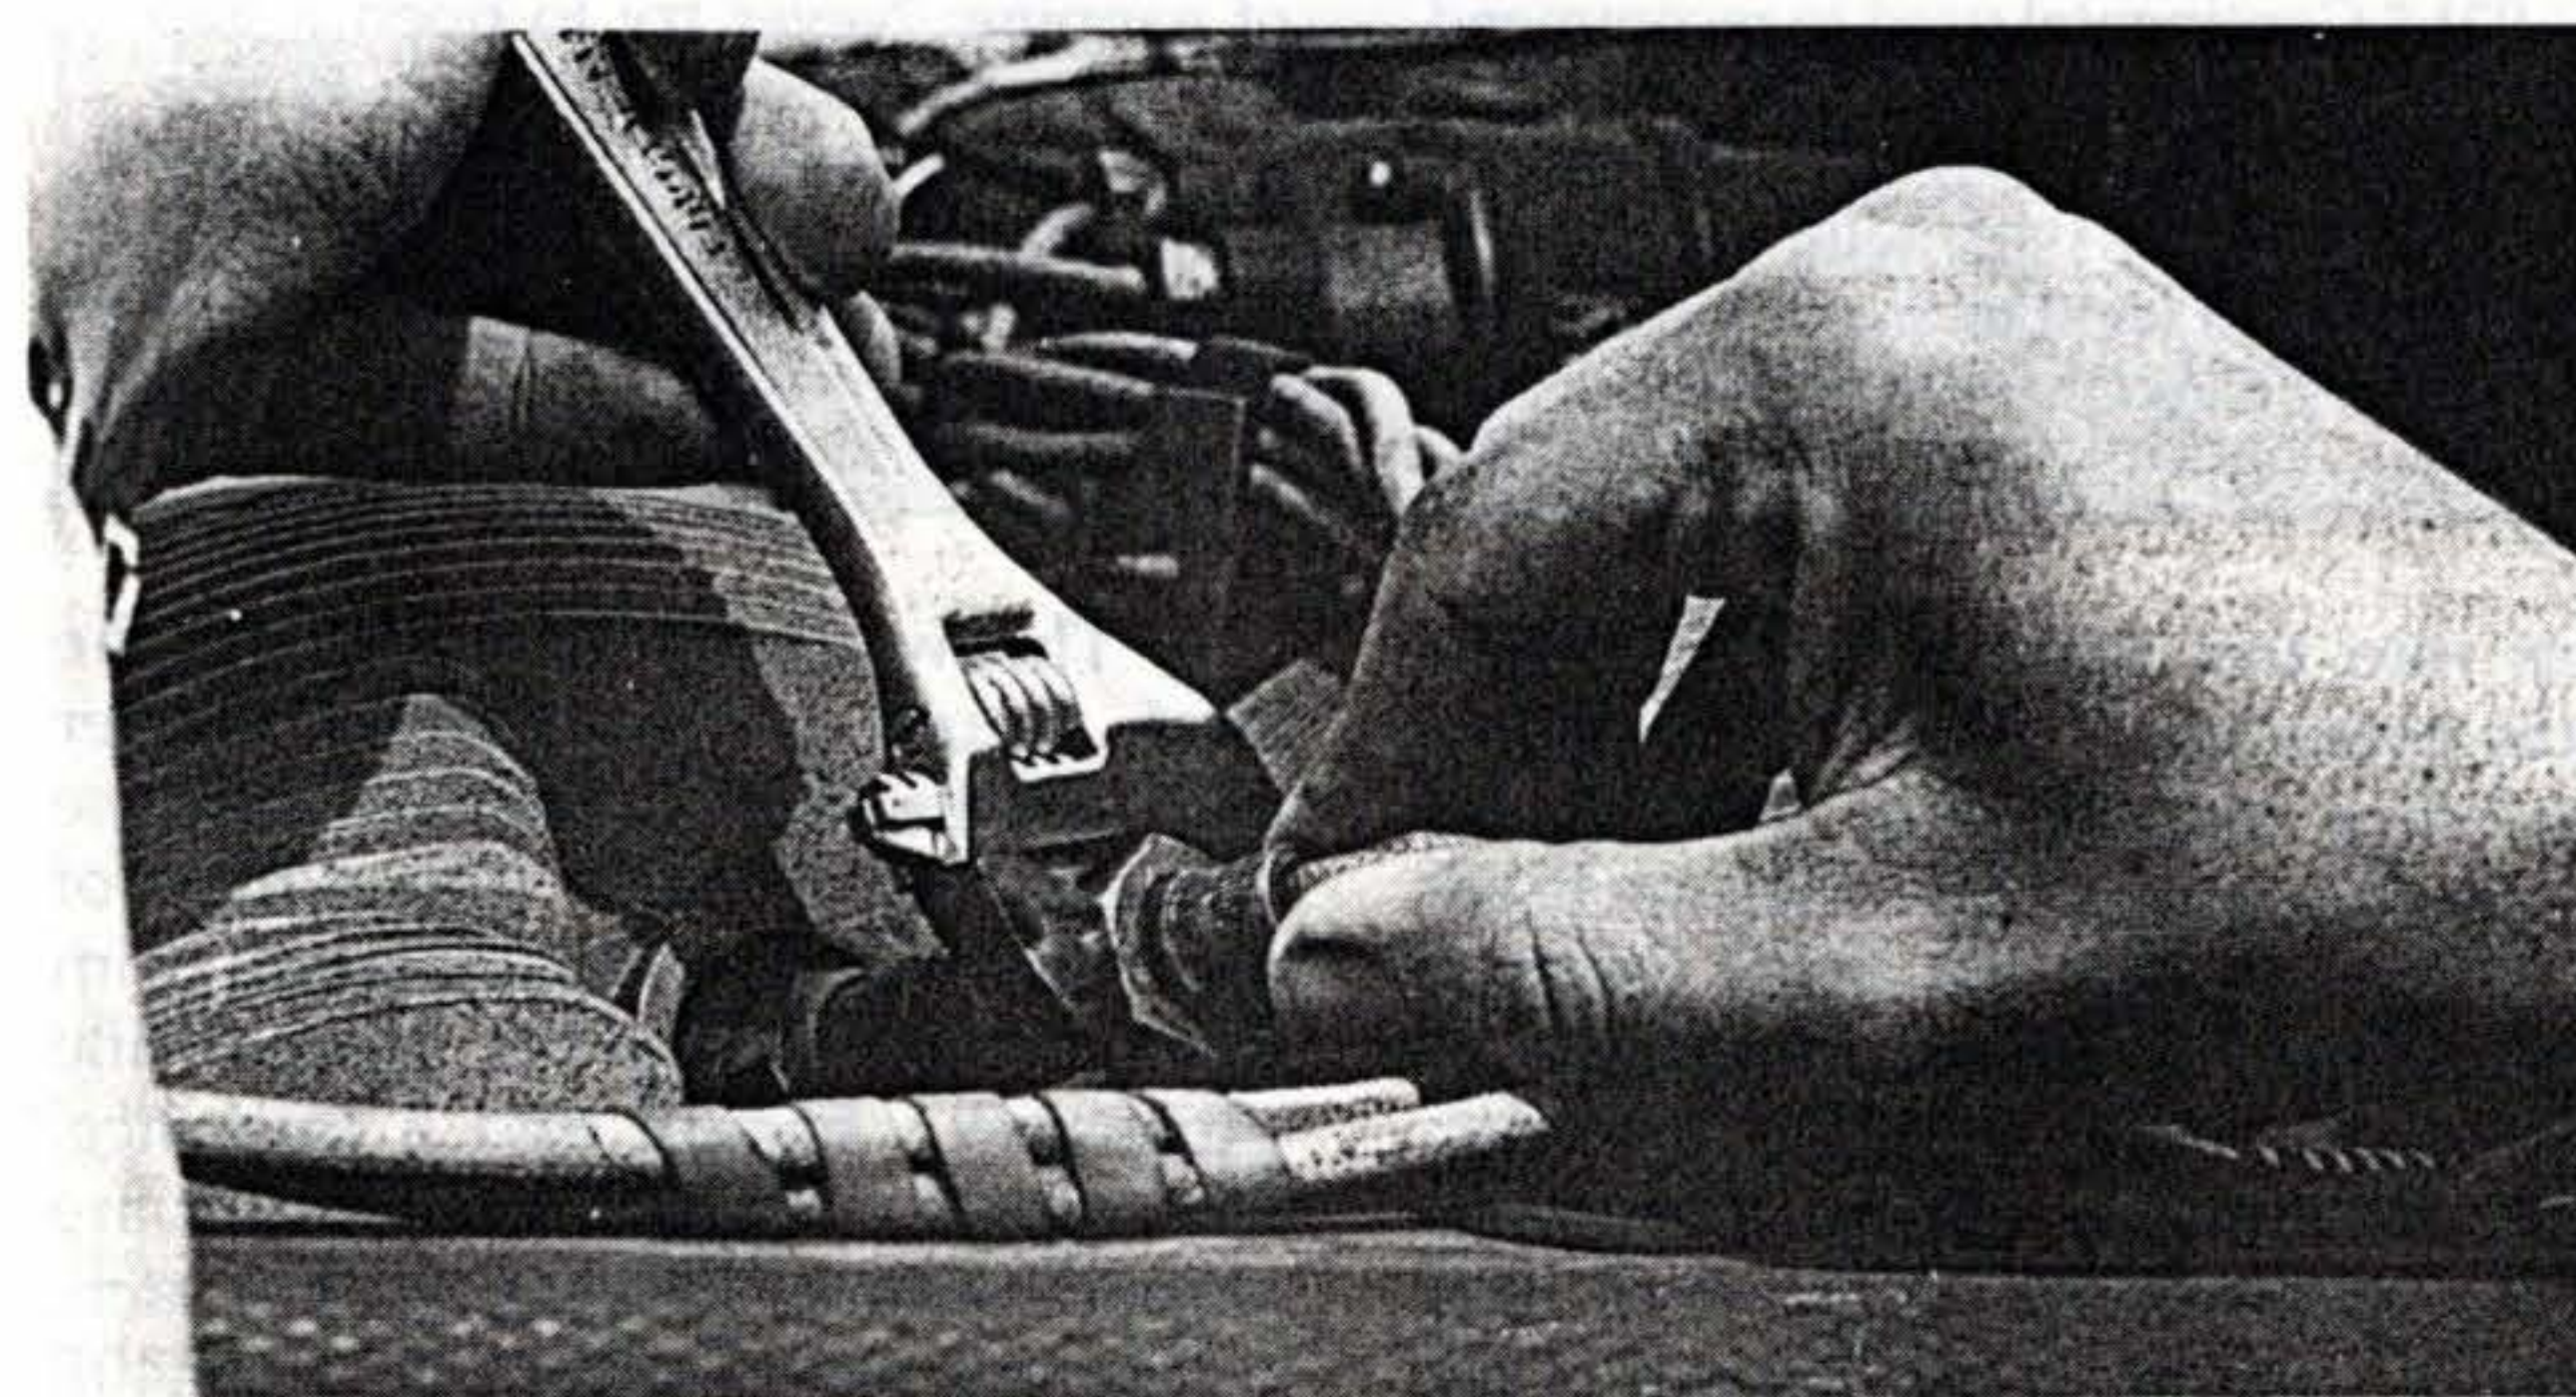
If your plugs are easily accessible, you may well be able to use an ordinary adjustable end (Crescent) wrench to remove terminal nuts. Be sure to hold the ignition wire to keep it from rotating with the nut.
