Upgrades for the Lycoming O-320

Overhauling the S-1200 Magneto

Slow Cranking: Causes and Cures

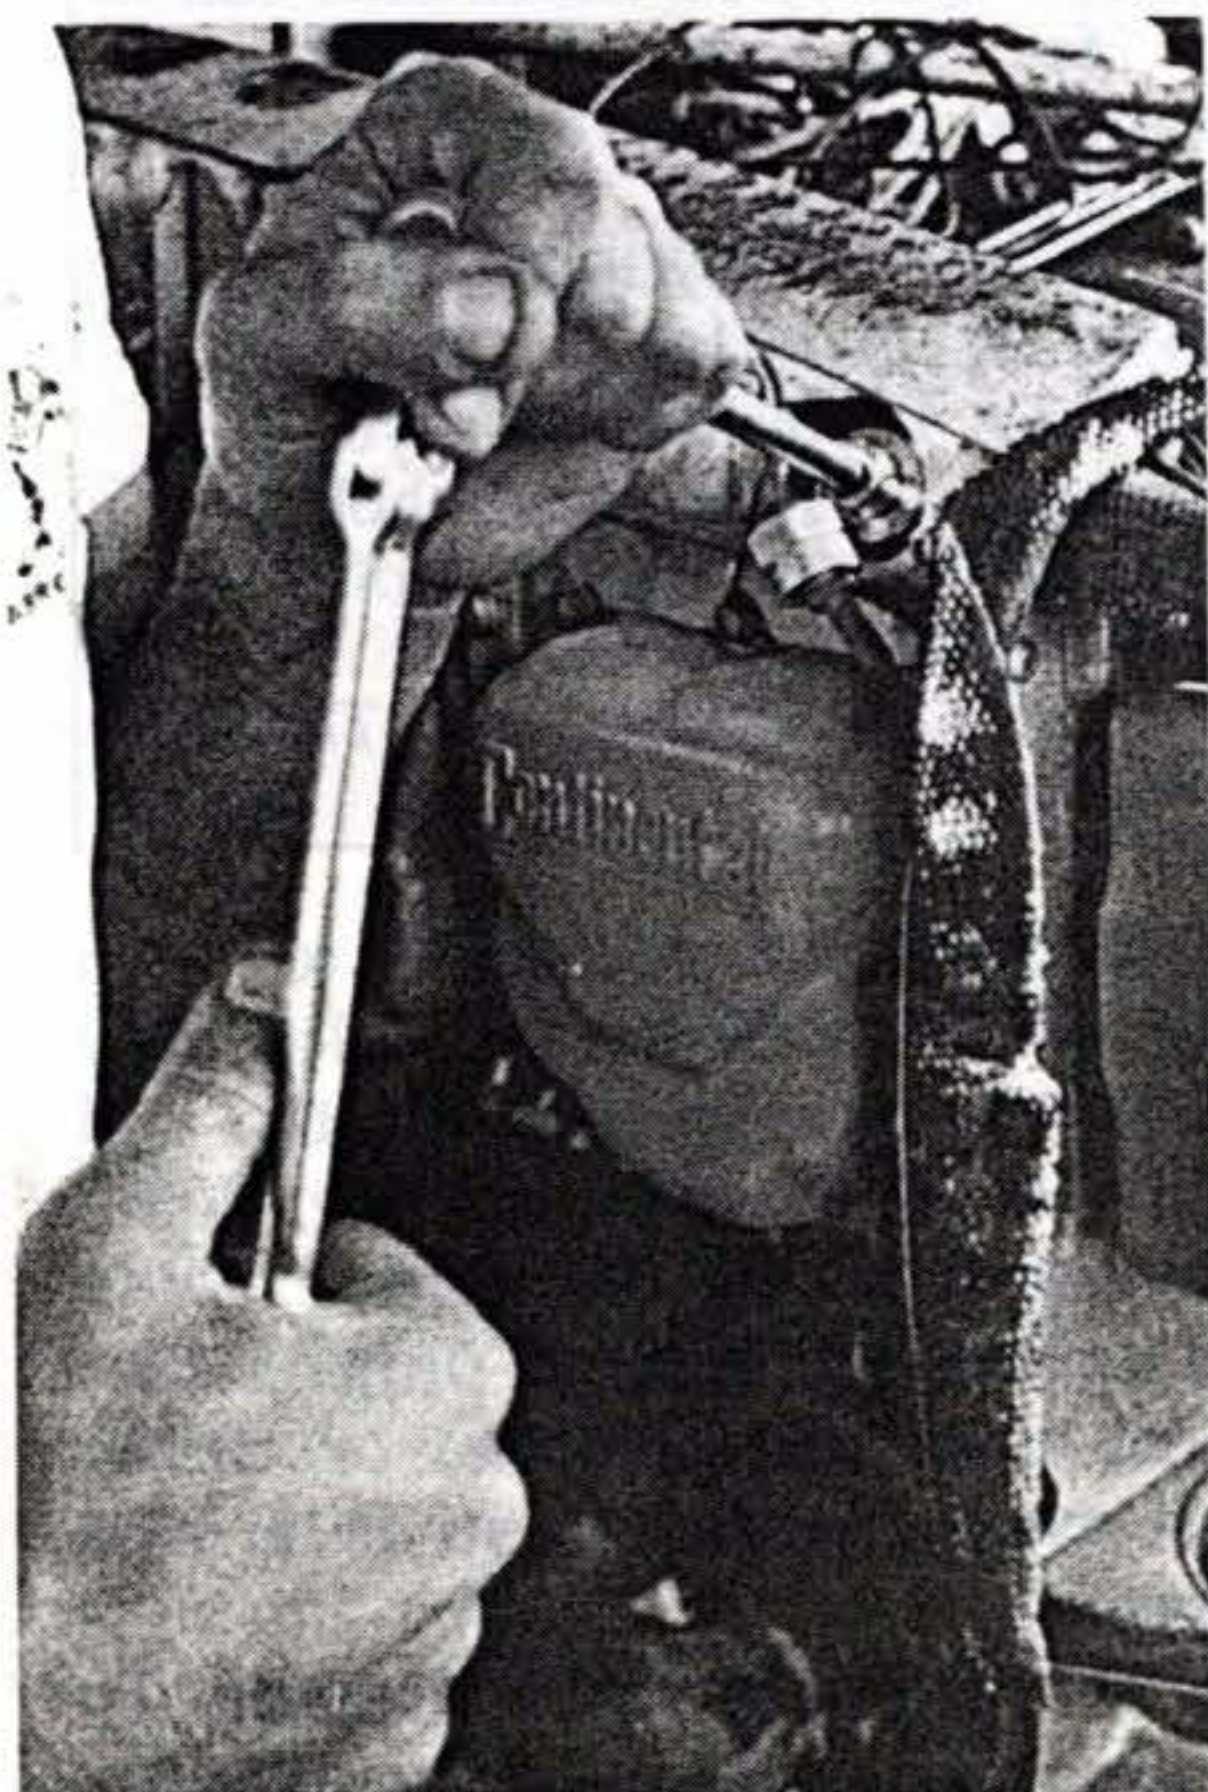
Application of Champion 2612 thread lube should begin a minimum of one full thread away from the firing end. Some people use Dow DC-4 or DC-10. Engine oil will tend to turn to coke, cementing the plug in place; if you use engine oil, be sure it's synthetic. Your torque wrench (below) can be 3/8-in. or 1/2-in. square drive. The important thing is that it is accurate in the 25-35 ft-lb range.

you should start with clean threads (in the hole and on the plug itself), and use a thread lube—either Champion No. 2612 (\$2.25 from Chief, above), or engine oil, preferably Mobil synthetic. If you don't clean the grit out of all threads, your installation friction drag will be artificially high and you'll reach "proper torque" prematurely. (Also, you may dislodge gritty particles into the combustion chamber.) The thing to do is to go over all threads with a bristle brush and/or terry cloth (not a thread chaser, which might back out Heli-coils). Then apply thread lube sparingly to each plug, starting a full thread away from the end. (You don't want excess to run off onto the electrodes, shorting out the plug.) We like Champion No. 2612, but if you don't use this product, at least use a dab of engine oil on the threads. (Synthetic oil will resist thermal breakdown.) Use *some sort of lube*. Otherwise the plug won't want to come out next time.

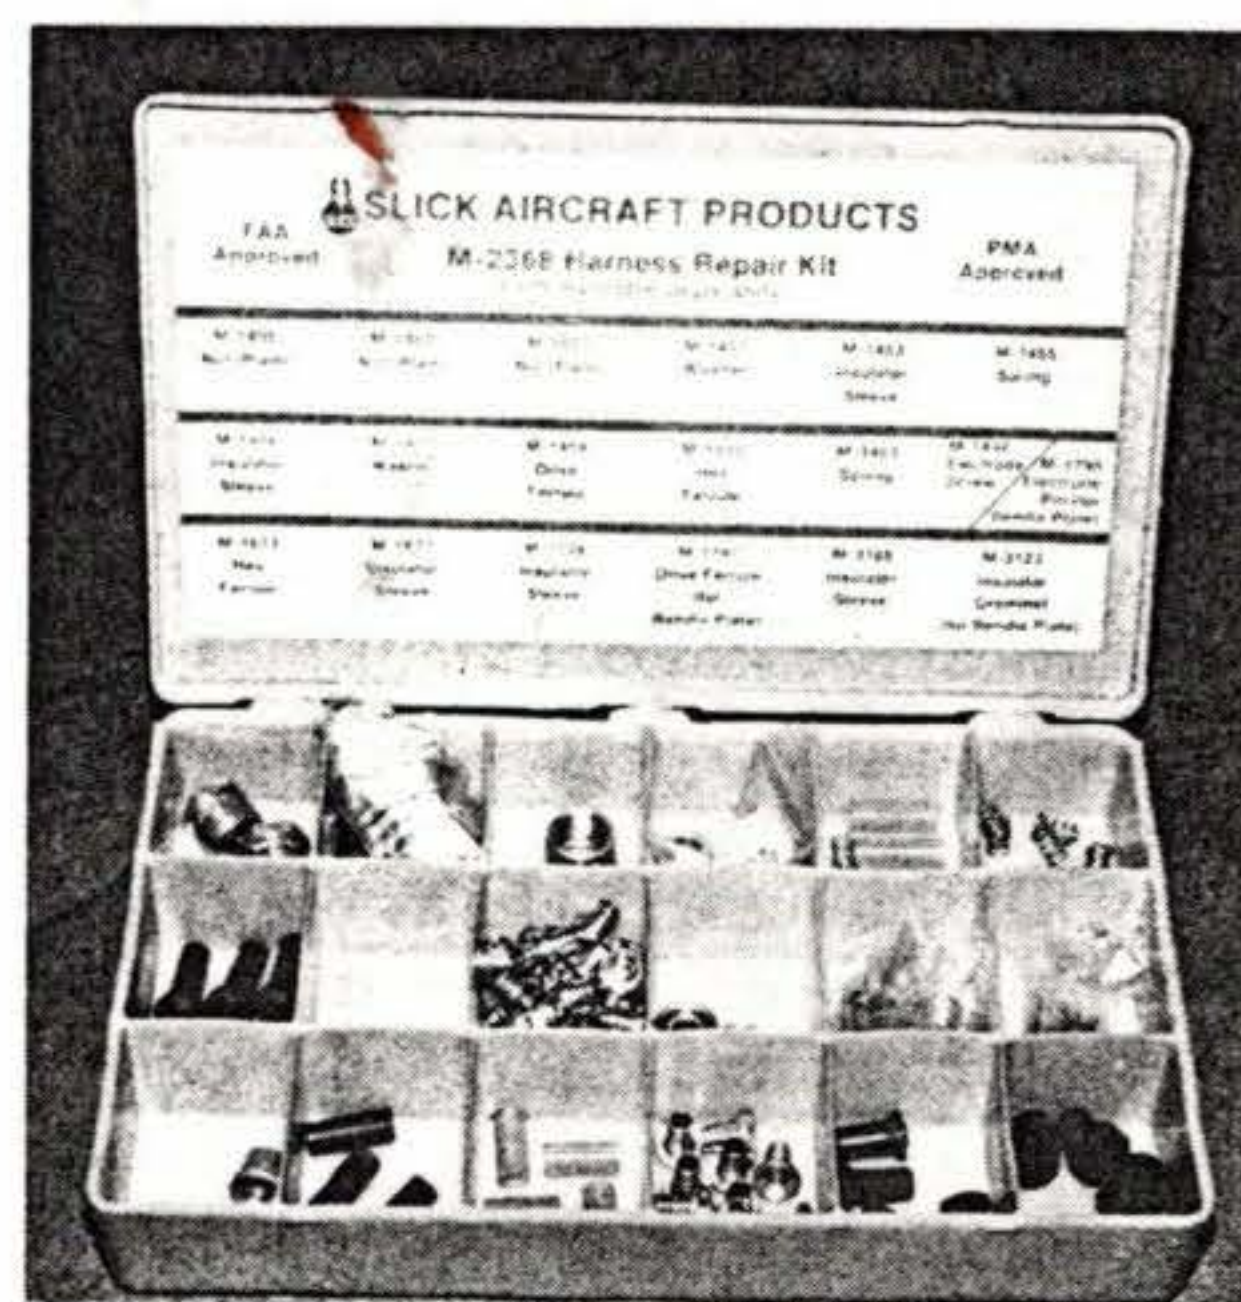
The Slick M-2368 repair kit contains a wide assortment of ferrules, screws, and hardware items, all of which are available separately. Special tools (above) include T-109 pressing pliers and T-111 vise pin. If your FBO won't let you borrow these, they can be bought for under \$50.

For this article, I had Chris Wray and Lance Drew of Wiggins Airways (Norwood, MA) show me how to make up both ends of a lead. We used a Slick M-2368 harness repair kit, which includes a variety of hardware (grommets, ferrules, etc.), 50 feet of ignition cable, and all necessary tools. This particular kit is intended for FBO use and is rather expensive,

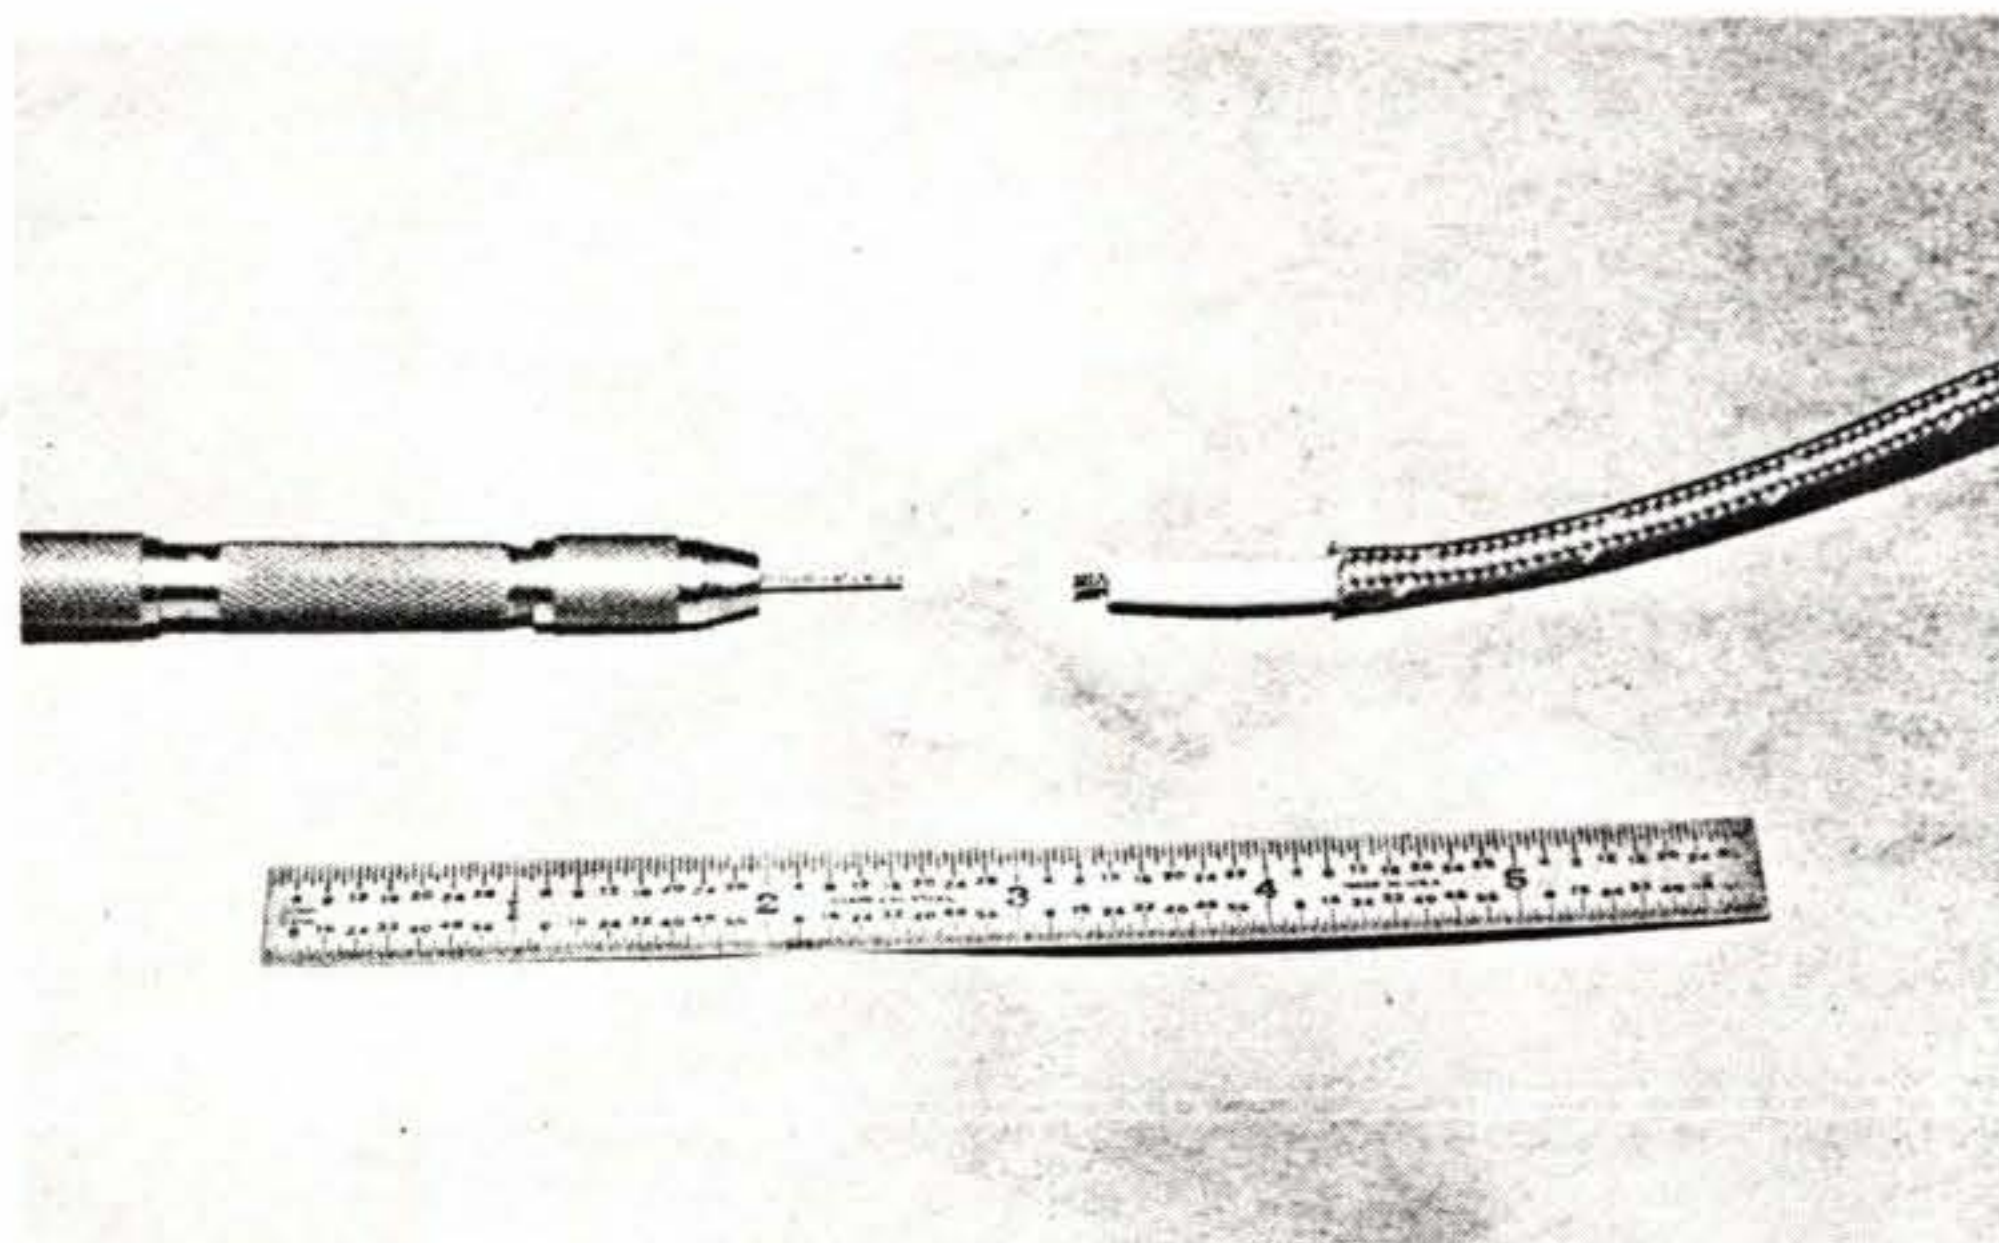
Here, the properly stripped wire is ready to accept an electrode screw (M-1498). Pin vise and No. 72 bit are shown on left.

Next, use your sharp knife to cut 1/8-in. of silicone insulation off the end of the wire. *Don't cut the inner conductor*, and be careful not to pull on the insulation as you're trying to cut it. Remove the insulation by gently pulling it and turning it clockwise. There should now be three conductor coils showing. Clean away any insulation that may remain in the center of the coil using a knife and #72 drill in a Slick T-111 pin vise.

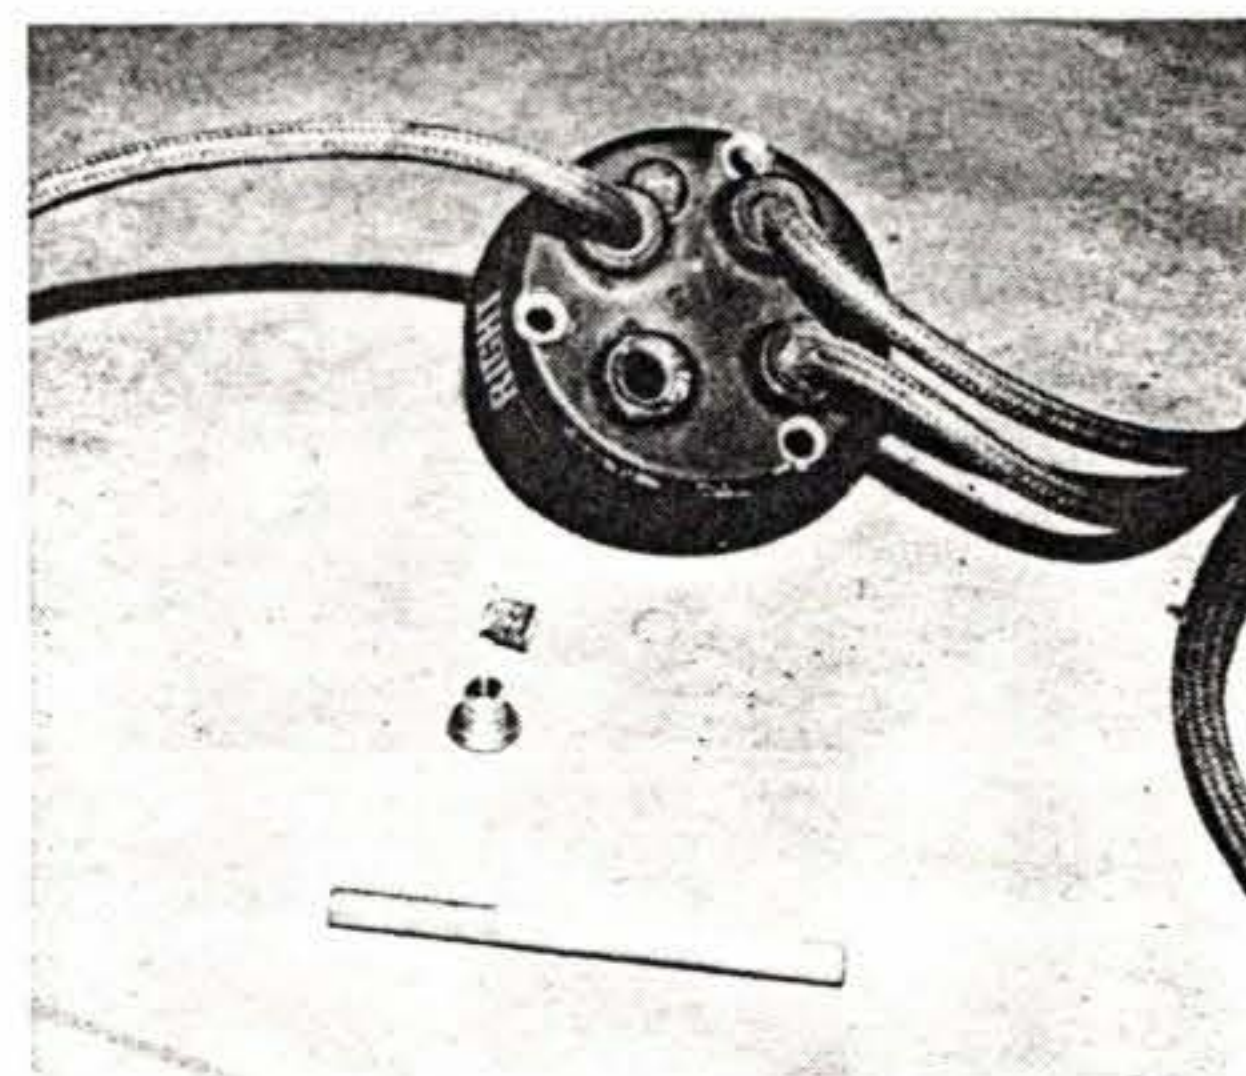
Below: Ignition harness hardware (for the magneto end).

Below: The ferrule, punched free and ready to be reused. (The small bit of shielding can be discarded.)

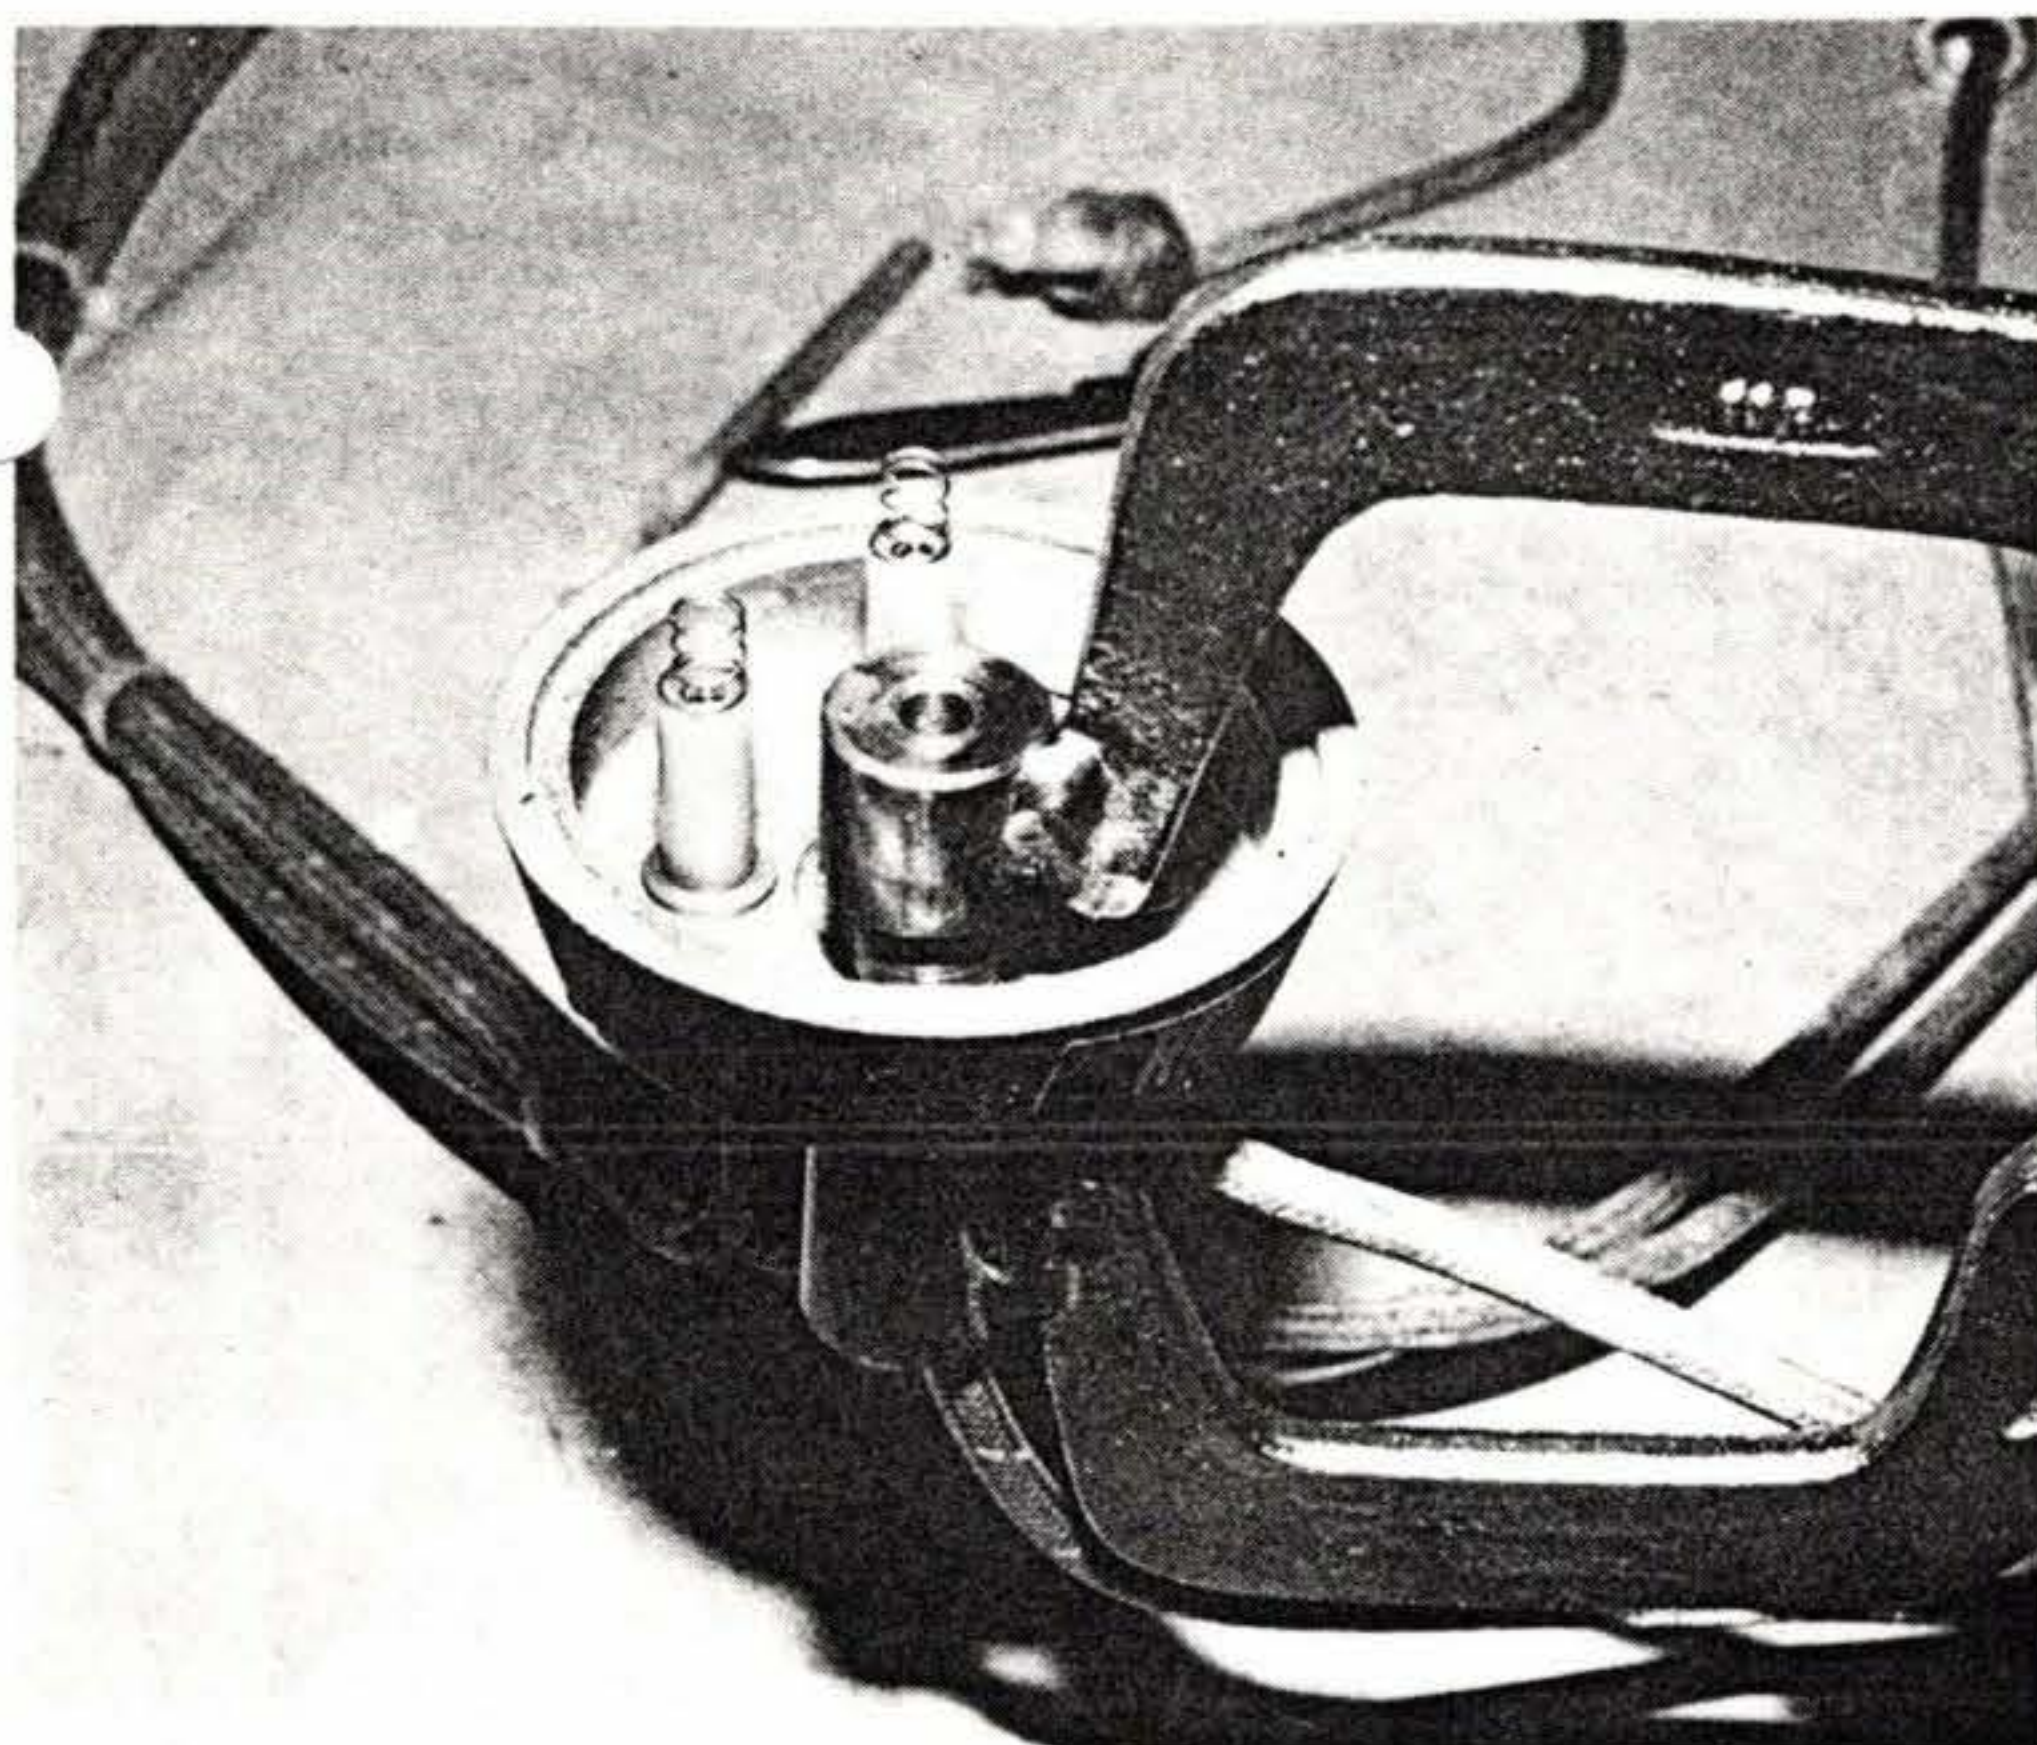
The T-109 pressing pliers are used not only at the spark plug end but also (as here) at the magneto cap end. Its purpose is to ensure good contact of the shielding to the M-1458 drive ferrule and an electrical ground (such as the mag end cap).

The astute reader has probably noticed that most of the special-purpose tools listed above are of the "nice, but not essential" variety and can be dispensed with, with the possible exception of the T-109 pressing tool (which is actually nothing more than a set of Vise-Grips with special ends that fit the ferrules). I have been told by knowledgeable sources that if you

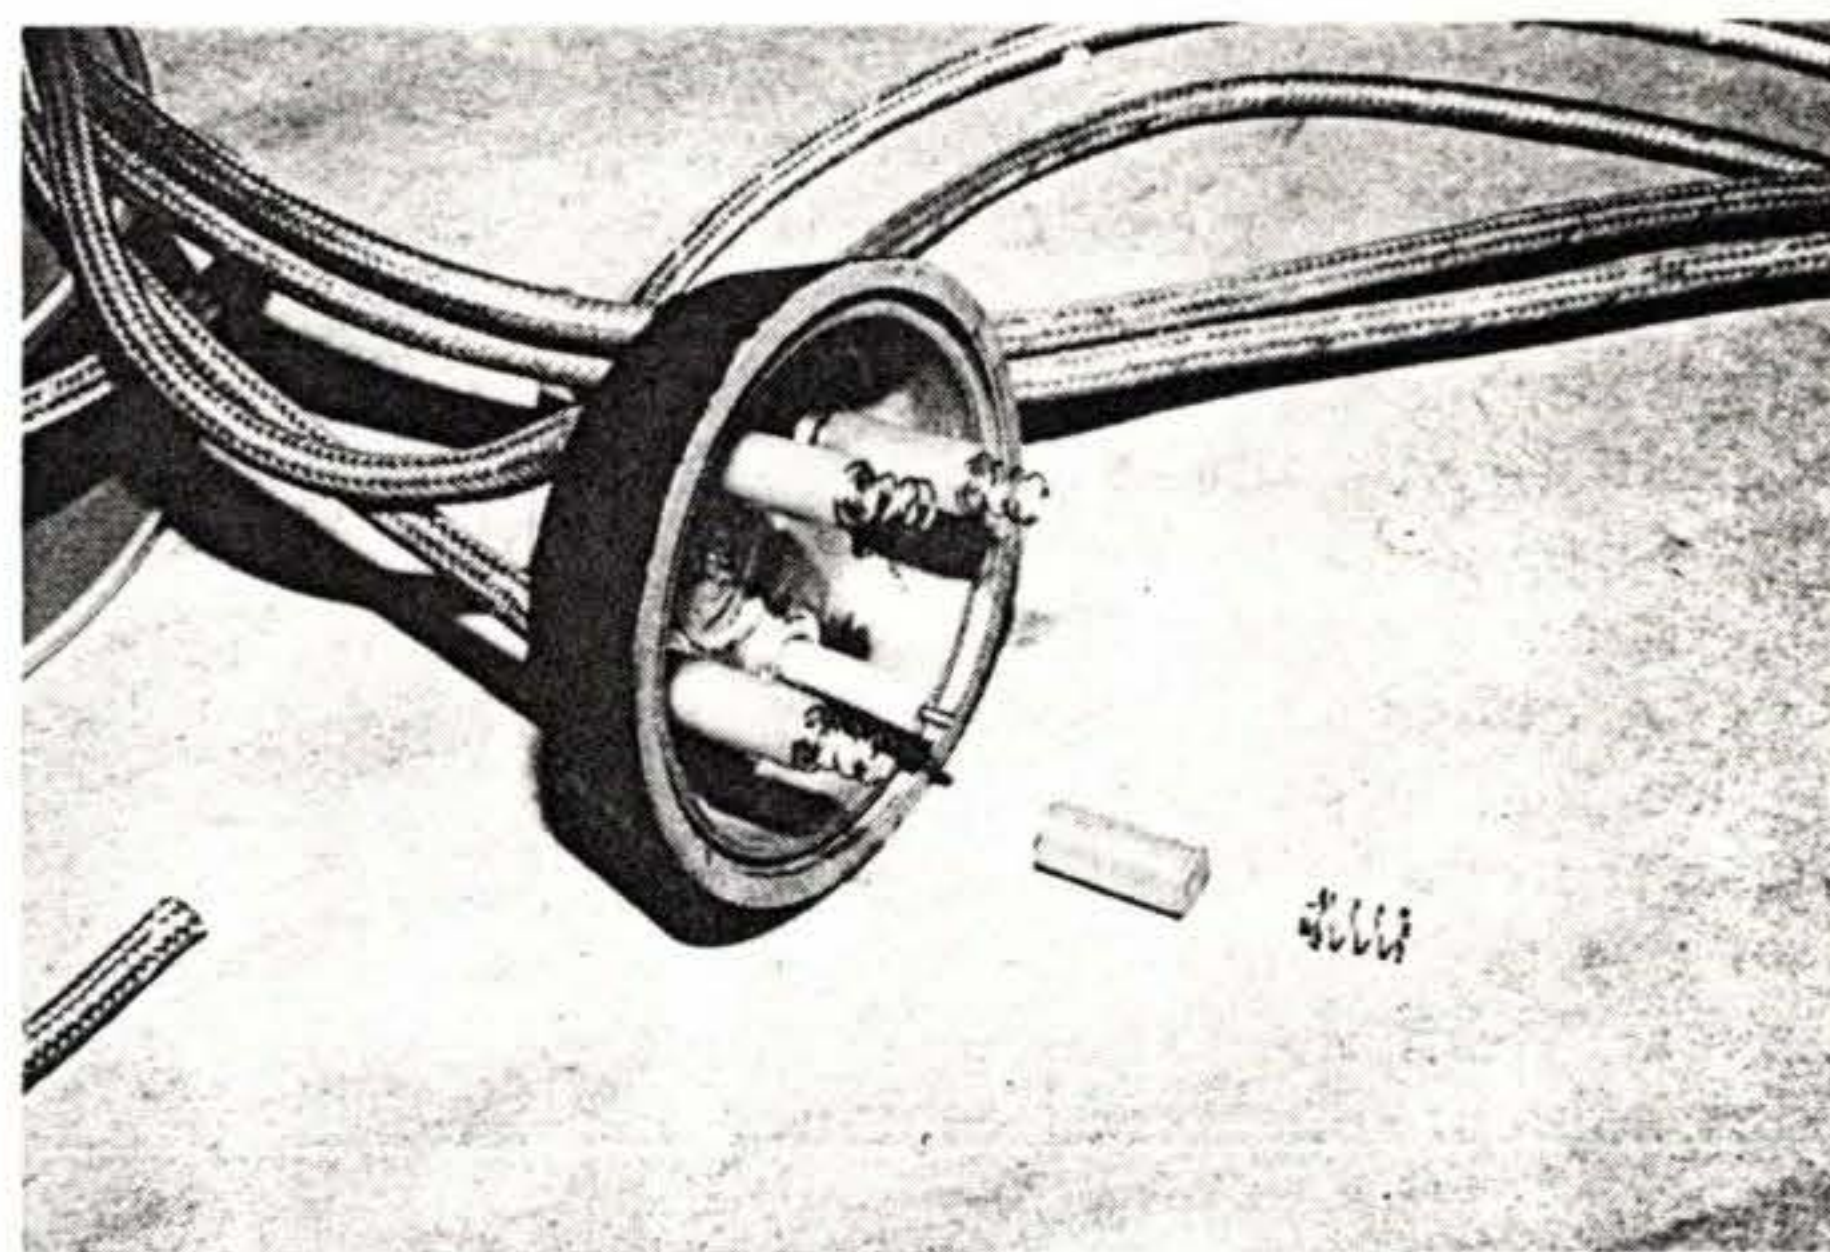
After pressing the cap and ferrule together, the proper insulator and contact spring can then be installed.

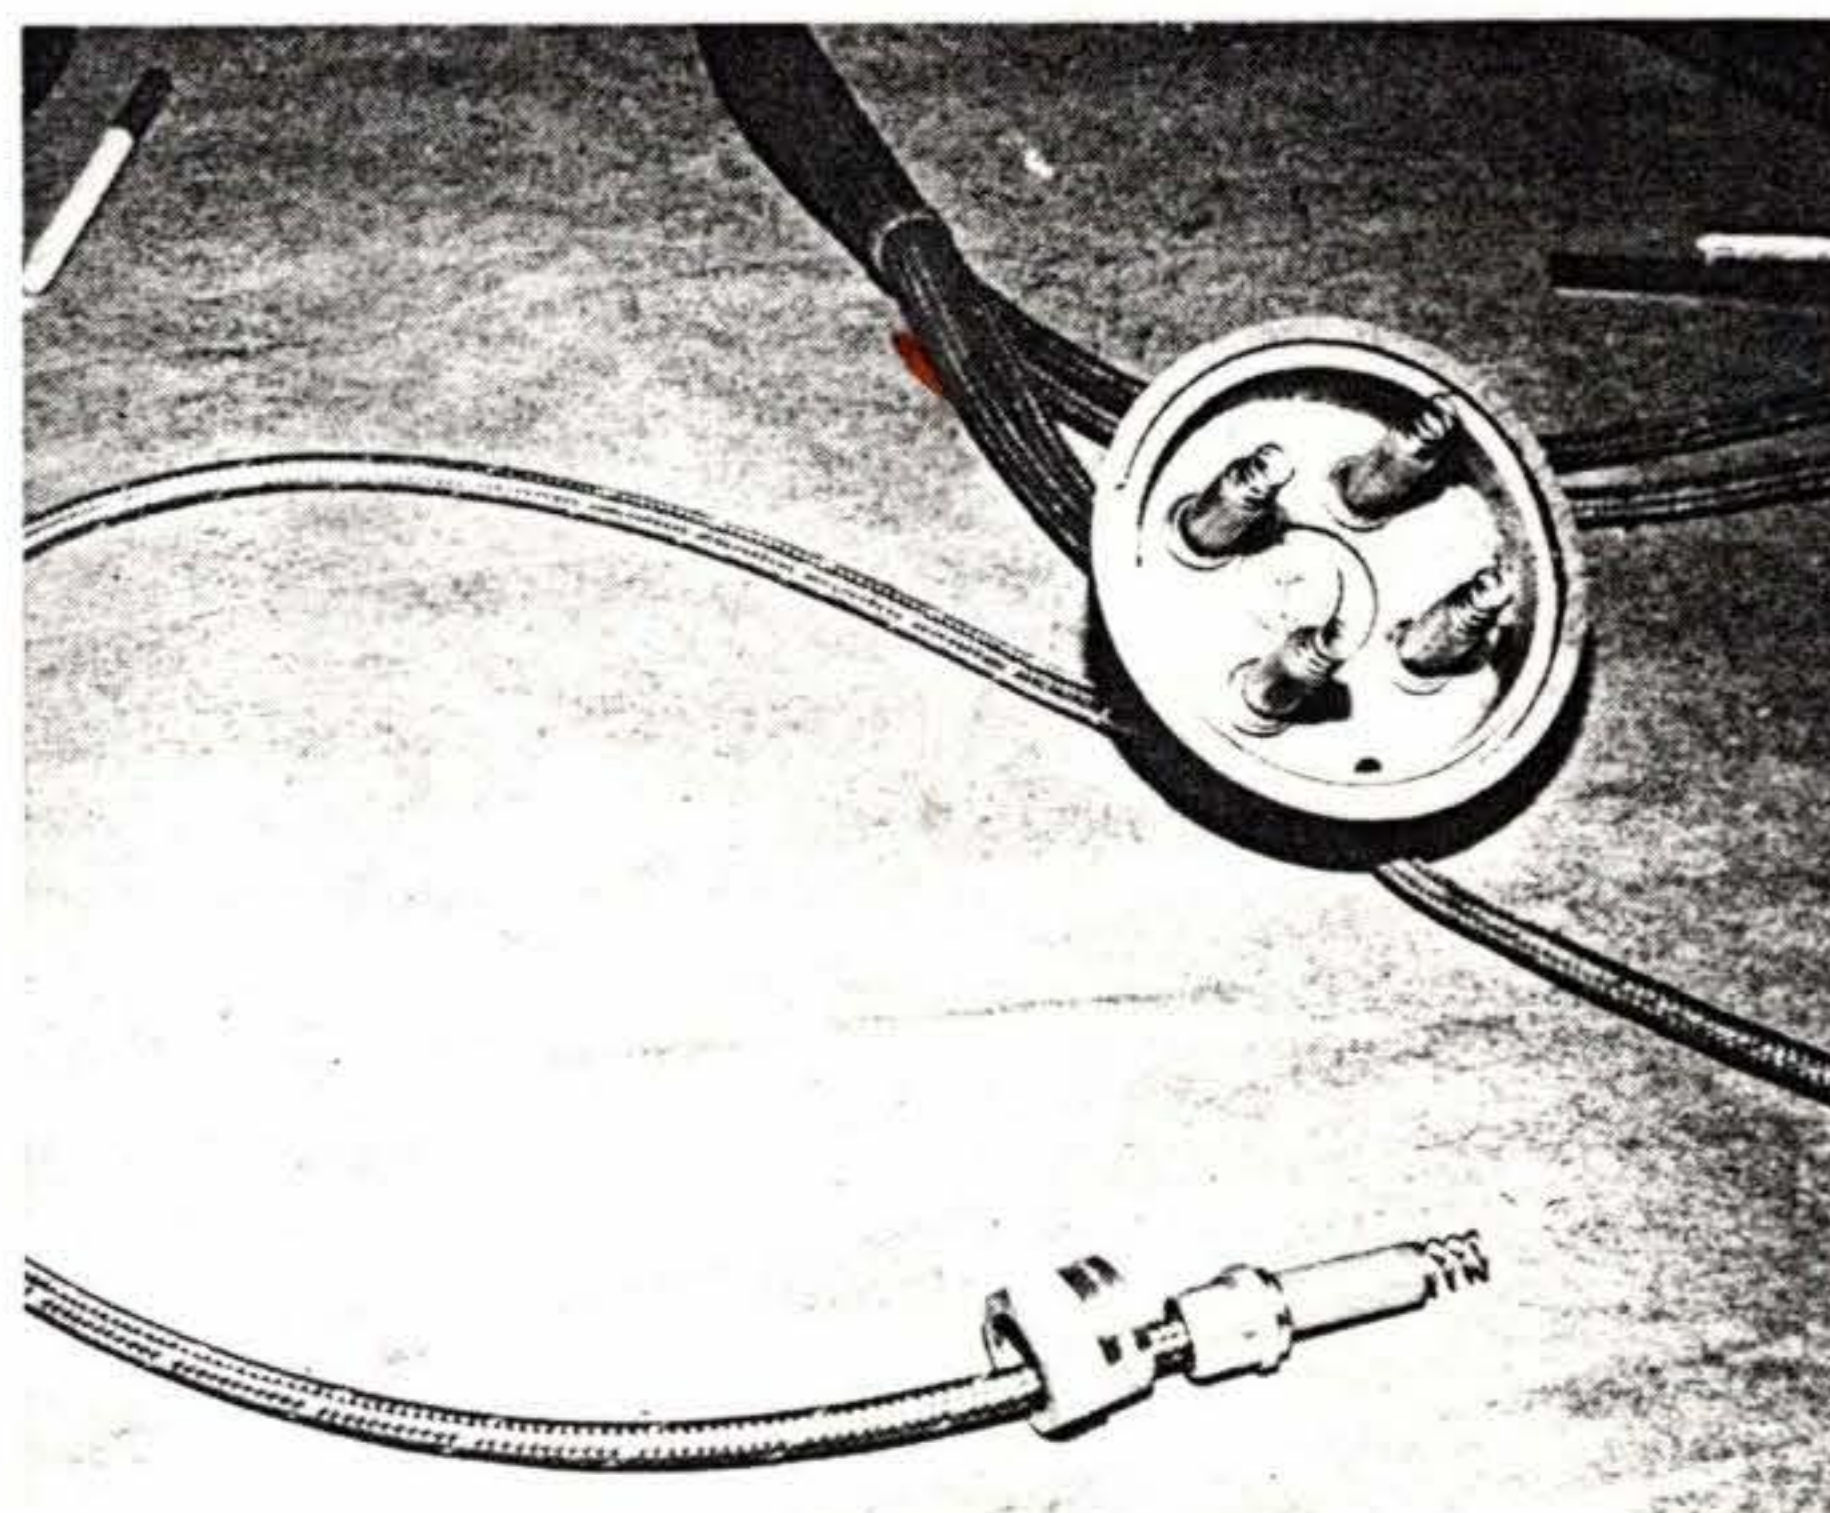
The finished lead, with new spark plug termination and magneto cap end.

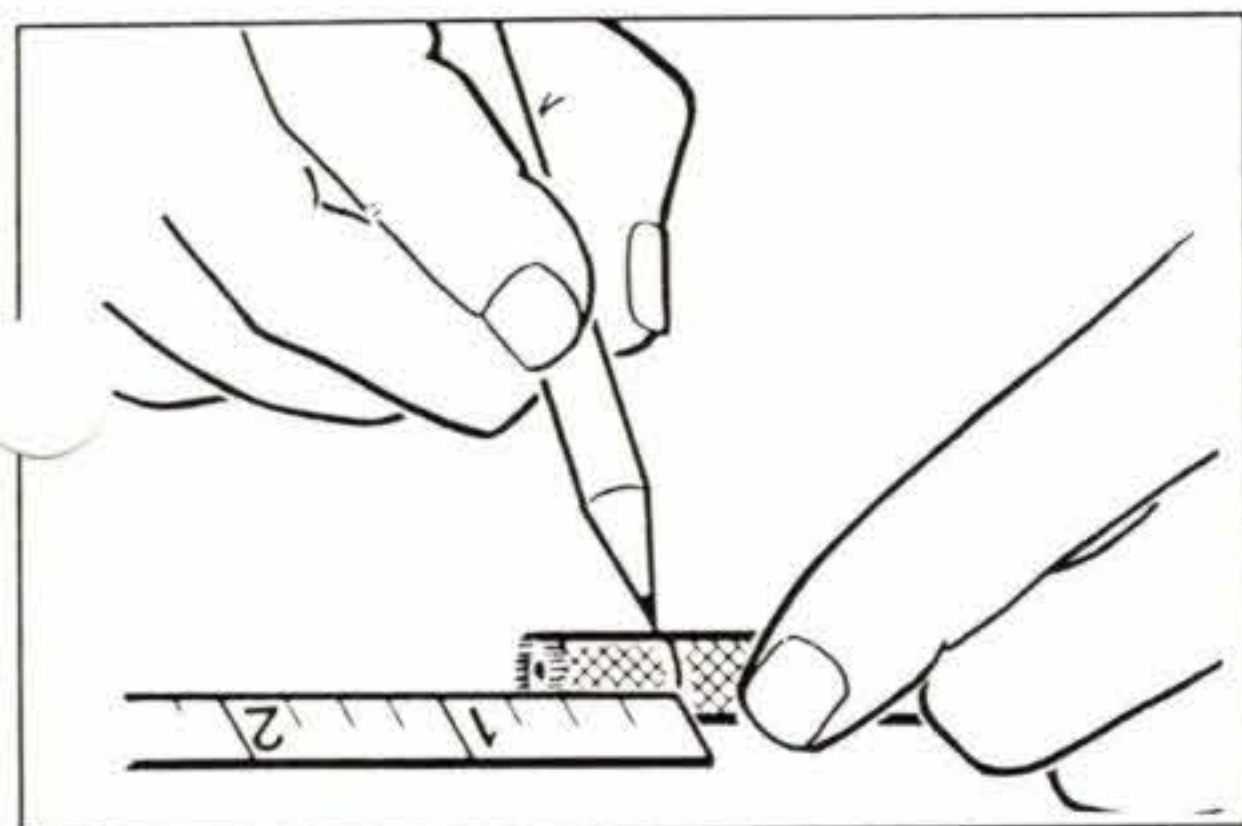
Mark the shielding 15/16-in. from the end (to make a 5/8-24 standard spark plug termination).

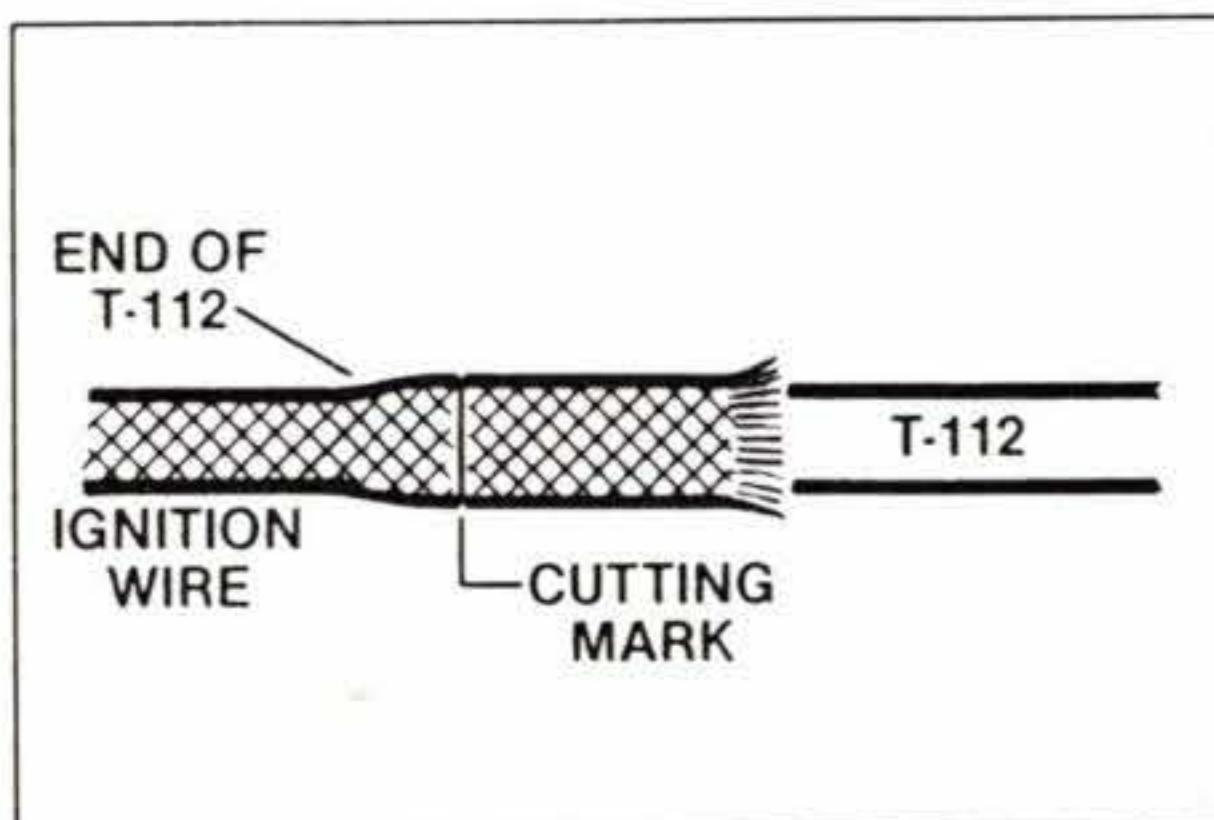
Insert the T-112 stripping tool under the shielding to beyond the mark. Then cut along the mark with a sharp knife.

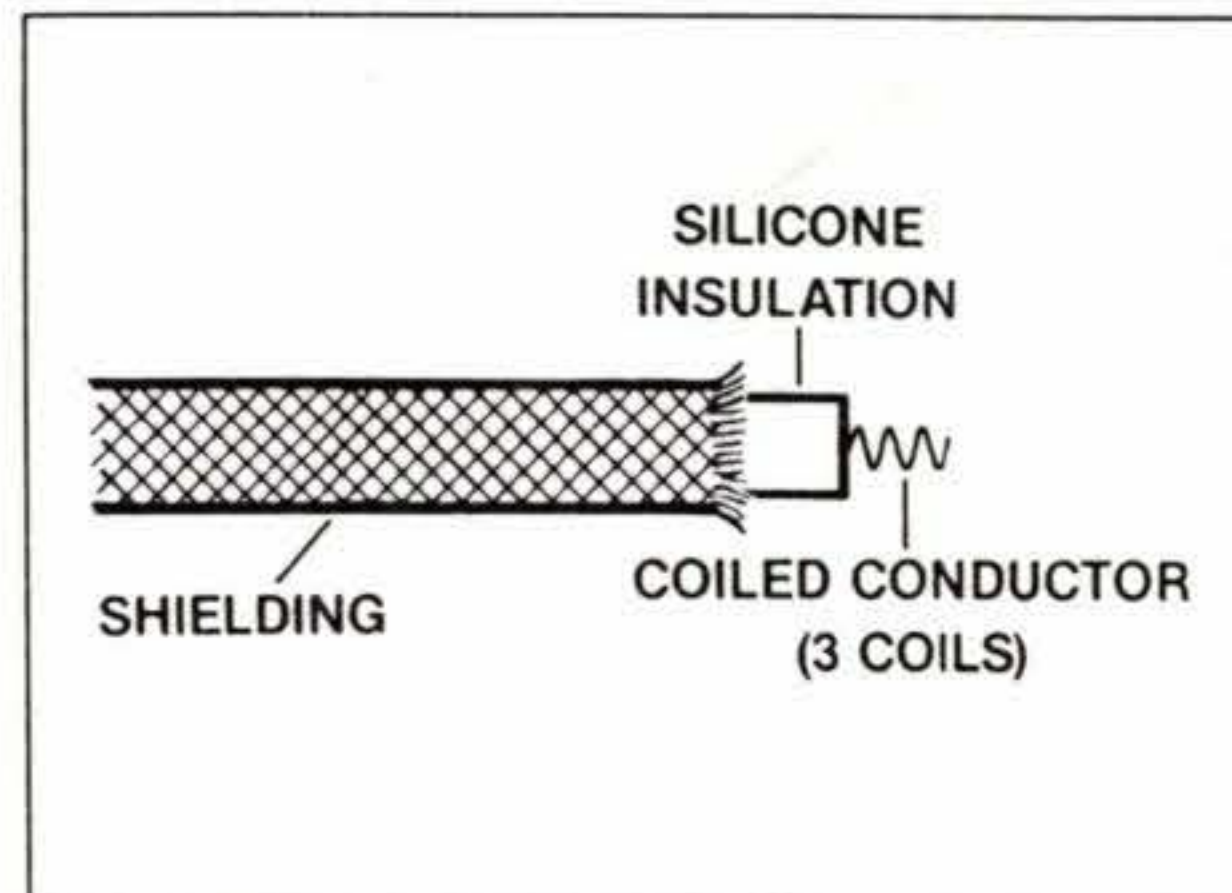
Carefully remove insulation to expose three coils of wire. Do not stretch the coils.

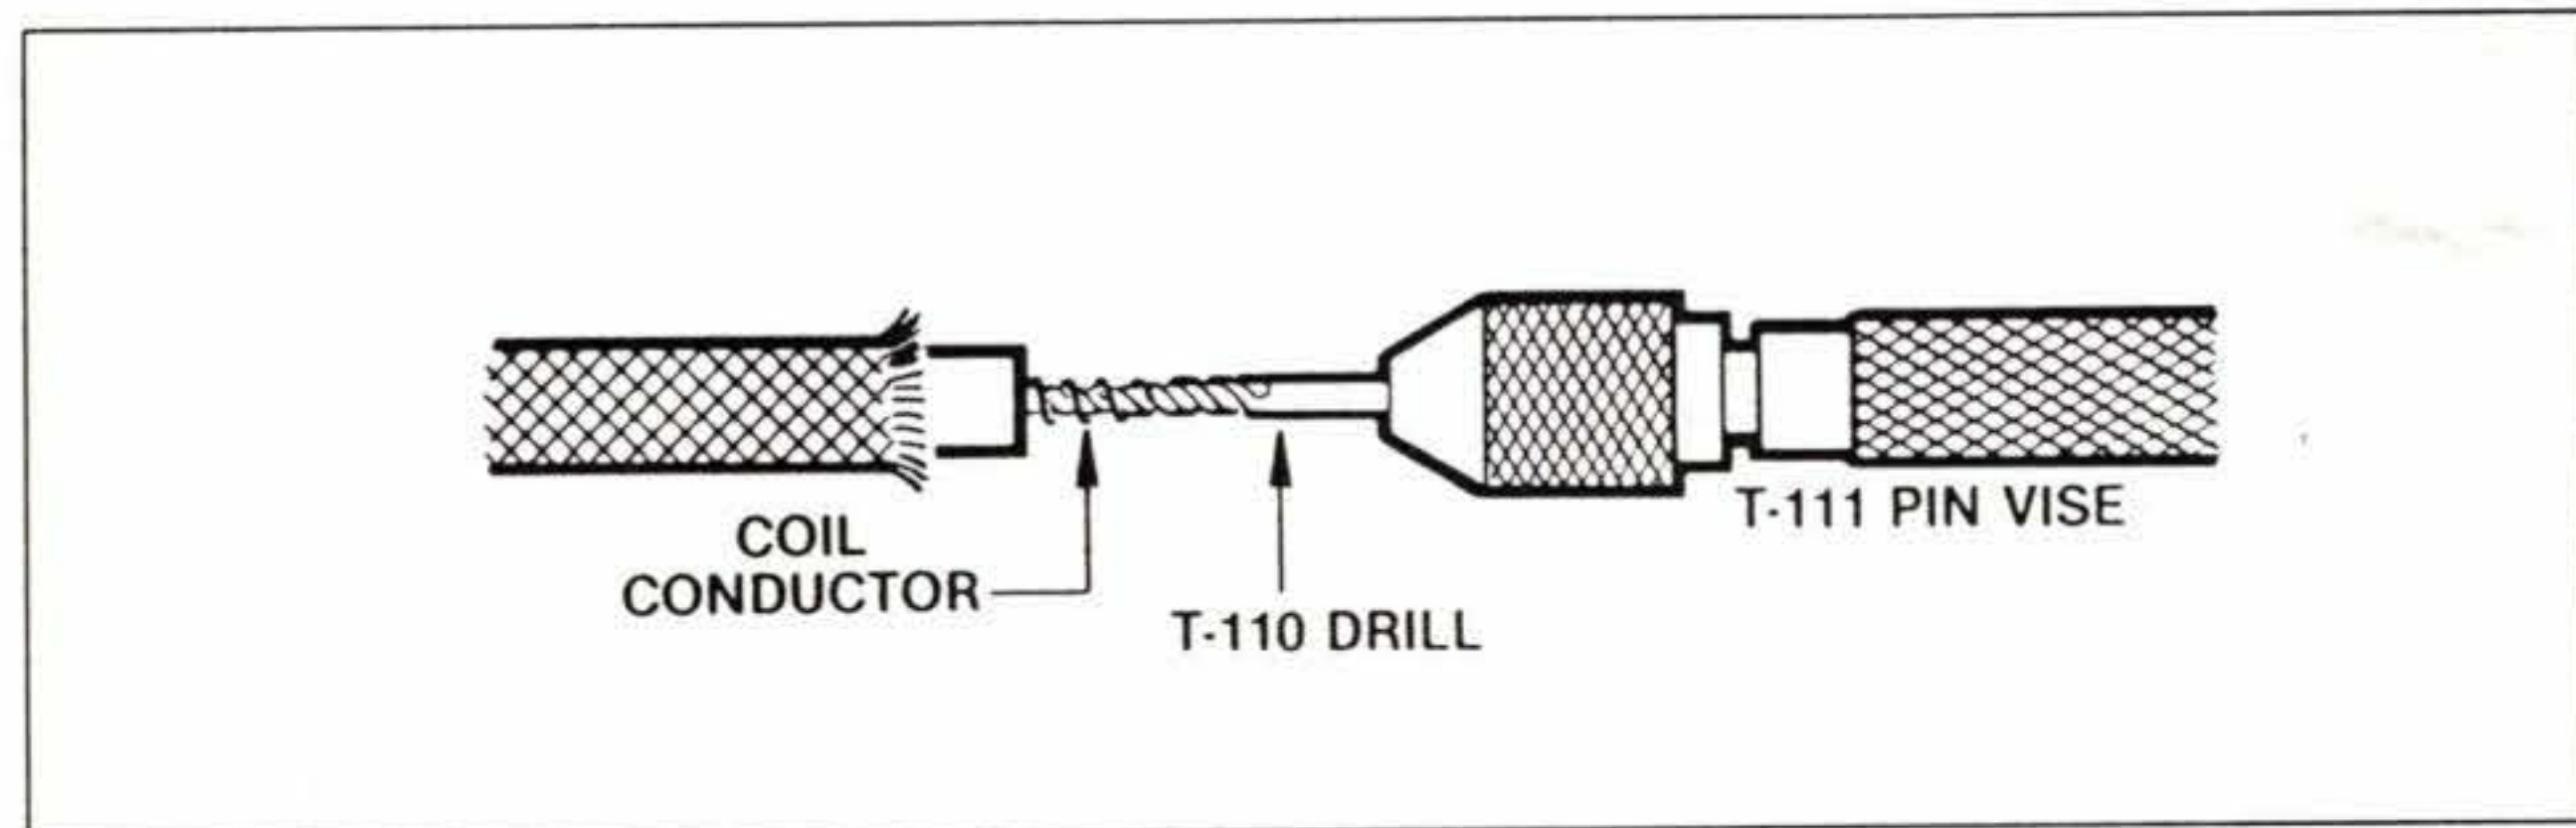
Using a No. 72 drill and the T-111 pin vise, remove silicone insulation from the center of the coiled conductor to a depth of 1/2-inch. (Turn the drill CCW when withdrawing.)
