Upgrades for the Lycoming O-320

Overhauling the S-1200 Magneto

Slow Cranking: Causes and Cures

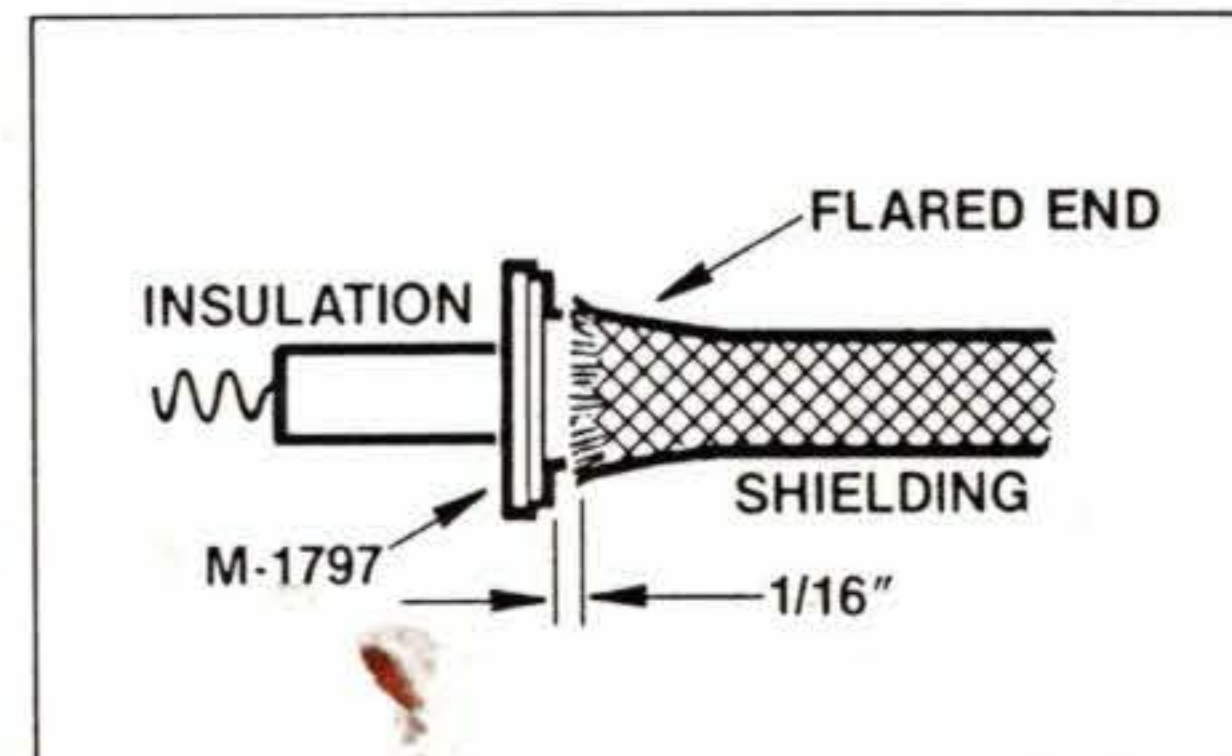
When inserting the flared end of the M-1458 or M-1797 drive ferrule into the shielding, stop 1/16-in. short of the ferrule's lip as shown here.
