Lord Mounts: The Shocking Truth

by Norm Bender

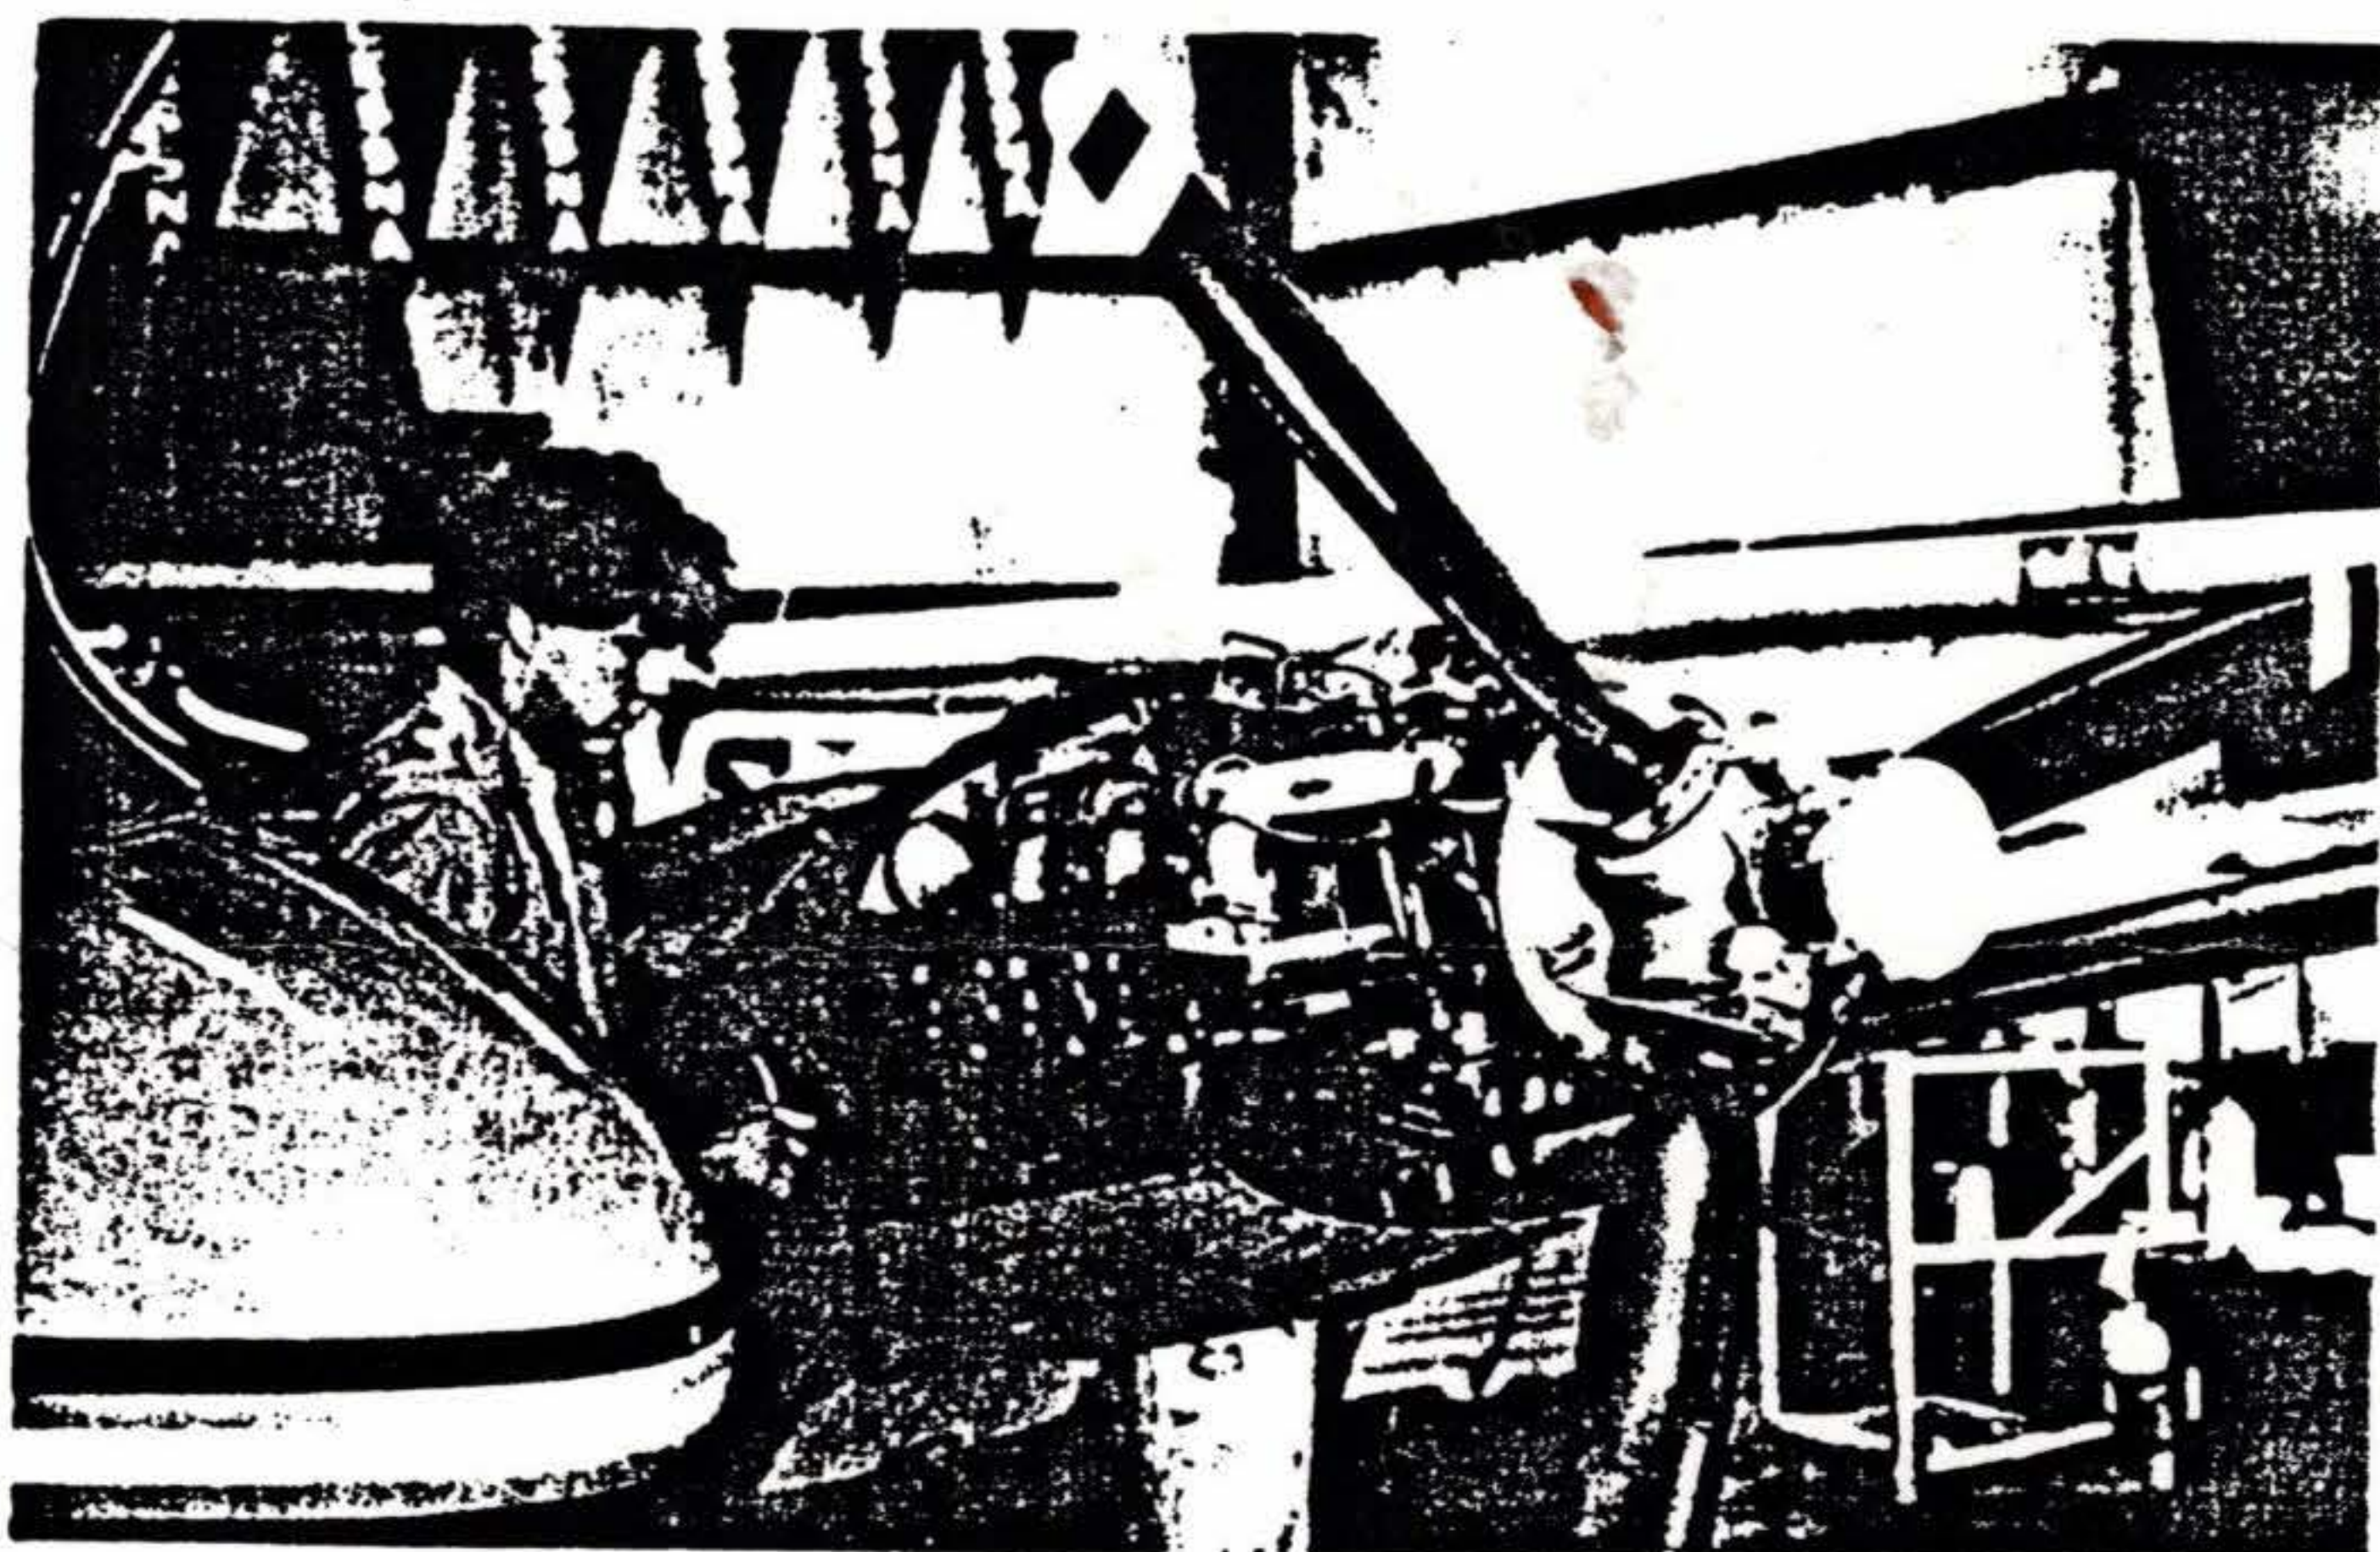
Because of the higher operating temperatures, turbocharged engines—such as the Seneca's Continental TSIO-360—need more top-end attention.

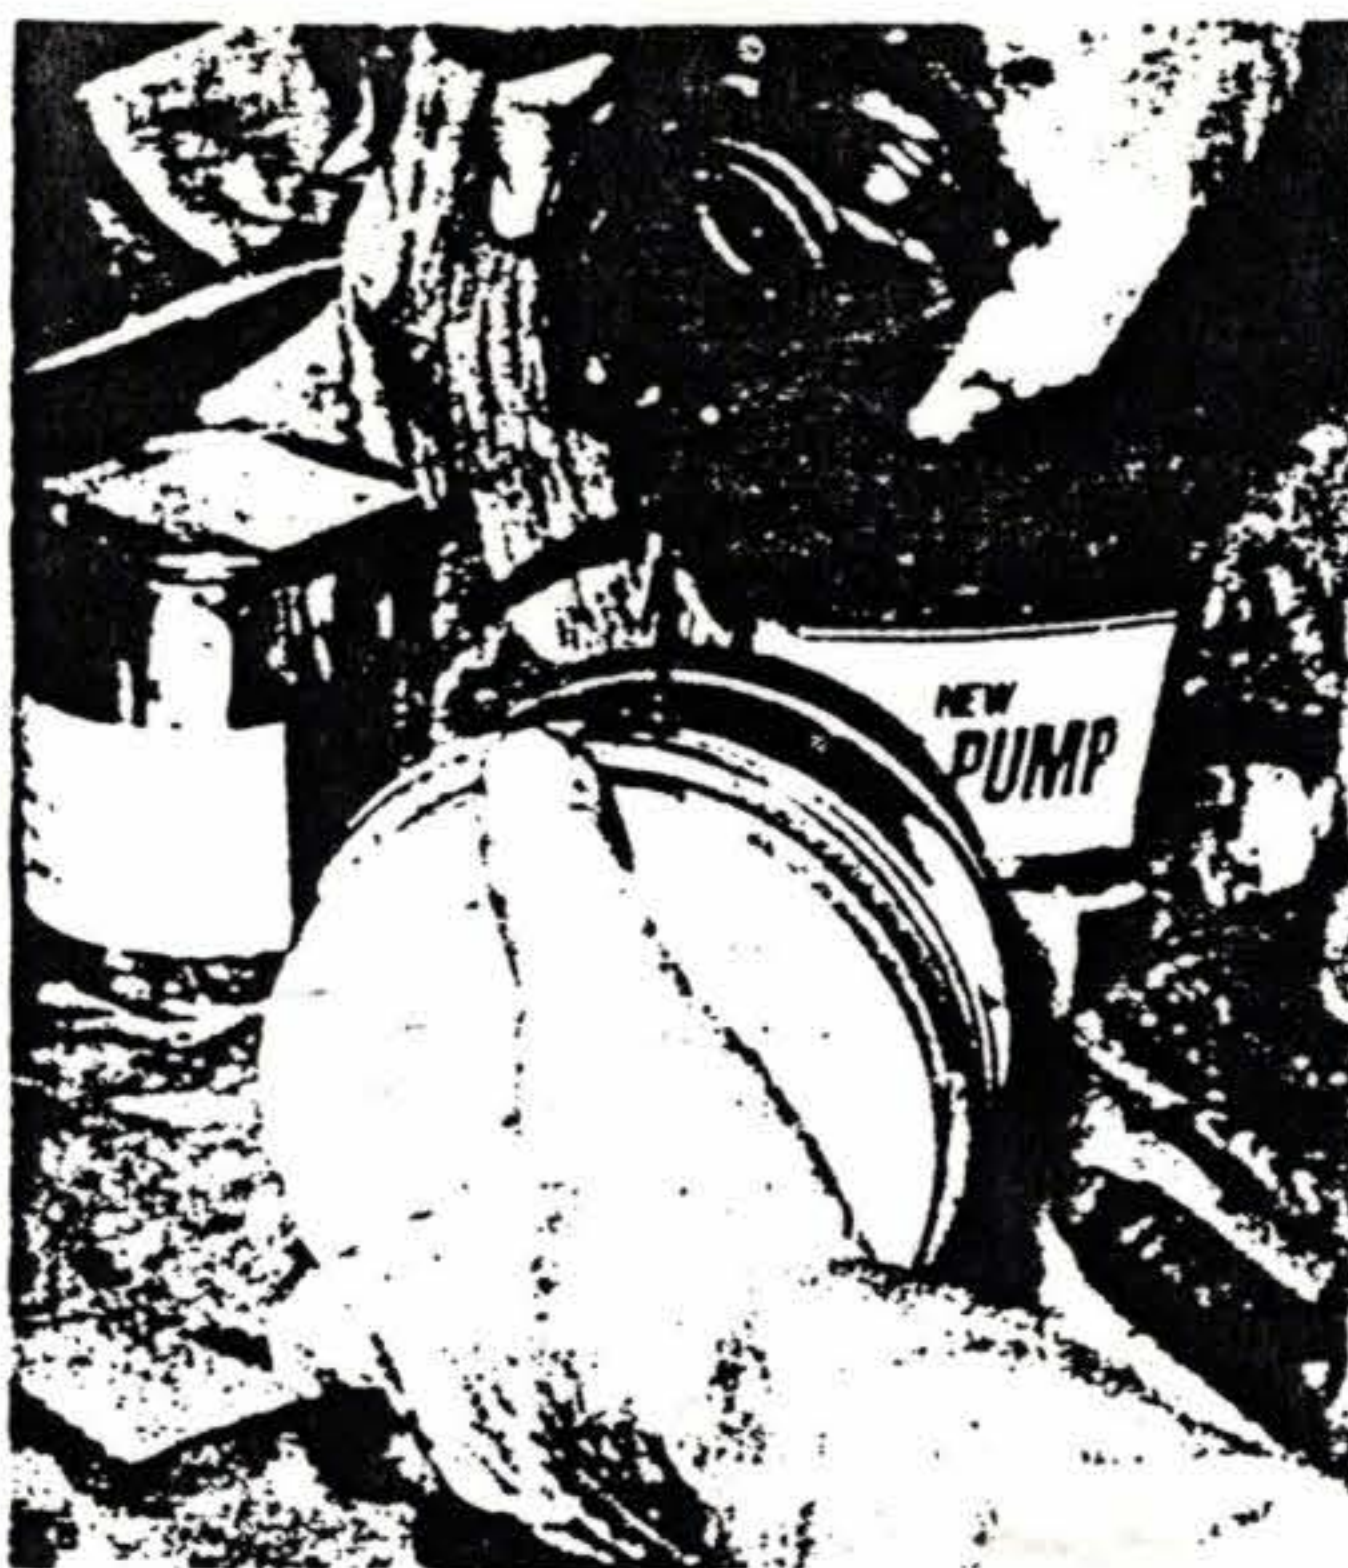
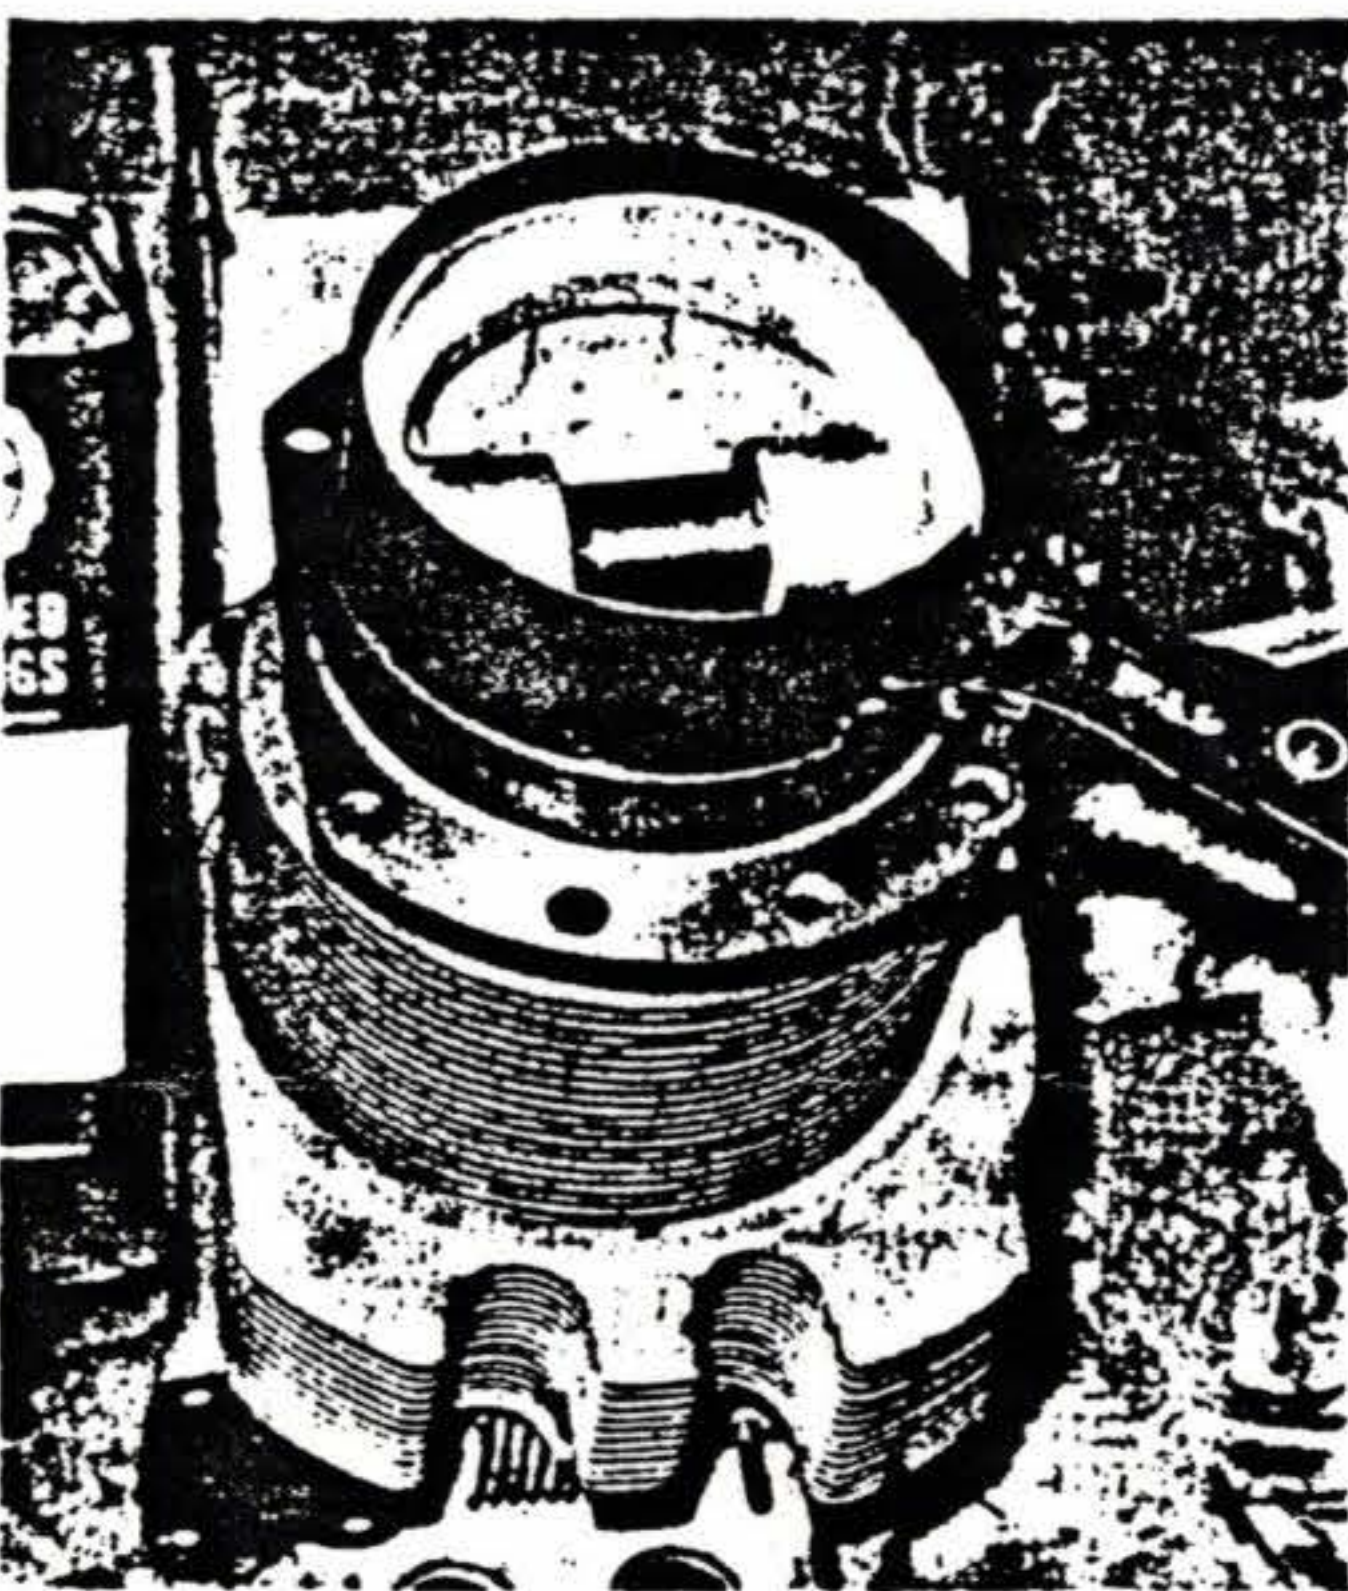
During buildup, parts should be coated with heavyweight mineral oil (top). A ring compressor is used (bottom) to fit the piston/ring assembly to the barrel before installing both on engine.

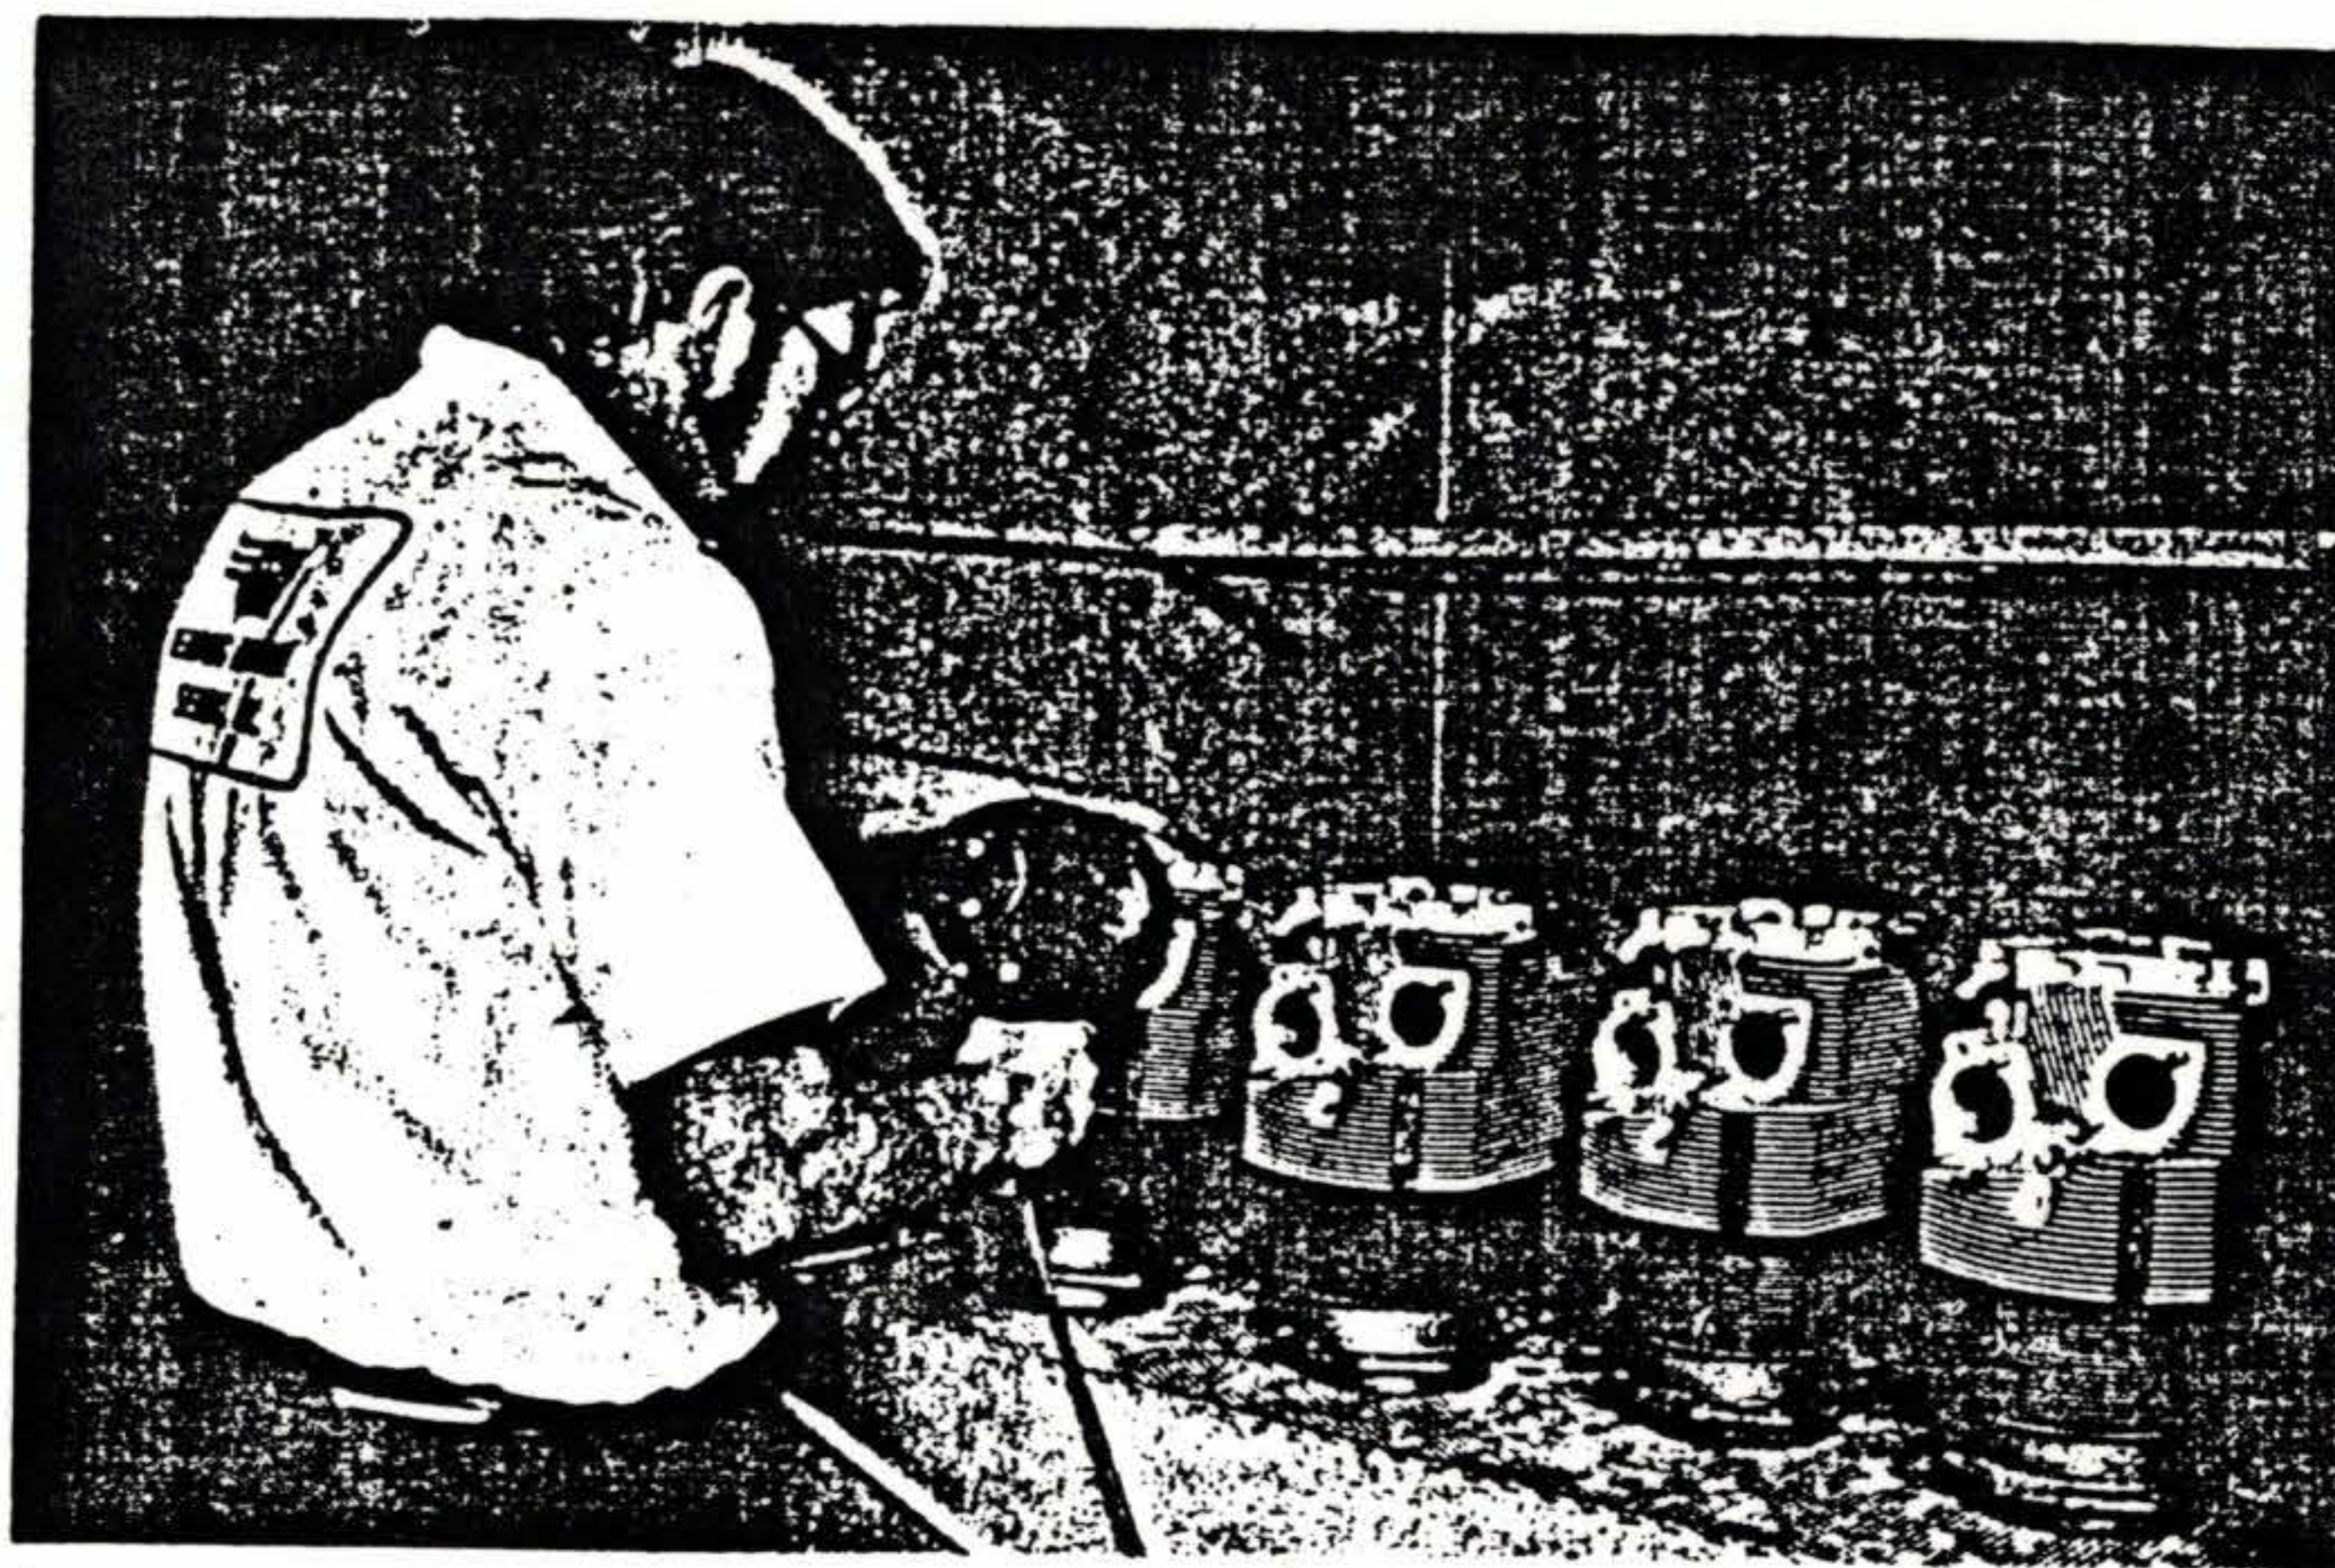
Cylinders are cleaned up prior to checking for choke, bore, step wear, and out-of-round. A thorough top will also include dye-penetrant inspection for cracks.

Suppose your barrels are scored (from too many cold starts without a preheat). Or suppose your rings have stuck (or begun to stick), creating a nasty wear step on the barrel I.D. at the top of ring travel. Or suppose your jugs are okay for I.D. and out-of-round, but can't be cleaned up while also maintaining the proper choke contour. (That is, if you regrind to restore taper, you no longer meet service limits for bore diameter.) The latter is not an uncommon problem in certain large Continentals. "If you take a cylinder off a Pressurized Centurion after 800 hours," one engine man told us flatly, "you can be damn sure the choke will be gone, and the cylinder can't be returned to service."

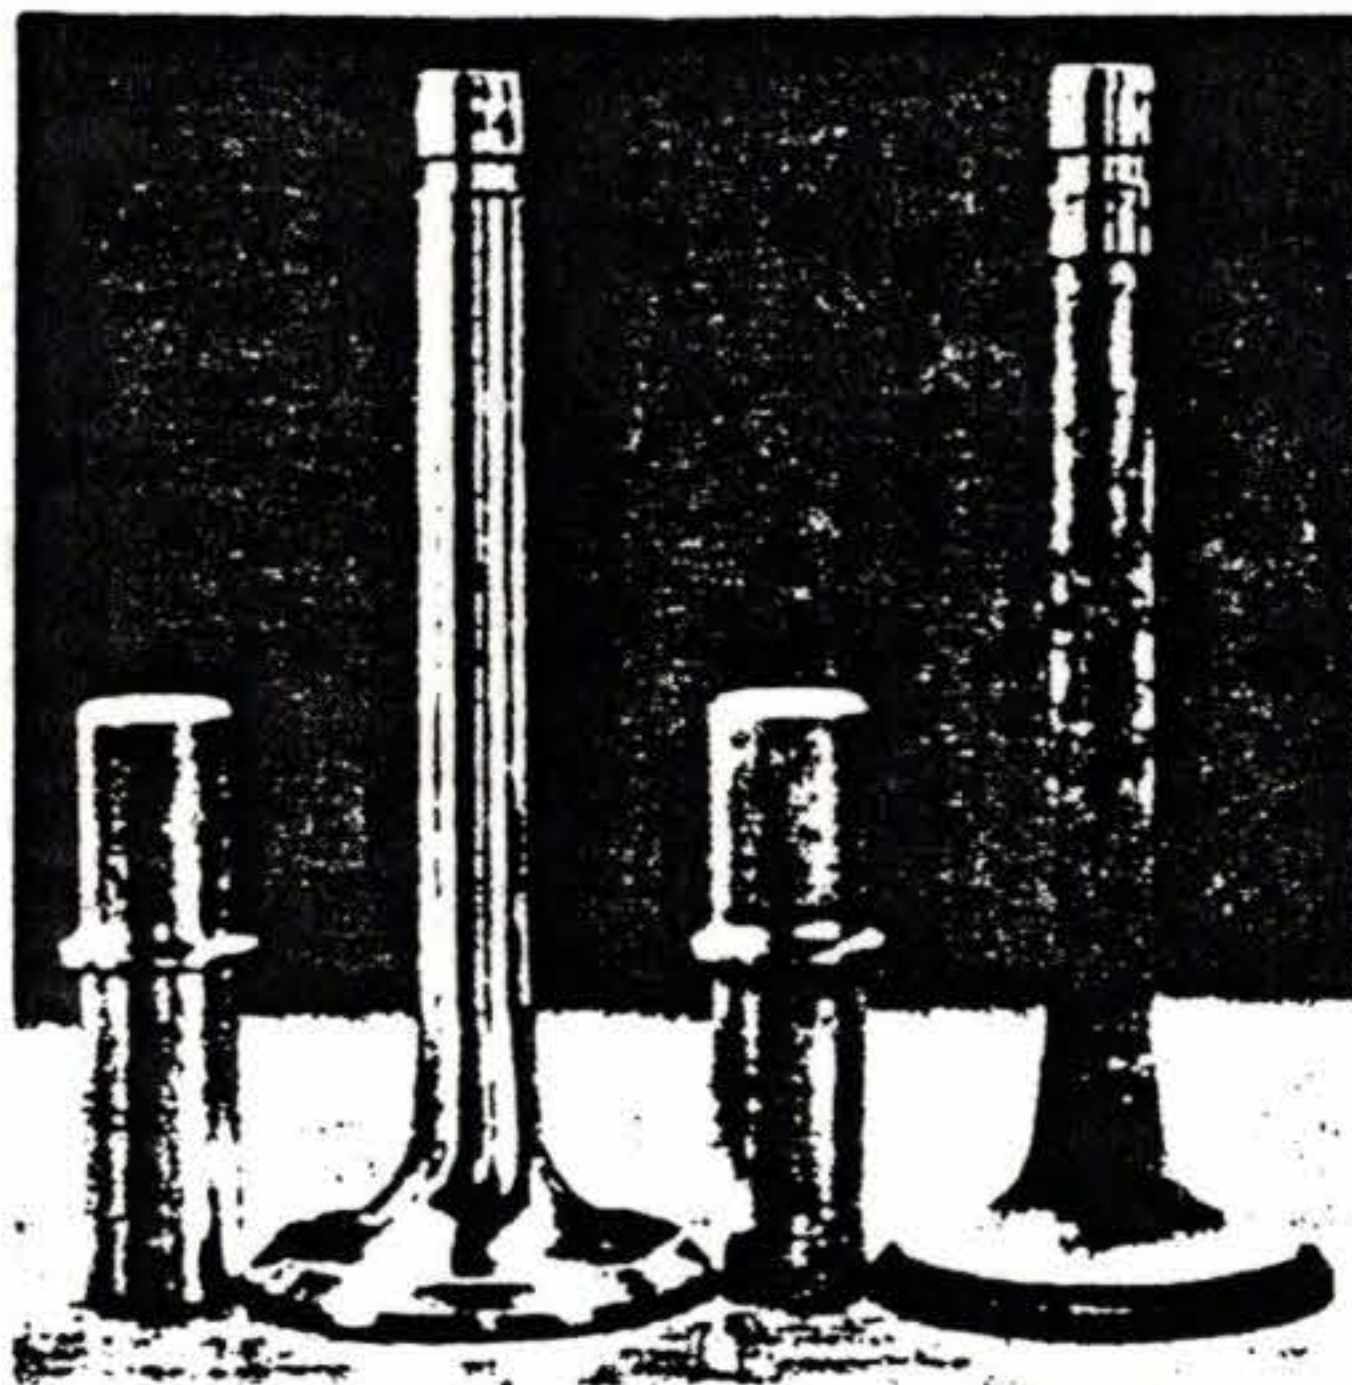
Valve stem wear is rarely as advanced as shown here (on the right), but exhaust valve to guide clearance is an important parameter to watch.

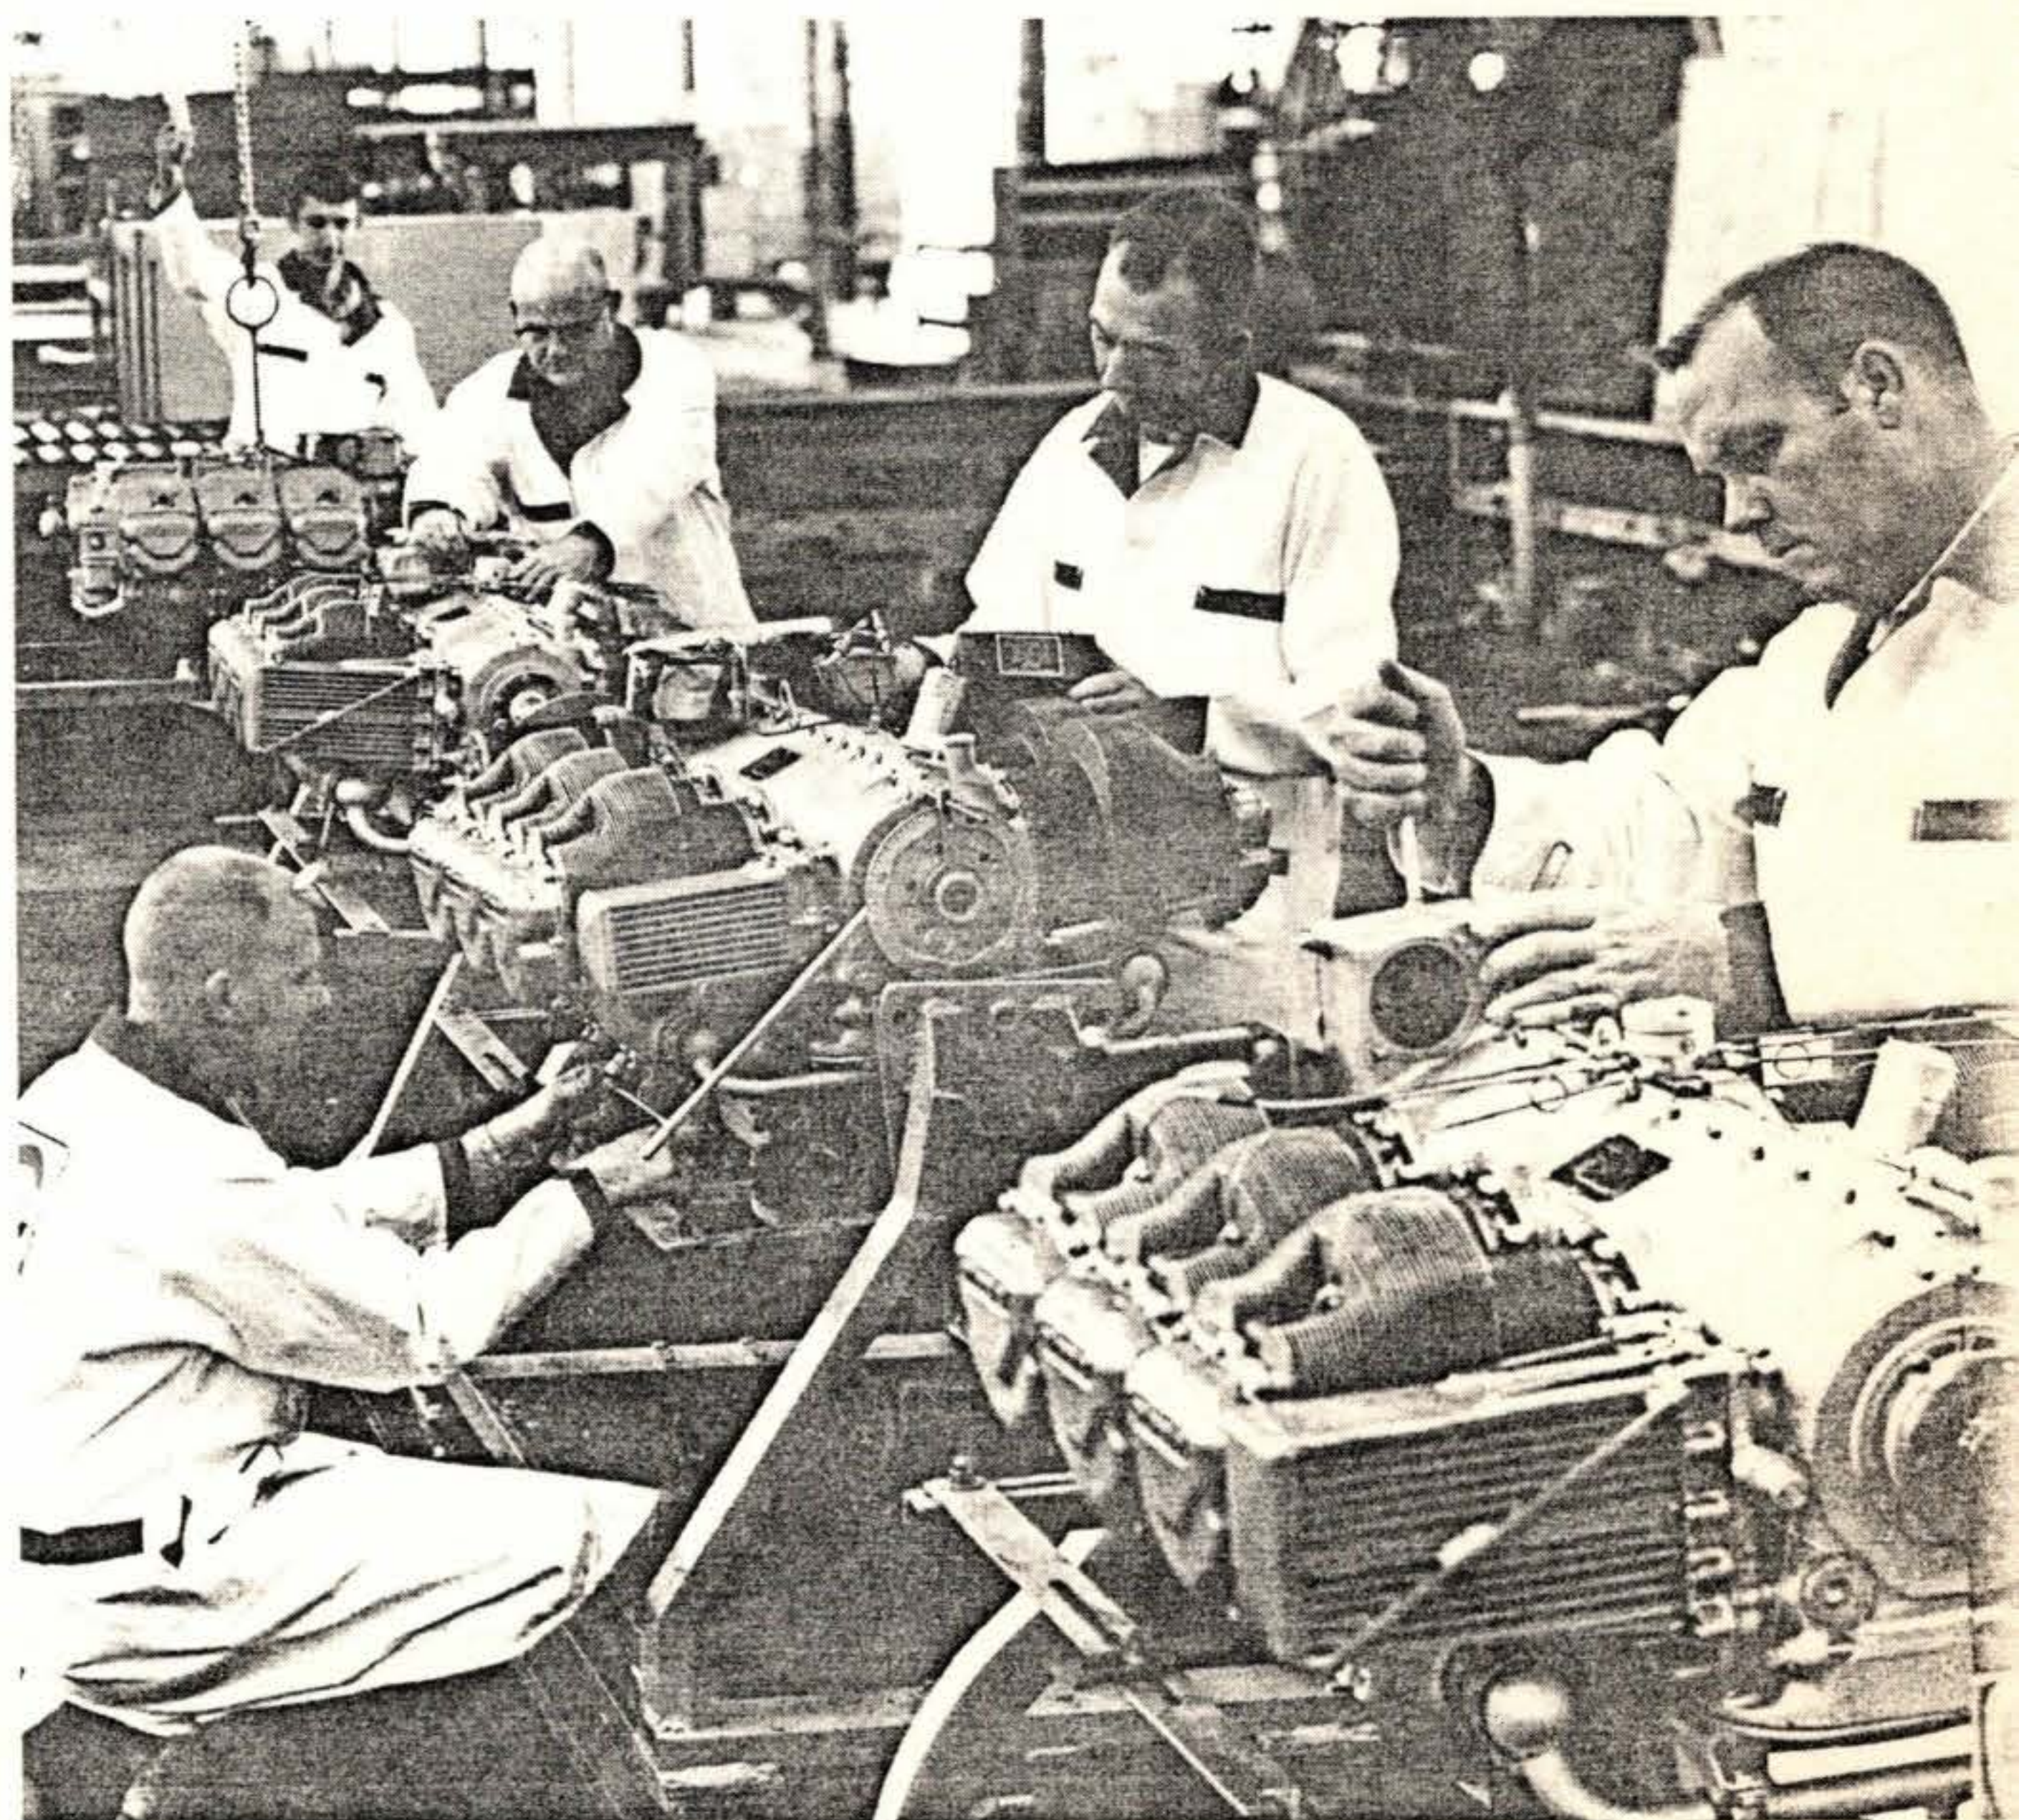
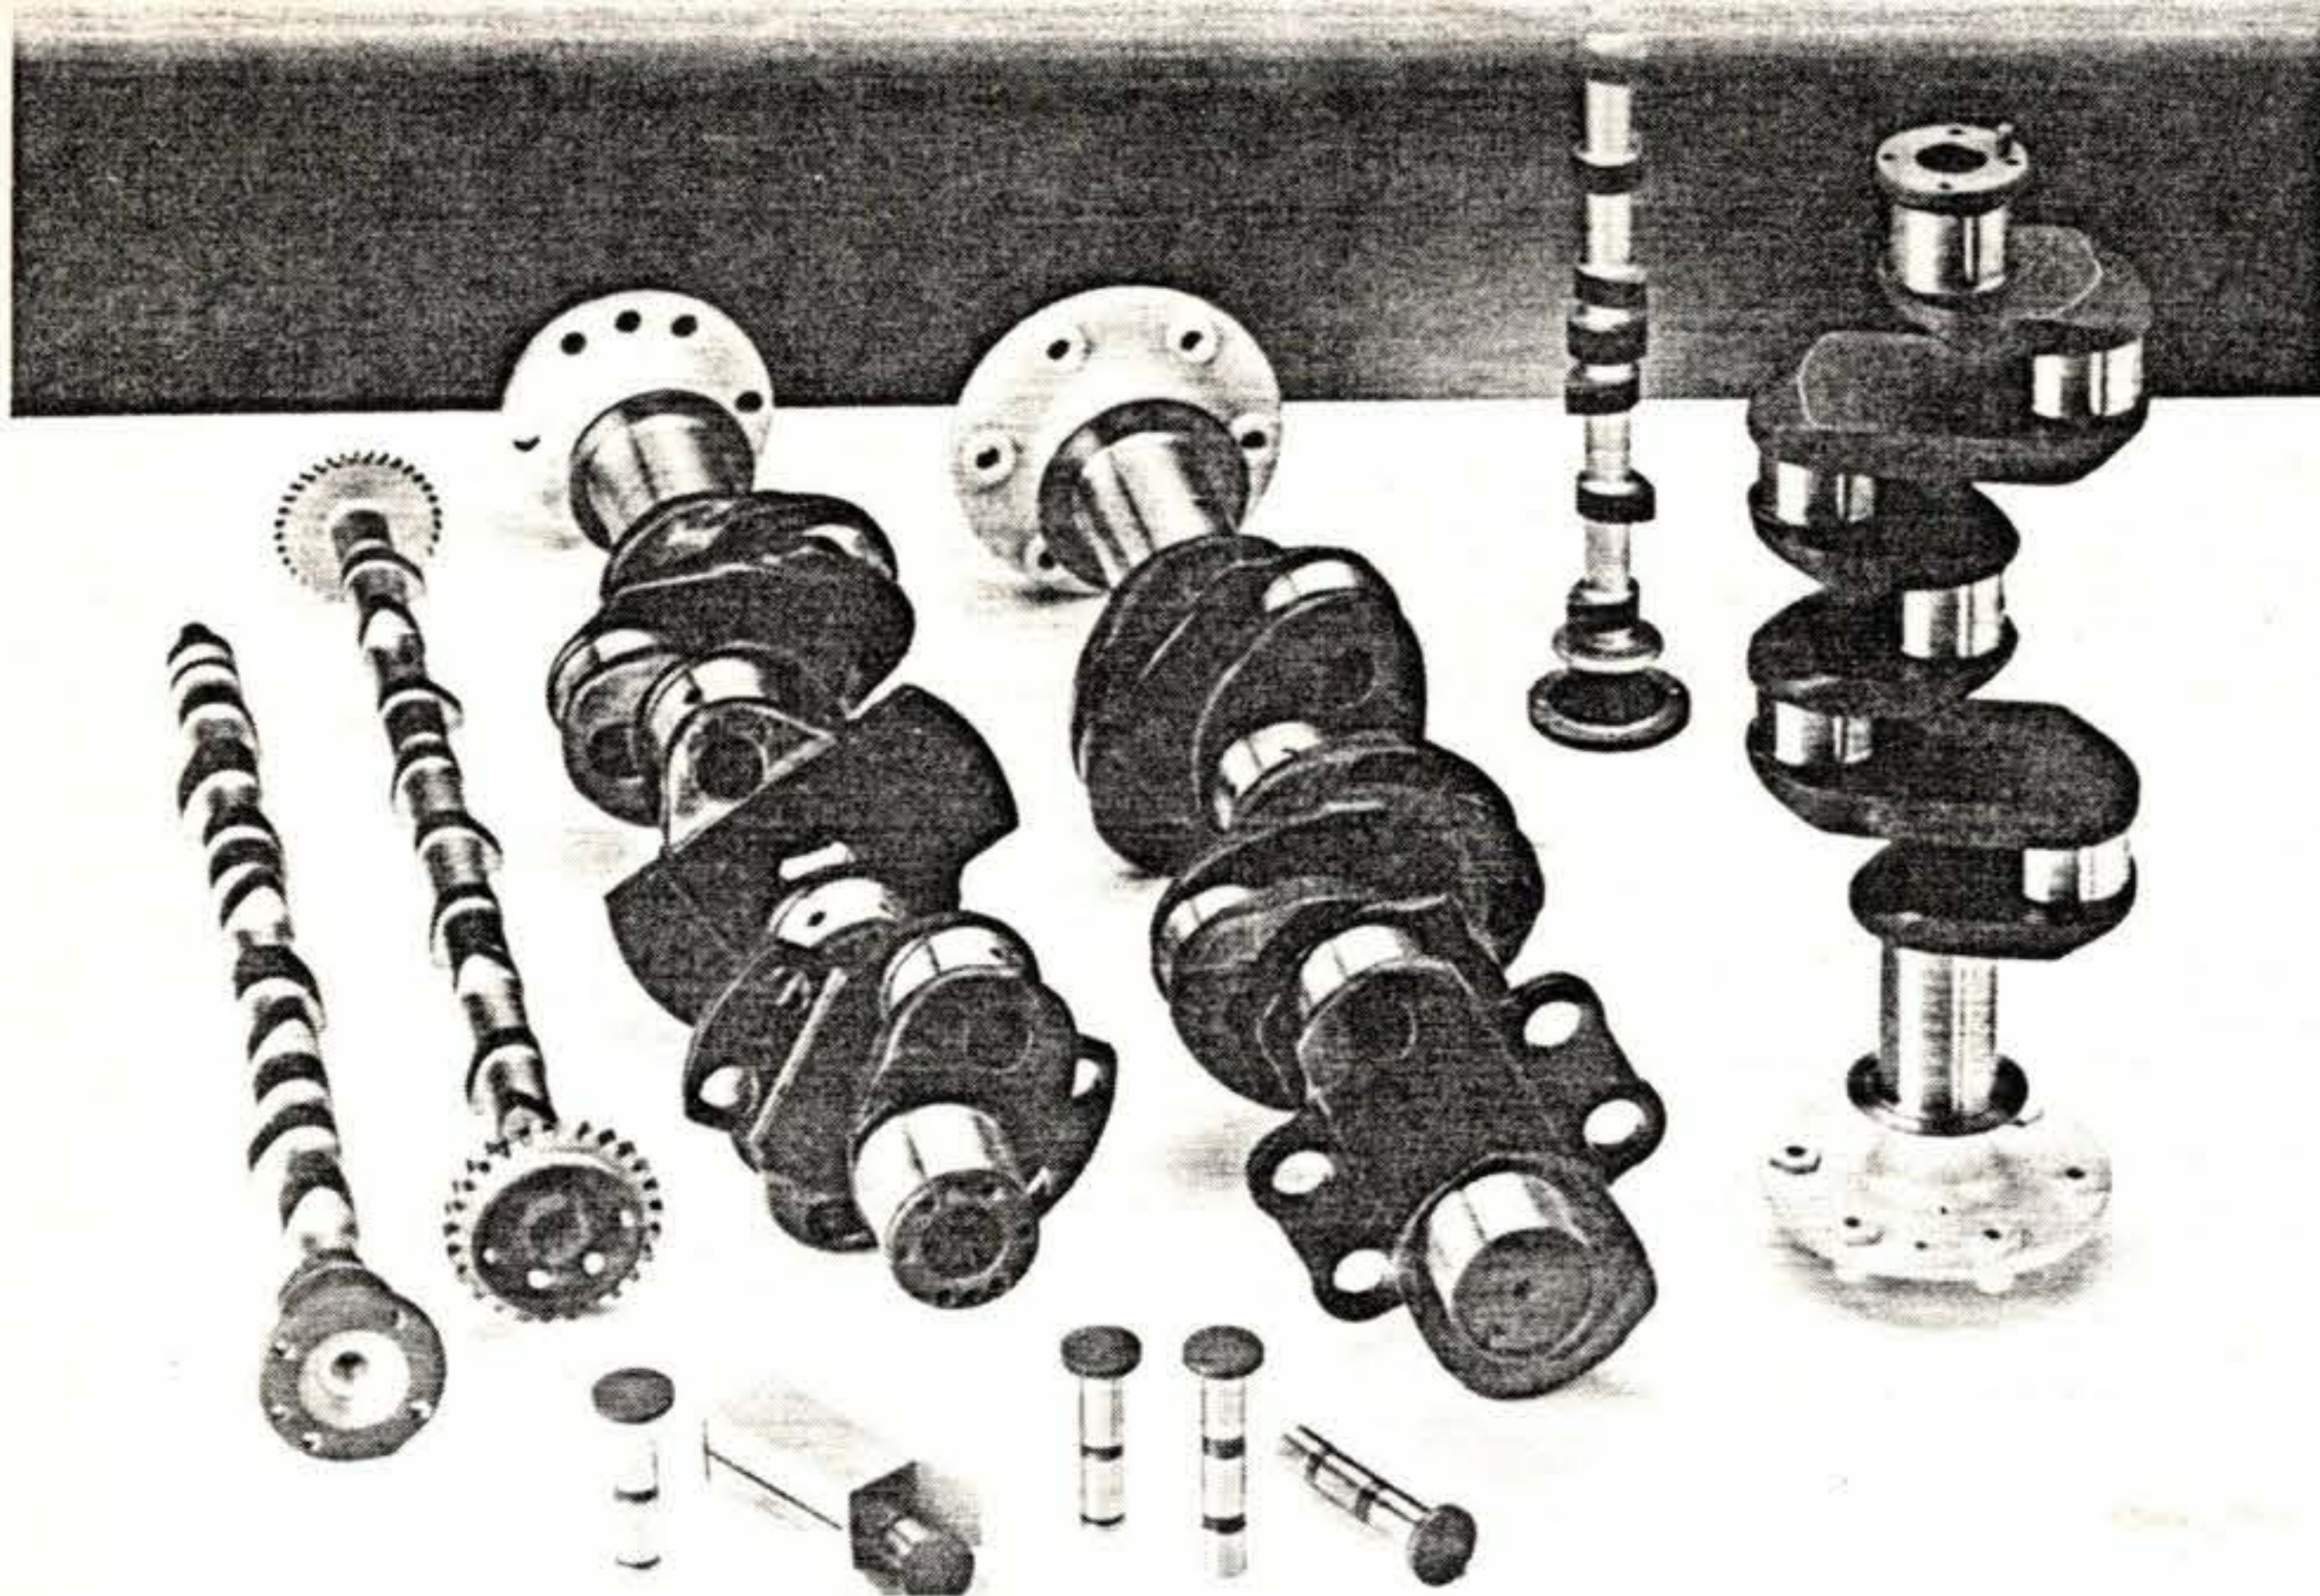
Crank, cam, and lifter regrinding can add extra cost to an overhaul. If grinding is needed, who pays for nitriding? Dynamic balancing? (Who warrants the reground parts?) Get answers in writing, ahead of time.
