Light Plane Maintenance®

SEPTEMBER 1985

Top Overhaul Facts and Fiction

By Kas Thomas

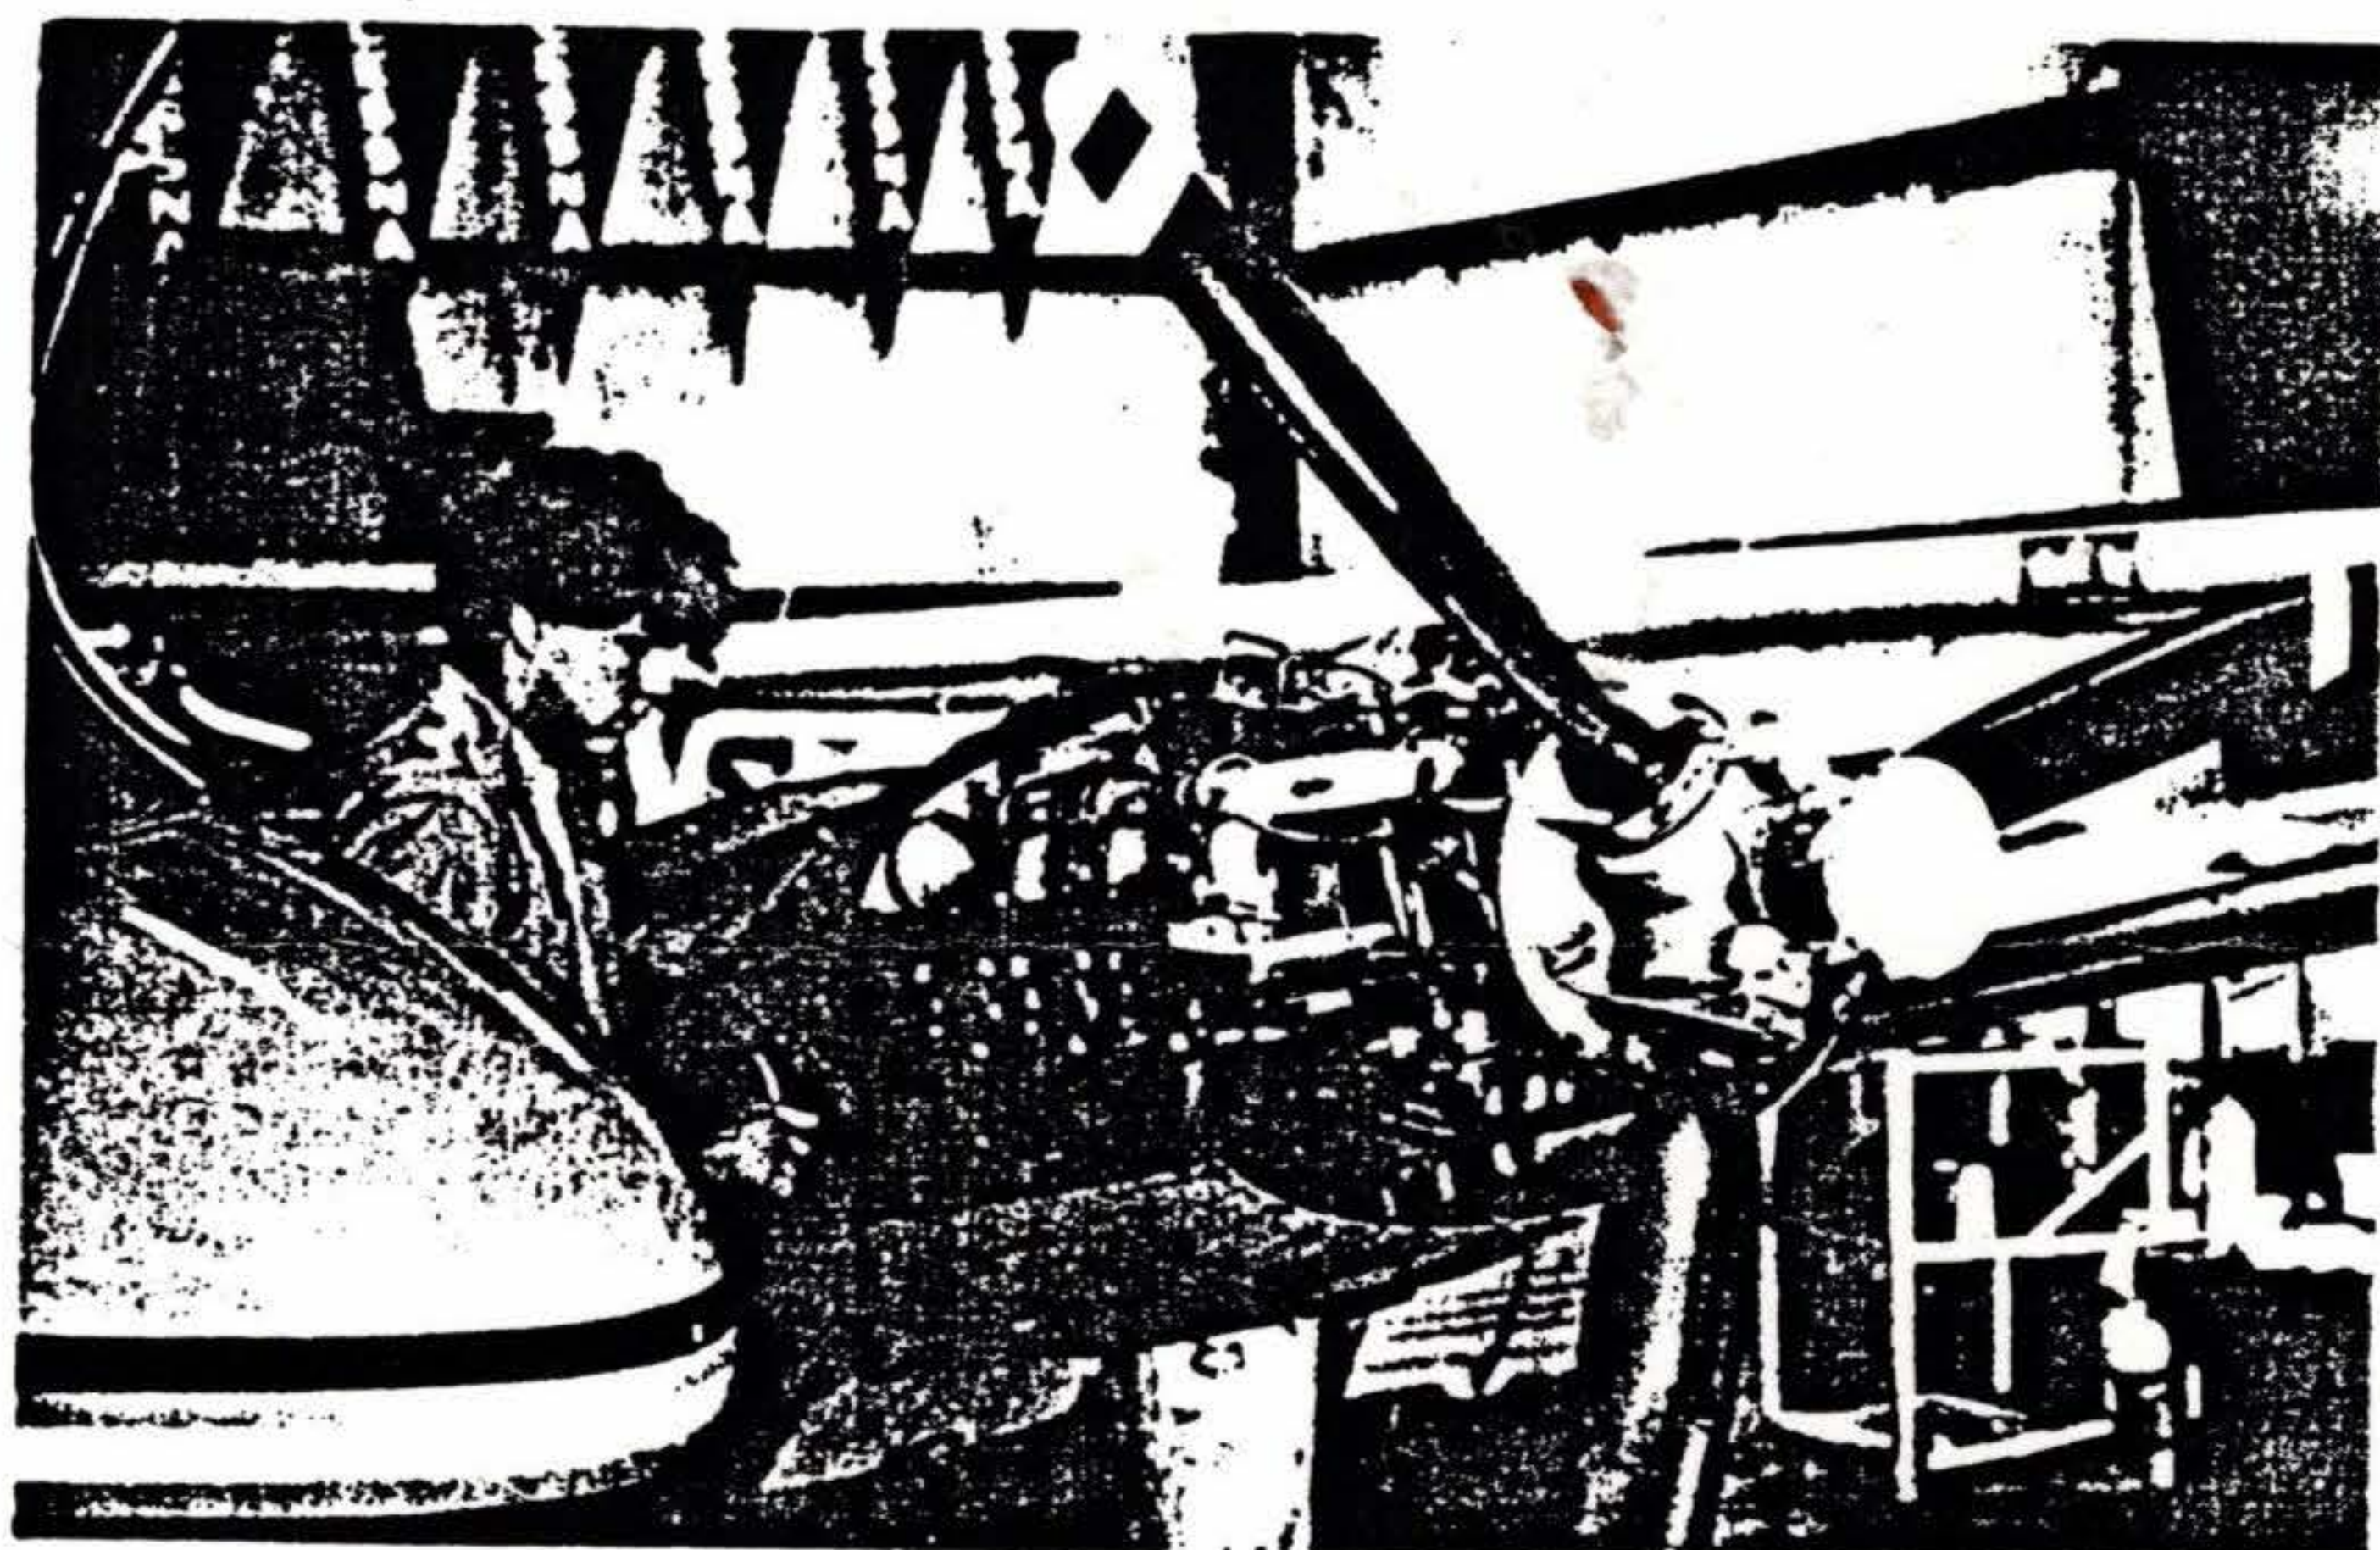
Because of the higher operating temperatures, turbocharged engines—such as the Seneca's Continental TSIO-360—need more top-end attention.

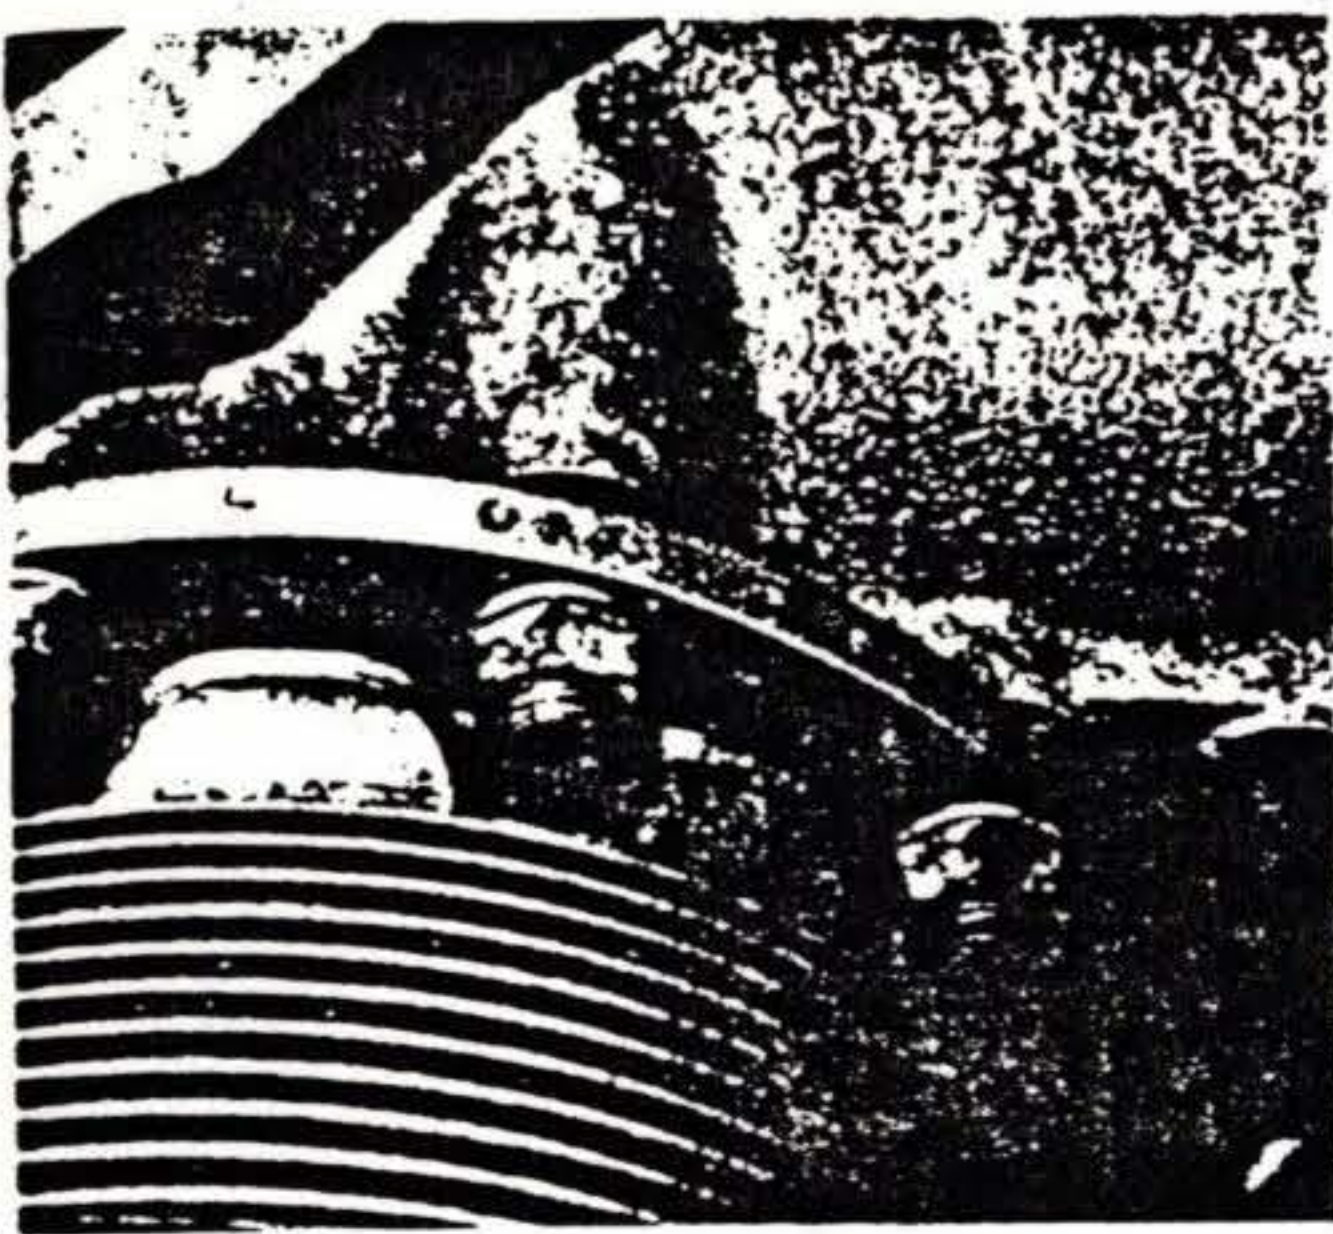
This barrel has been stamped '015' at the base to indicate oversize status.
