Propeller Blade Protractor

I just received a propeller protractor from Warp Drive, maker of composite 2, 3, and 4 blade ground adjustable pitch props. This protractor unit was developed by Warp Drive to check blade angle of variable pitch propellers while installed on the airplane. It could also be used to check blade angles on fixed pitch propellers.

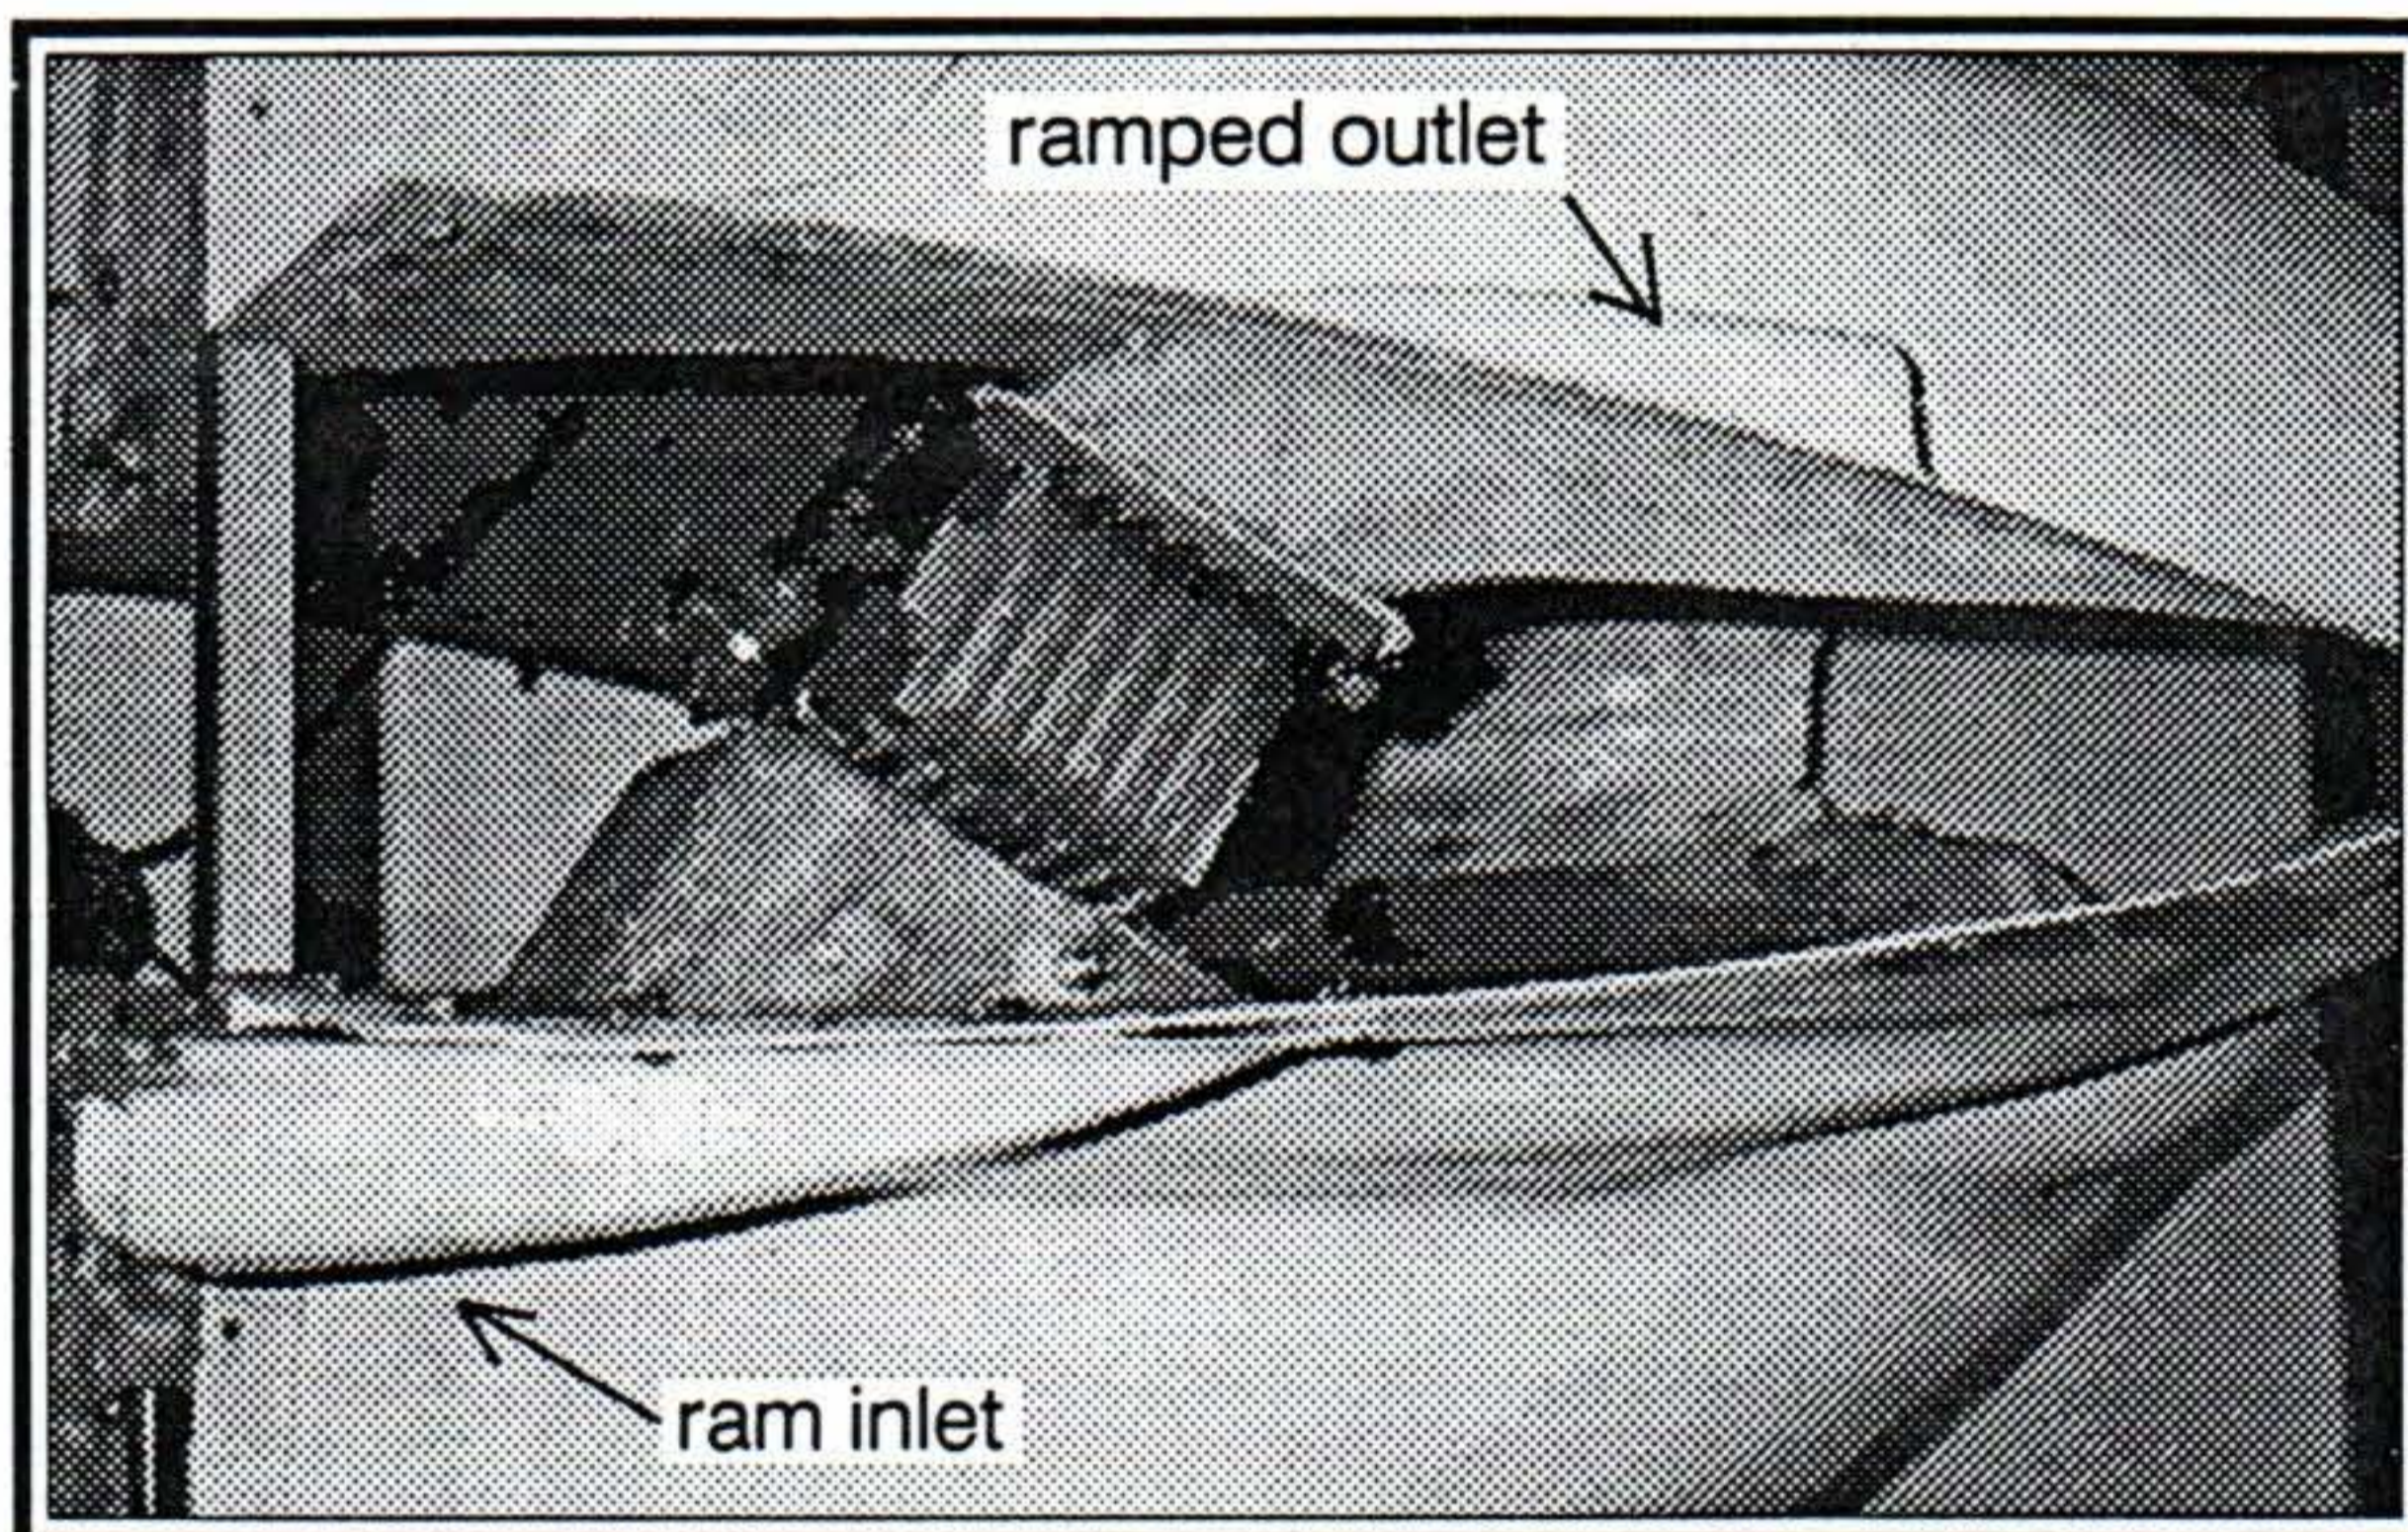
Dedicated inlet and outlet help assure adequate airflow to the oil cooler and reduces the heat load in the cowl

The 9 section oil cooler pictured is oversized from the plans recommendation. I am sure I am creating a little drag with this installation but I can't see it on the airspeed indicator. It appears I have reduced #3 CHT about 20°F.

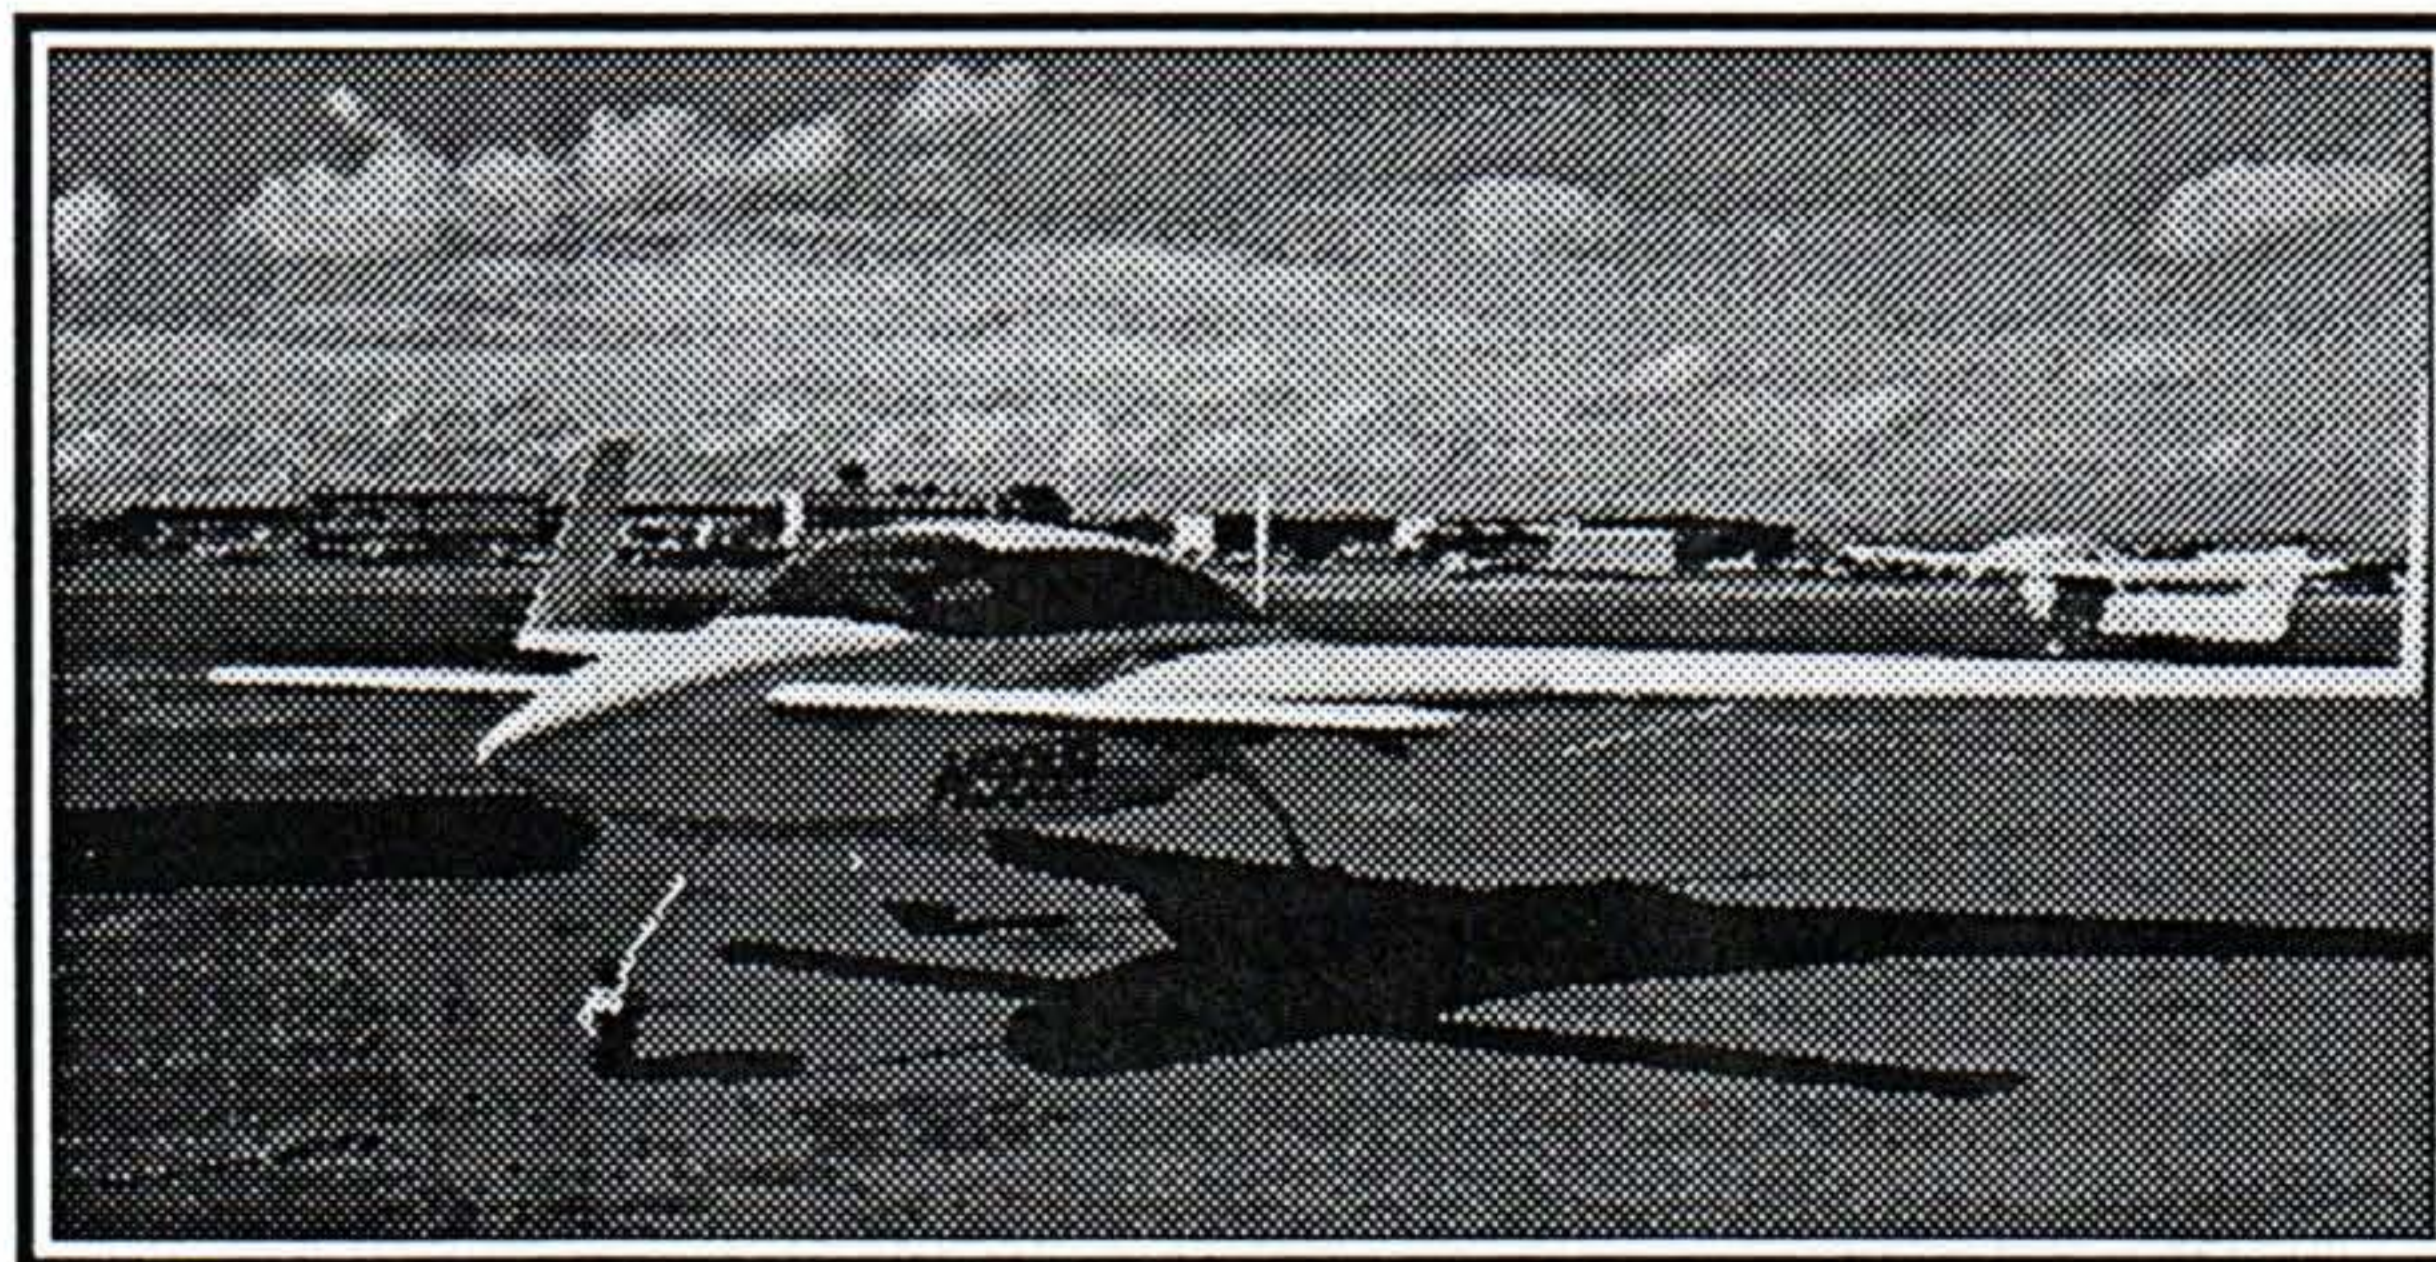
Superior workmanship is evident on this oil cooler installation

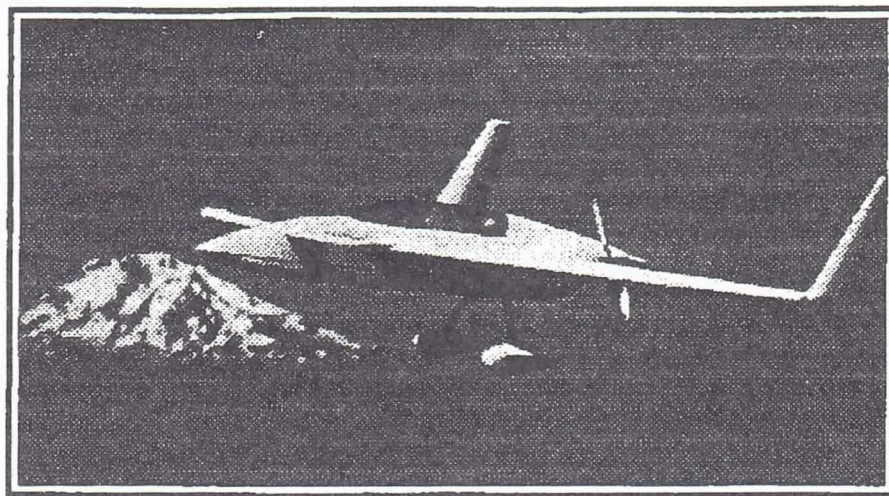
CHT's are down - Thanks to Atkinson & Coha Ideas

Vance Atkinson's tip on "clamshells" around the cylinder bases and Al Coha's idea with glass and silicon on the heads. (I used graphite cloth as it looks slightly cooler) Guess what? **A 100° F drop!**

I even jury rigged a borrowed CHT gage and bayonet to double check. Previously, I always had to throttle back and stay full rich on climb outs. Now full throttle to 18,000 = 340° F max. I'm very pleased. Also I installed an LSE ignition system. It took about 10 hours.

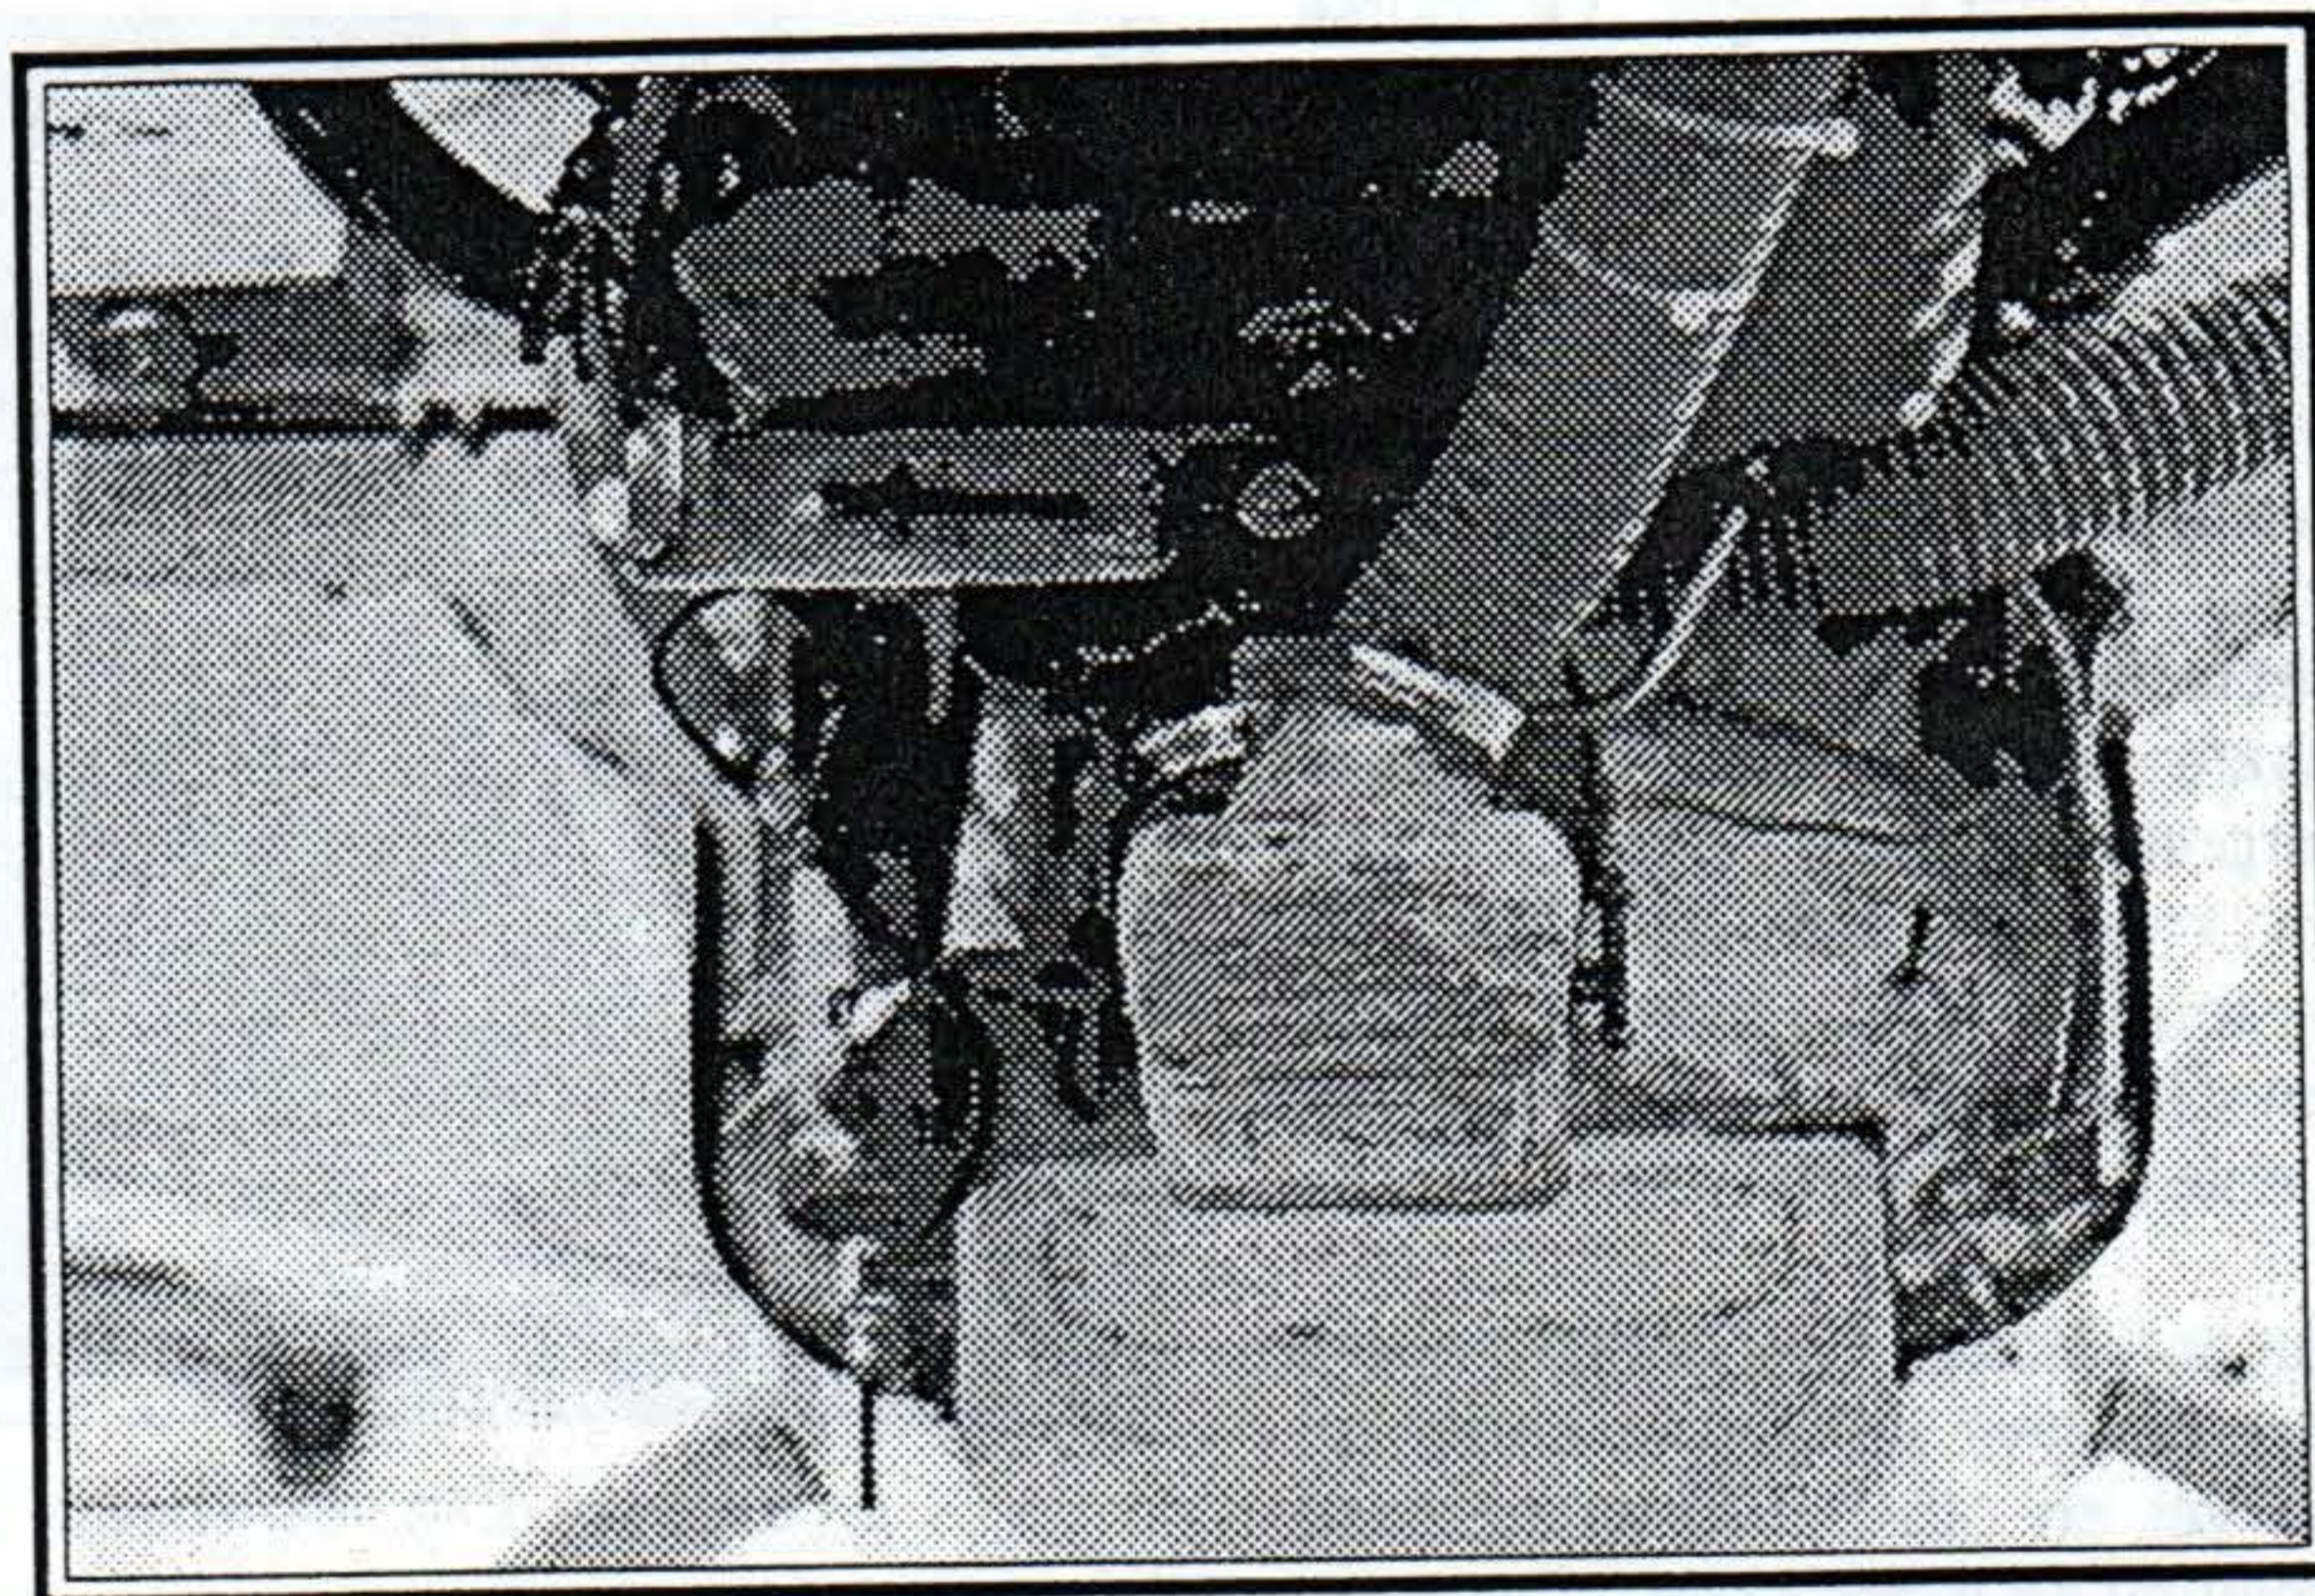
Heat enters aft of the carb from a muff on the right side exhaust

I designed a carb air box that would allow use of my previous carb/cabin heater muff and permit both to function. Since I had only one heat muff I decided to use a design that permitted selection of carb heat or cabin heat, but not both simultaneously.

The extra induction hoses were removed and the air box was fitted with a Bracket foam air filter having just over 16 square inches of surface area. A traditional throttle style valve was fabricated using silicone baffle seal material to cushion the edges of the valve. This is the way the stock carb heat valve is done. Due to close proximity of the cowl bottom, my carb air box is only about 2-1/2" high at the carb inlet. That allowed me only about 9 square inches of cross section at the carb air box valve.

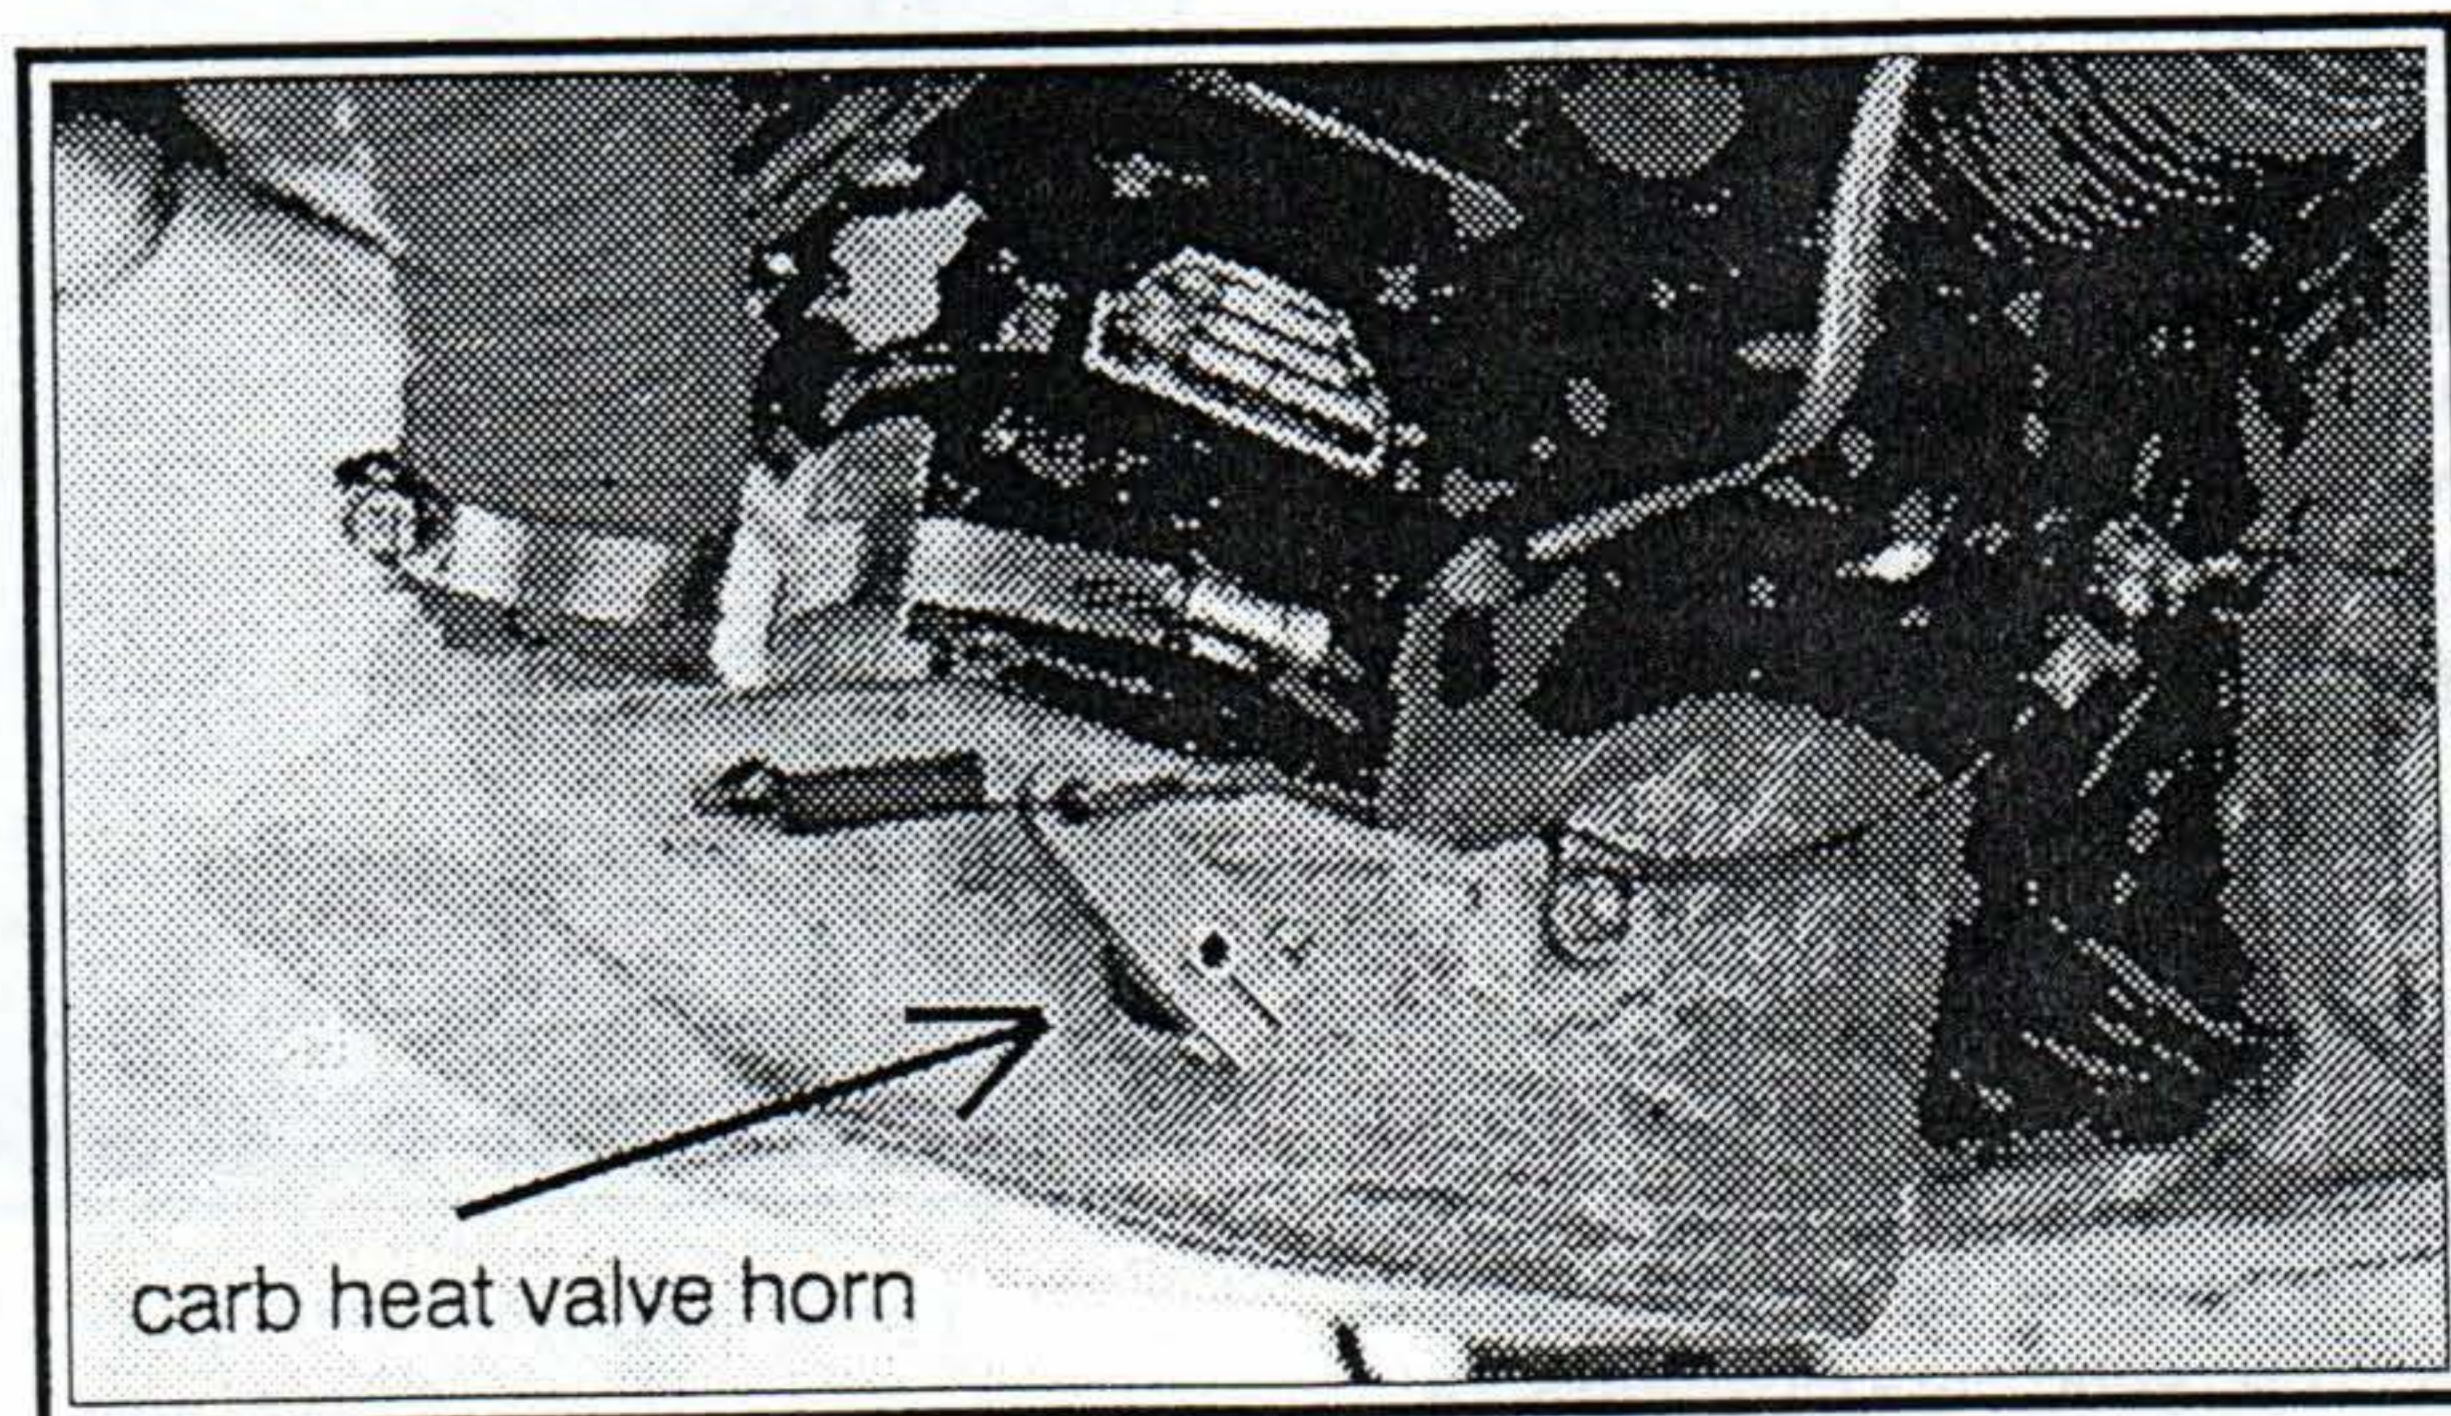
Note clear path for NACA duct inlet to the cylinders (above) and air box clamp mounting to carb (below)

The new carb air box mounts to the bottom of the carb with two fiberglass straps that go up the front and back of the carb body and are secured with a screw type hose clamp. I did not want to have unsafetyed bolts inside the induction system to come loose and go through the engine. The clamp method has worked well so far. I have not seen any loosening or slipping of the box. (photo p. 26)

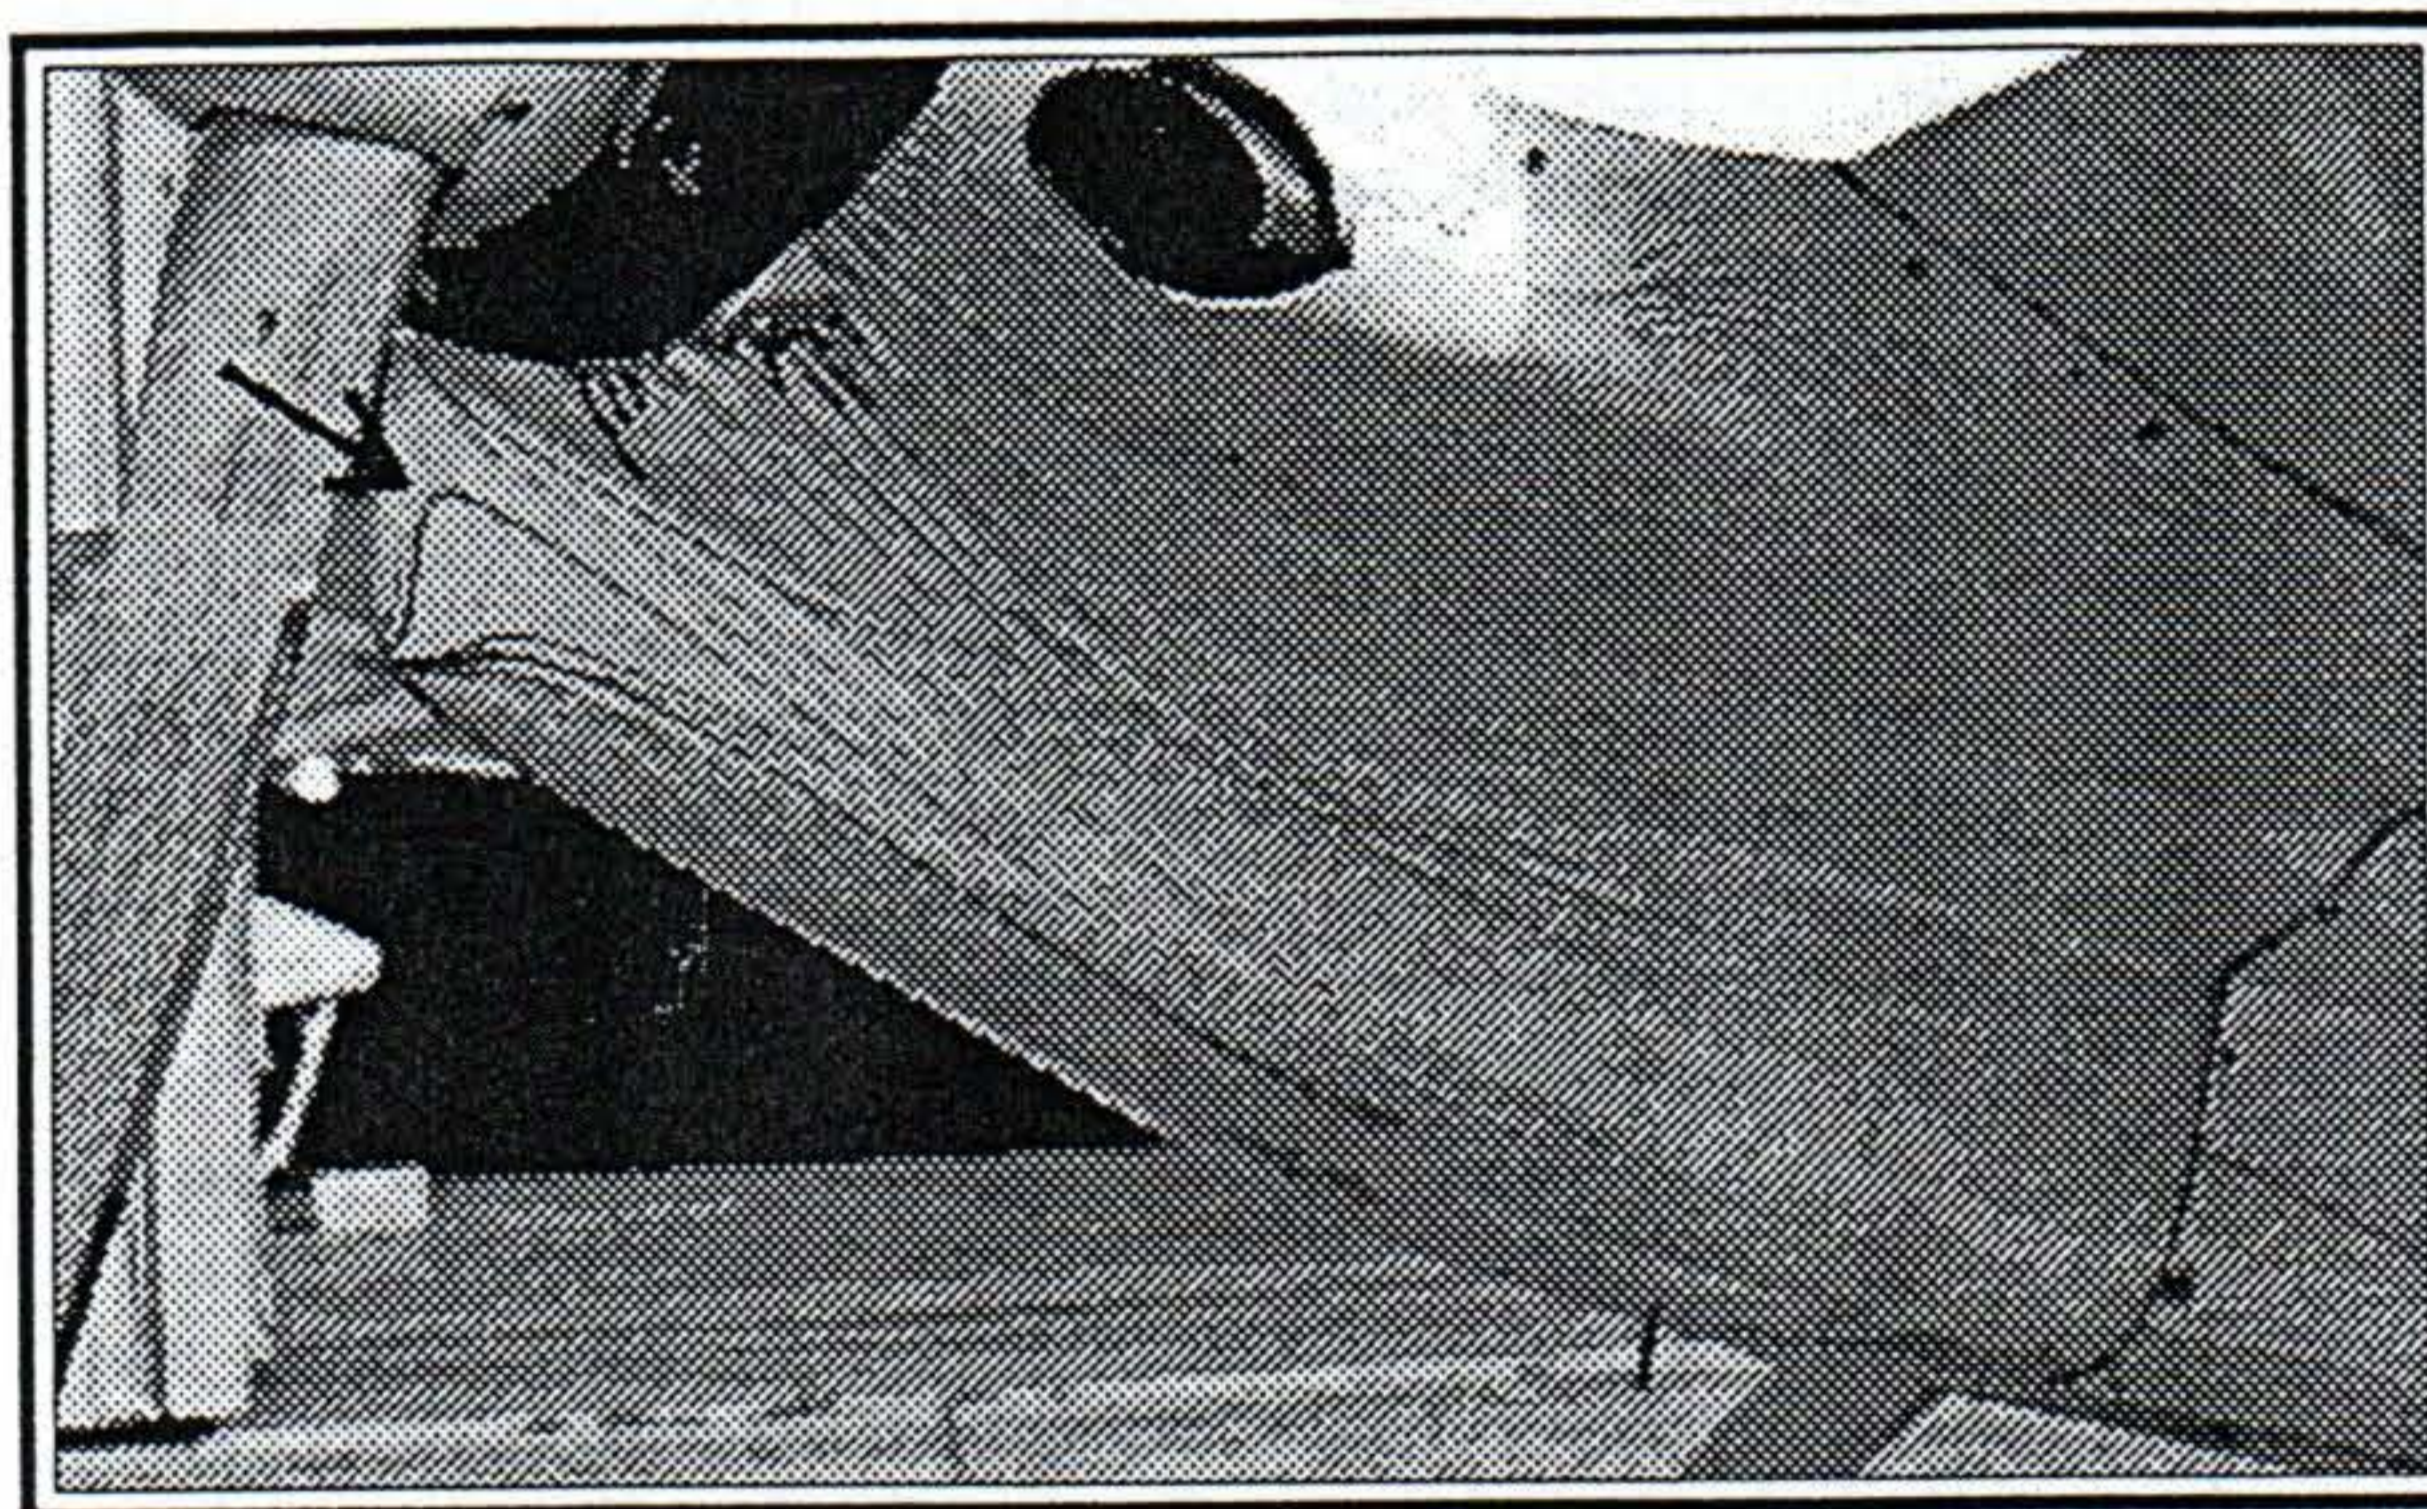
Note laminar flow except near outlet

while trying to keep the 7 degree angle. (Subsequent oil flow flight tests, photo p. 28, show fairly constant oil stream width thus indicating air flow is not slowing down very much. That leads me to believe the curving angle is not excessive which would cause drag by disruption of the air flow).

Oil flow still indicates disruption around the exhaust outlets and perhaps the 4 pipe exit inside the cowl, as recommended by Charlie, Gary, and Klaus is called for to get further performance gains.

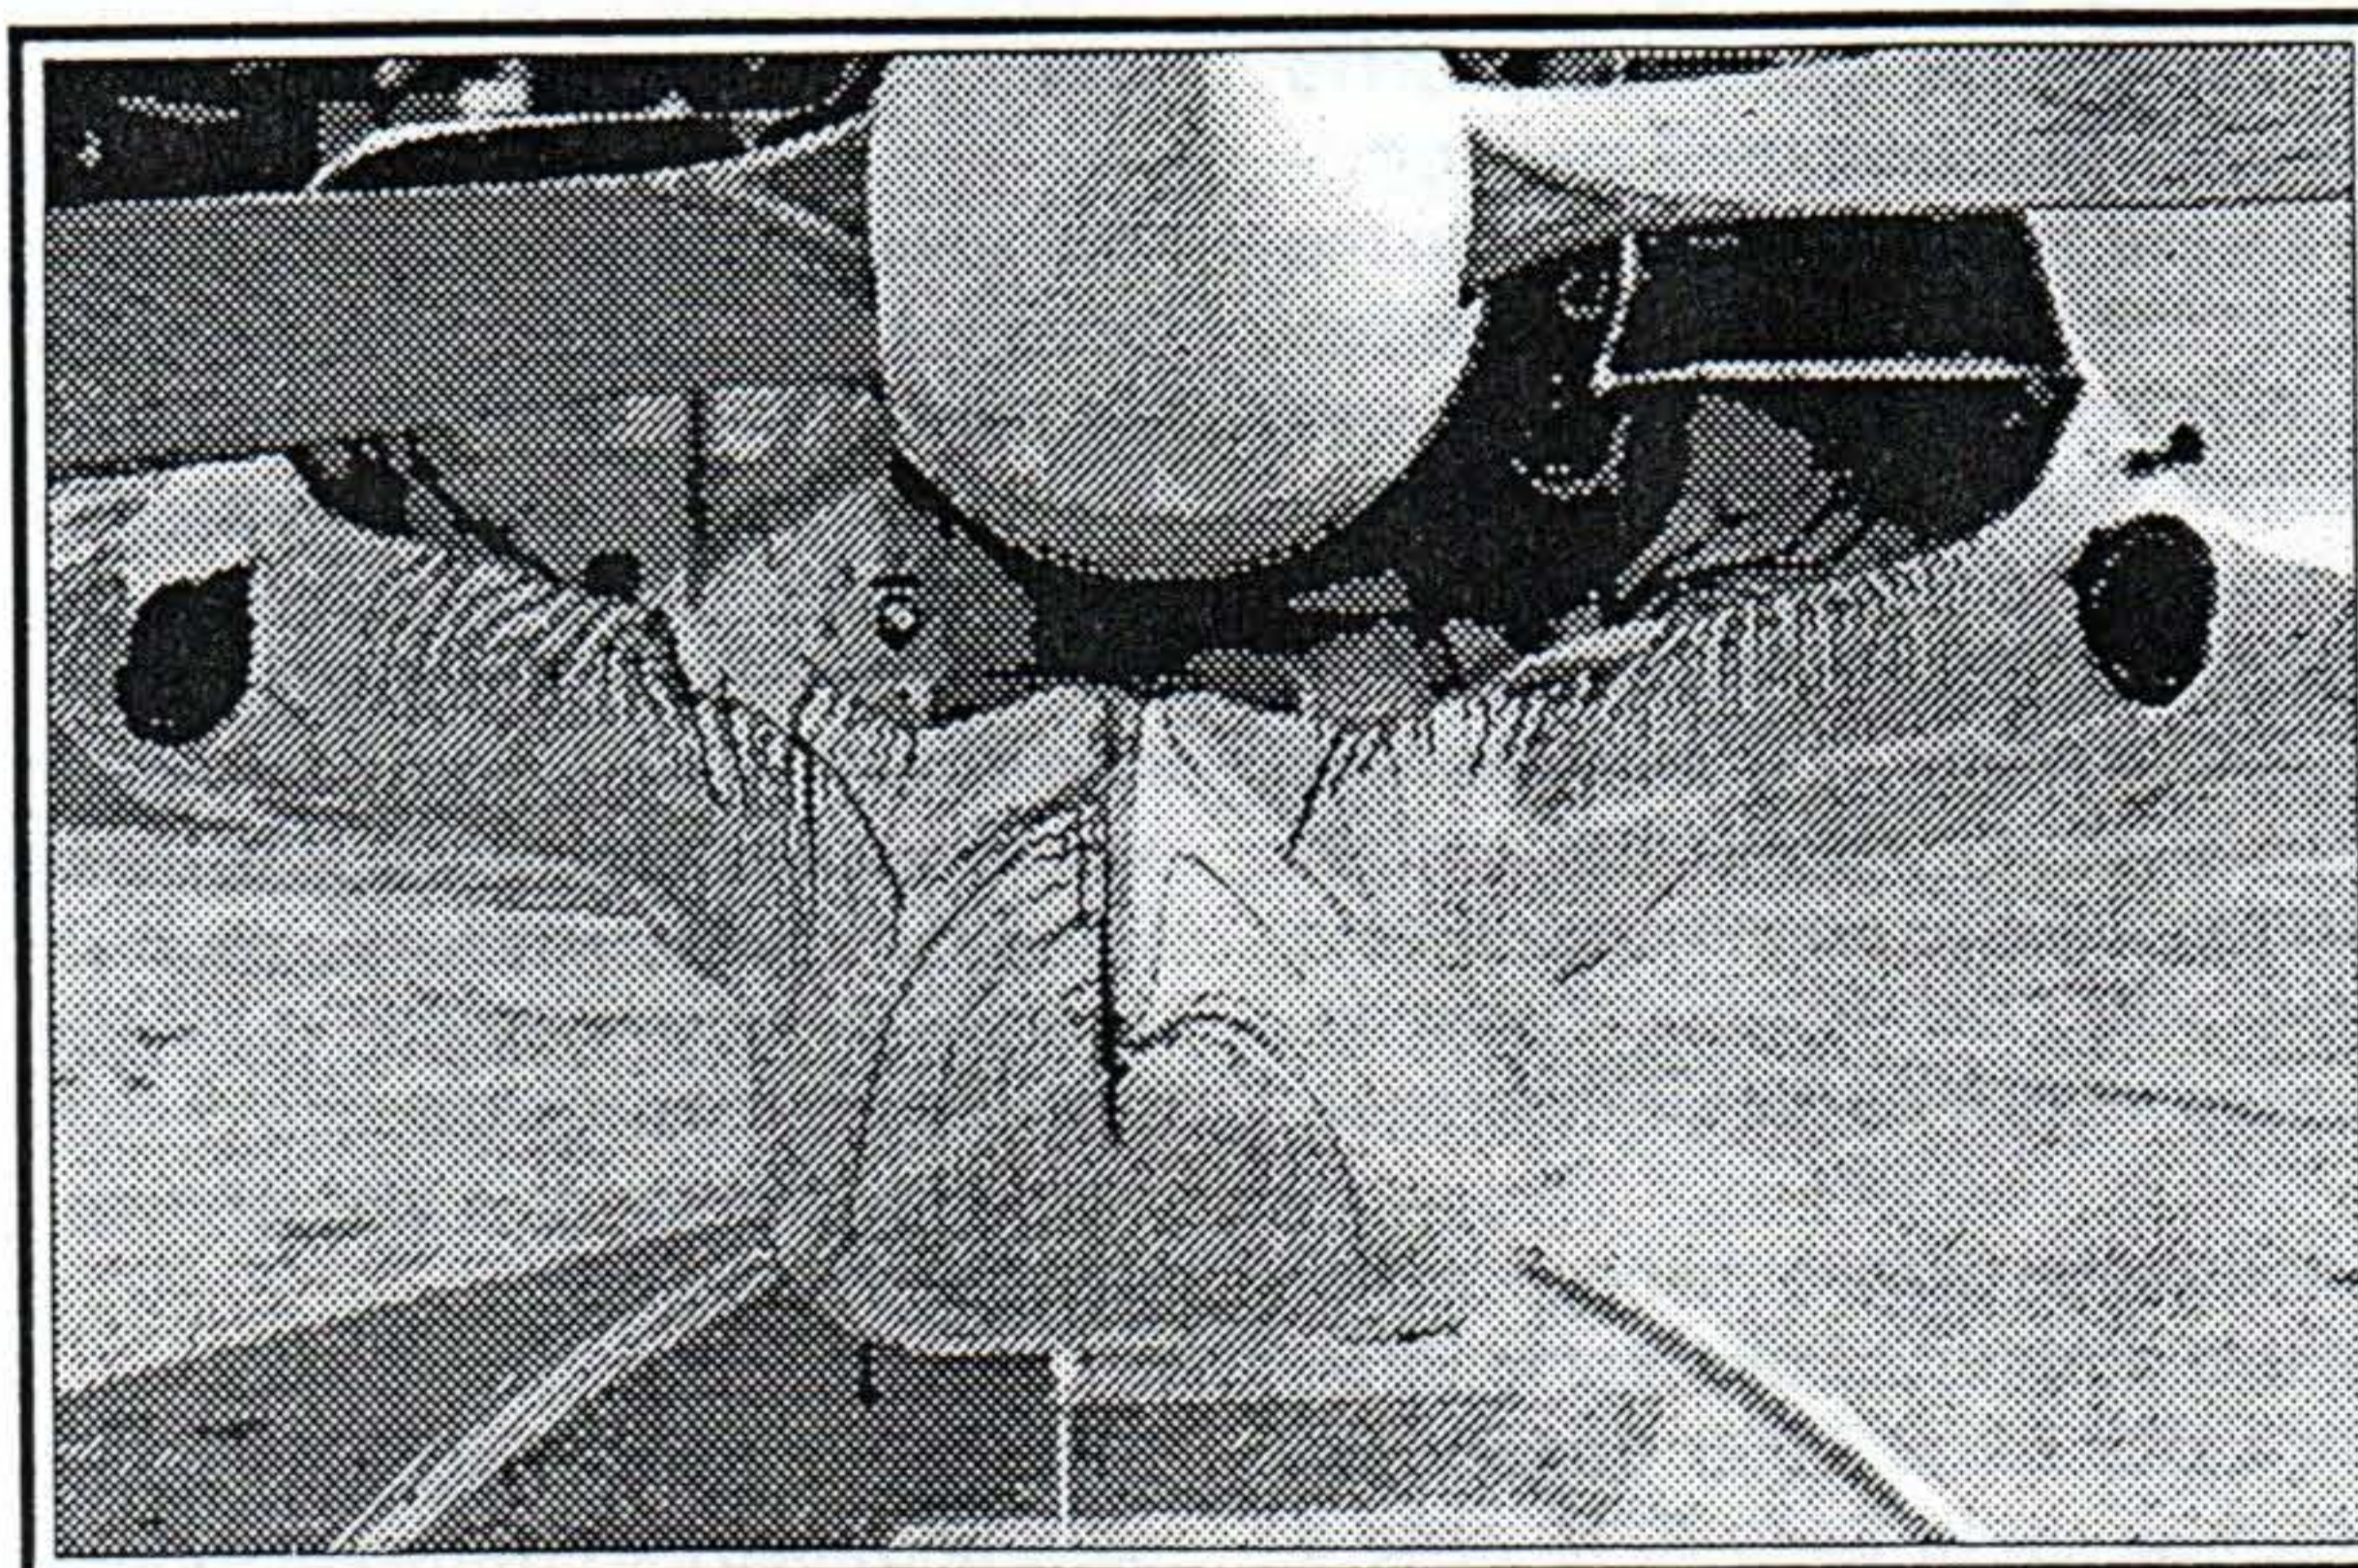
Interesting oil flow appears effected by prop rotation

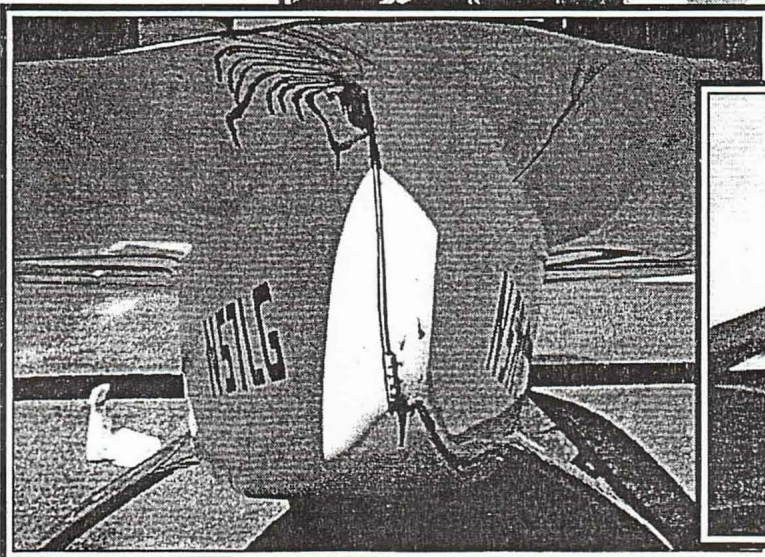
Not all boat tails
are equal, some
are more equal.
Observe the flow.
