Propeller Blade Protractor

I just received a propeller protractor from Warp Drive, maker of composite 2, 3, and 4 blade ground adjustable pitch props. This protractor unit was developed by Warp Drive to check blade angle of variable pitch propellers while installed on the airplane. It could also be used to check blade angles on fixed pitch propellers.

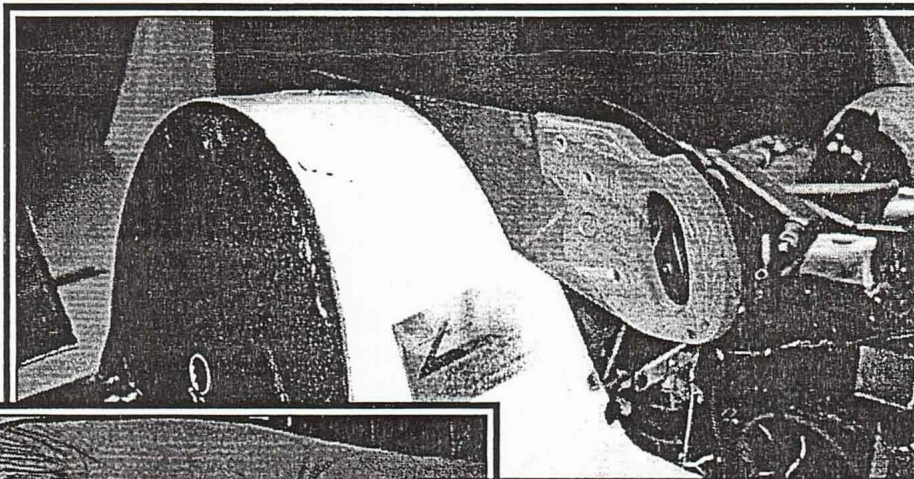
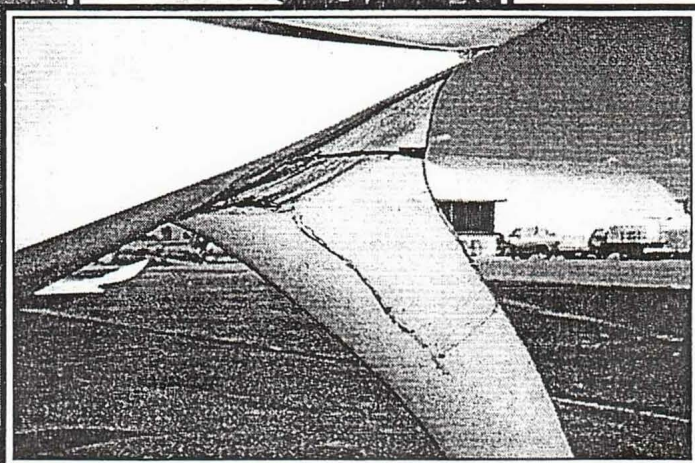
The good and the bad: Fuel seepage out of the fuselage side walls showing good attached flow to the trailing edge
