French Vari-Eze F-PBJL

Ernest Magallon Graineau (France) The main gear wheel pants are of my own design, fabricated from two spinners. The front half is a dome spinner while the back half is like the type made by Klaus.

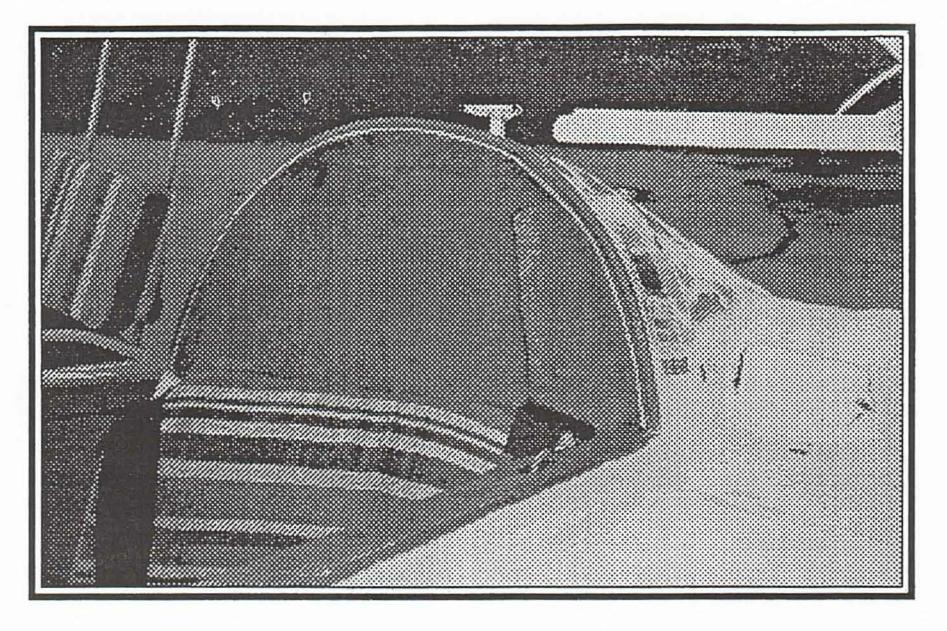
Aft canopy is spread for greater back seat room and visibility

The canopy is different from those used in the states. It looks like the one istrated on p. 17 of July 95 CSA awsletter. Most European Vari-Ezes are built that way as it offers better downward view. The different profile requires a changed firewall plan form and provides a larger fuselage fuel tank.

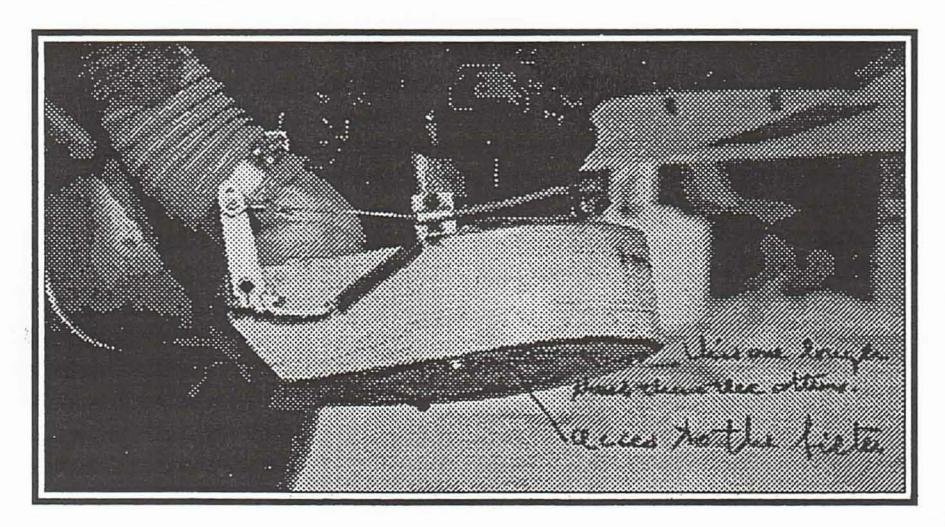
Carb ram air box appears to be made of honeycomb material

I built an air box to house a filter that mounts directly below the carburetor. Both hot and cold induction air are filtered. The lower cowl had to be modified into a boat tail to accept the changed air box.

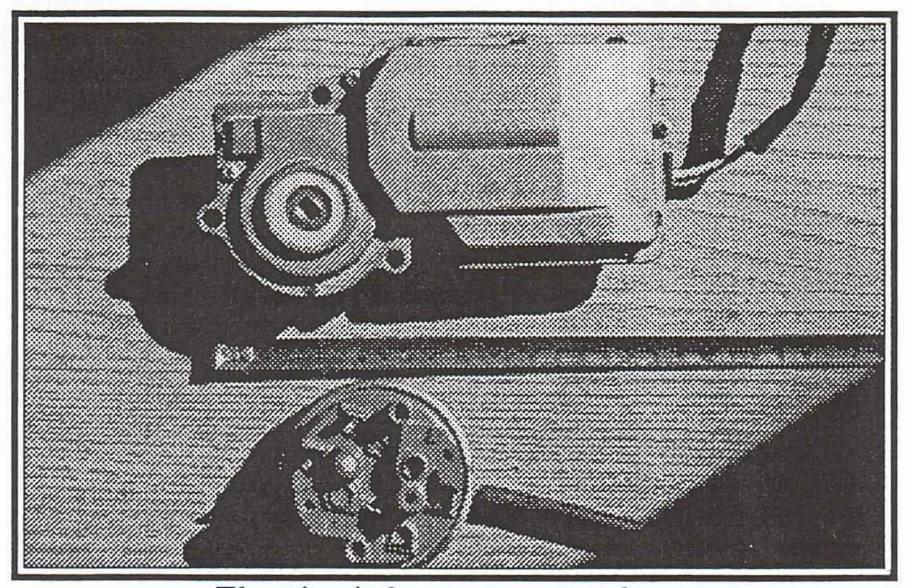
Electric window motor extends nose gear

The nose gear is actuated by an electric motor. The fail safe unit mounts on the torque tube between the Brock gear box and handle. Should you wish to disengage the motor, just push the handle and manual activation is restored.

The self extension feature is obtained by use of a pressure vane in parallel ""th the air speed indicator. When Jair speed (frontal pressure) drops below a certain value contact is made to the nose strut extension motor.

Other micro switches ensure this happens only when the canopy is closed, the engine RPMs are low, etc. The same switches activate gear position indicator lights and high/ low power lights.

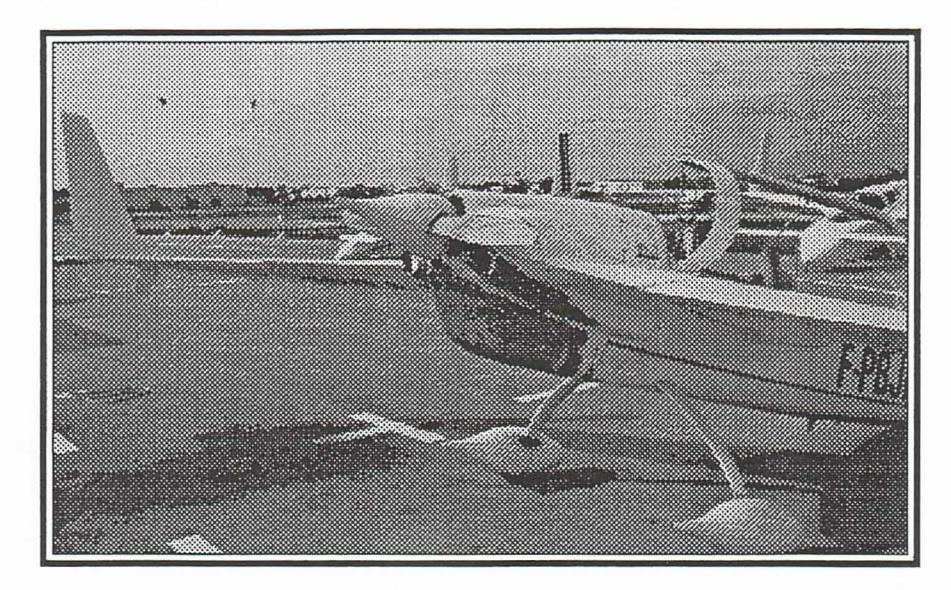
Unique wheel pant design and boat tail cowl set off Vari-Eze

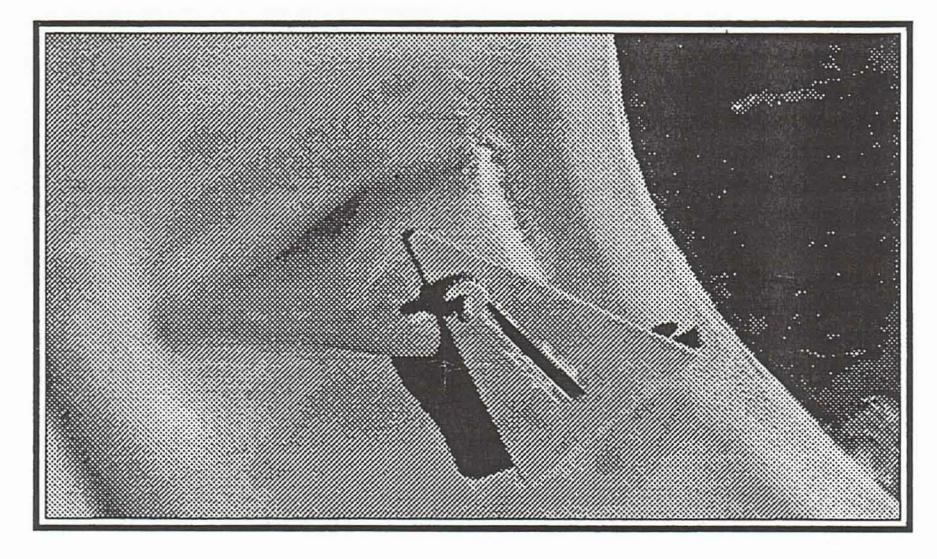
Adjustable vent cover directs air flow

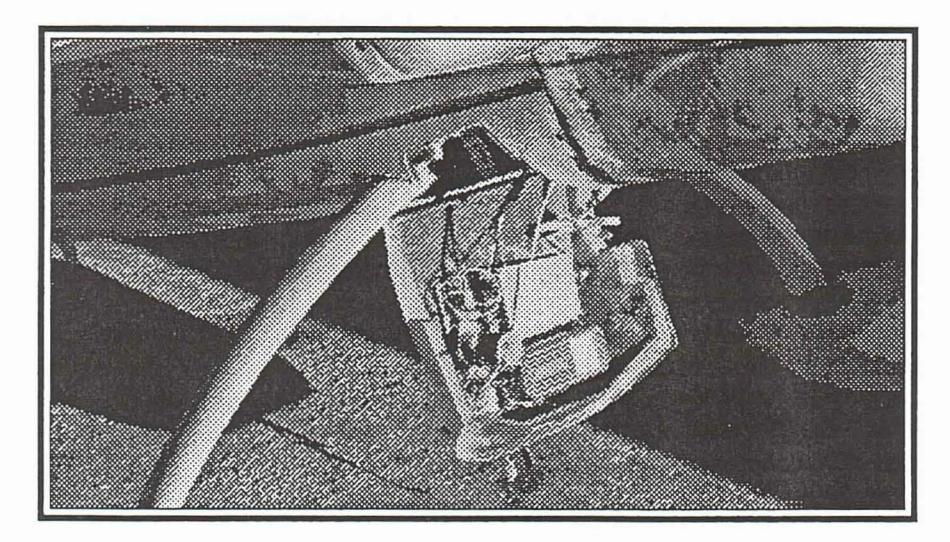
Drop down door allows easy access to electronic ignition module. Structure is reinforced to carry landing gear loads.
