Brakes "Go" Instead of "Whoa?" Install a Pair of Chromed Discs

by Dennis Shattuck

Article reprint from Aero Magazine, October 1982

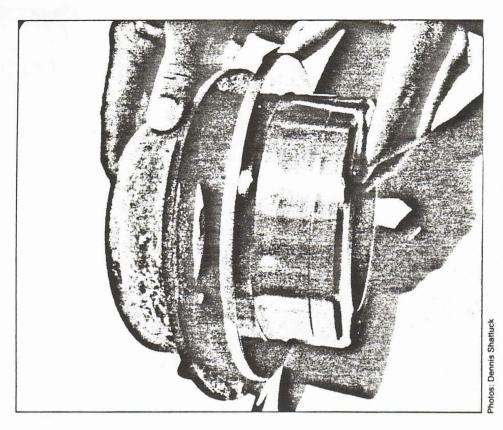
Consultation revealed the need for two new discs, plus new linings and a general clean-up of the brack components. John Bakos, affermarket sales manager, suggested that + try some of the new Cleveland chrome plated discs just coming on the market. Those the fait, would give better service in the compared disc in which I mostly fly, and Compare the new chromed disc on the right with the pitted relic it replaces. Smoother surface guarantees more effective braking.

brakes were still weak, though marginally better than before. A closer look at the brake discs showed the reason: the discs were heavily pitted from corrosion and actually worn off on a bevel so that only part of the new linings made contact. What I was getting was only partial contact of the linings with the discs, and then an inadequate contact because of the eroded faces of the discs. I estimated I had about 10% of the braking power I should have been getting.

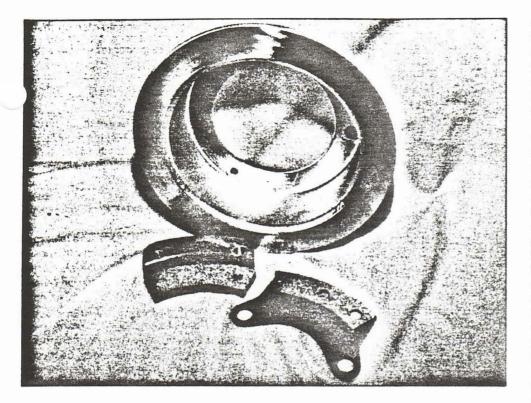
With new heavy-duty brake pads riveted to the backing plates and the chromed disc ready to be attached to the wheel, this brake refurbishment is nearly complete.

Assuming that all items are clean and acceptable, it's time to step over to the workbench and put together the new brake shoes and their mounting plates. First, however, you've got to have the right tool, and that's one of those little riveting tools sold by all the aviation parts supply houses, both local service and mail order. Prices range from \$10 to \$15 for this tool, and it is well worth the cost. It's both a rivet-removing and a rivetclenching tool, so it is doubly handy. Clamped into your shop vise, it uses a guided punch that you whack a couple of times with a hammer to poke out the old rivets and remove the worn brake pad.

It's a good idea to clean off the brake mounting plates with a steel brush to remove any residue and permit the pads to seat
