# **Cooling System Evaluation on N91CZ**

**C. Zavatson, 4-18-2006**

## **Abstract**

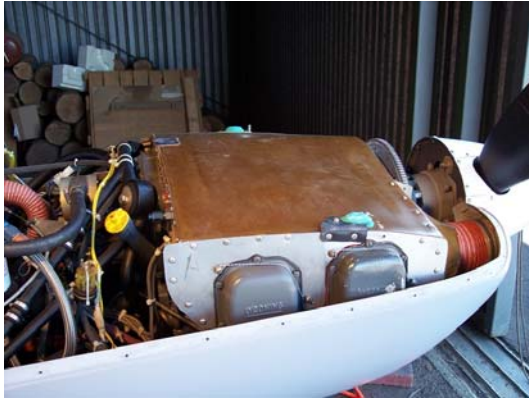
Figure 1, Cooling System

The aircraft cooling system on N91CZ is not standard for the Lancair. The cowling inlets are 2 inches long and slightly forward of the stock configuration. They retain the 3.5 inch nominal diameter in the throat for a total area of 19.2 in<sup>2</sup>. These feed into a fully sealed

plenum chamber through two diffusers. The oil cooler (SW10599) is located in front of the #2 cylinder. The face area of the cooler is partially blocked with 21 in<sup>2</sup> exposed. The cooler exit air is funneled towards the engine centerline through a 5 in<sup>2</sup> opening, in addition to a 1.5 inch diameter duct for cabin heat air. The cowling exit is approximately 50 in<sup>2</sup>.

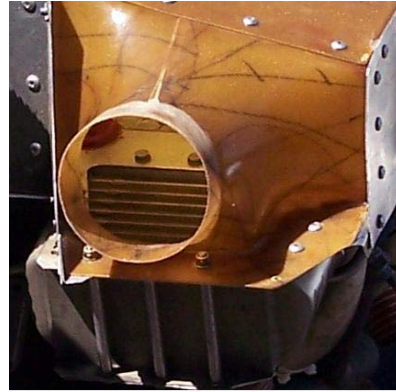
Figure 2, Oil Cooler

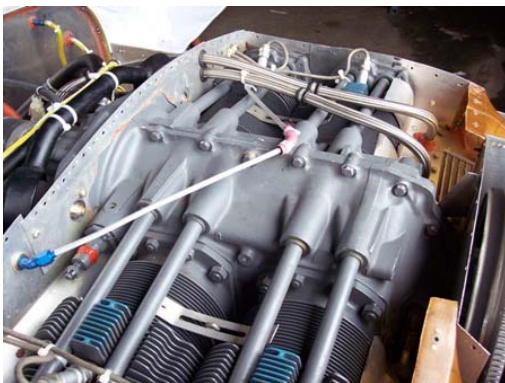
Figure 3, Piccolo tube above engine

Pressure data was taken with a spare airspeed indicator (ASI), UMA 40-200 kts, SN B4157 (Fig. 7). Piccolo tube probes were made of 3/16 inch and 1/4 inch diameter aluminum tubing for measuring static pressures above the engine (Fig. 3,4), at the cylinder exits (Fig. 5), the cowling exit (Fig. 6) and both the oil cooler inlet and exit (Fig. 9). A pitot tube was fabricated for measuring the velocity in the throat of the inlet (Fig. 8). In groups of three, the probes were plumbed to a central manifold with needle valves on each leg. For most tests the main line off the manifold was plumbed to the pitot side of the test ASI and the static side of the test ASI was plumbed to the aircraft static system. Prior to testing both the test ASI and the aircraft ASI were calibrated using a water manometer. The aircraft ASI read slightly low across the envelope, while the UMA test ASI had a parabolic excursion in the mid range, reading too high. Both errors would have led to results higher than actual. The resulting calibration curves were used to correct for instrument error in the measured data. After connecting the test equipment, a pitot-static check was performed to ensure a leak proof system.

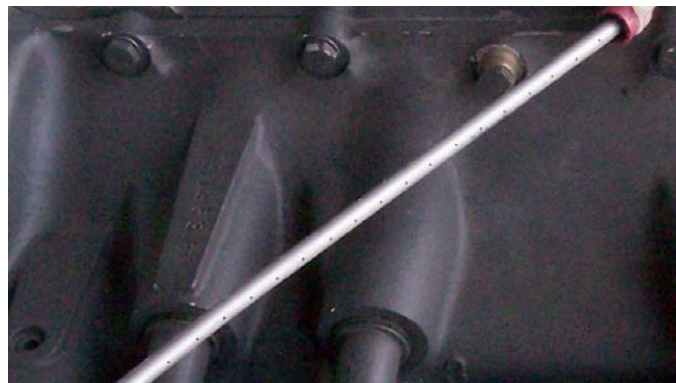
Figure 4, Piccolo tube above engine

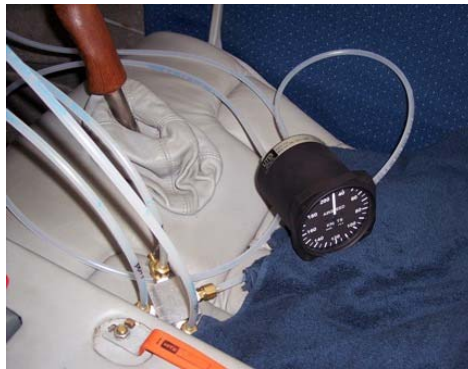
Figure 7, UMA Test ASI

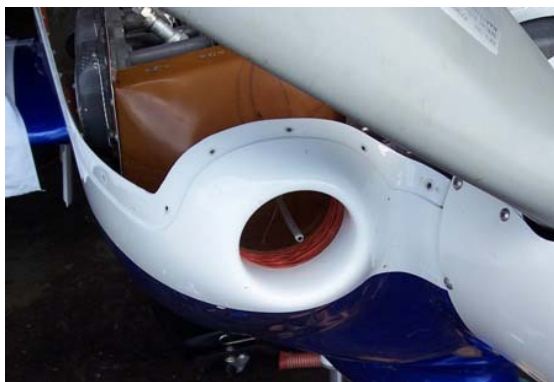
Figure 8, Inlet Pitot Tube

Inlet velocity was measured in the throat of the cowling inlet. Only the centerline velocity was measured. The velocity profile and the ratio of average to centerline velocity are not yet precisely defined. A mapping of the velocity profile using rakes may be done at a later date. Until the profile is actually measured, the following assumption will be made. The Reynolds number for the inlet throat ranges from about 200,000 to 600,000 over the operating speed range. The flow is clearly turbulent in this region, but will not be fully developed, having just barely entered the duct. Fully developed flow with the given Re values would reduce the average velocity to about 0.86 of the measured center line velocity. This ratio would cause an excellent fit to the data. However, this

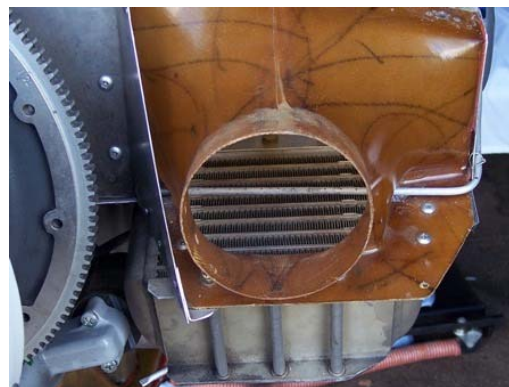
Figure 9, Piccolo tube in front of Oil Cooler

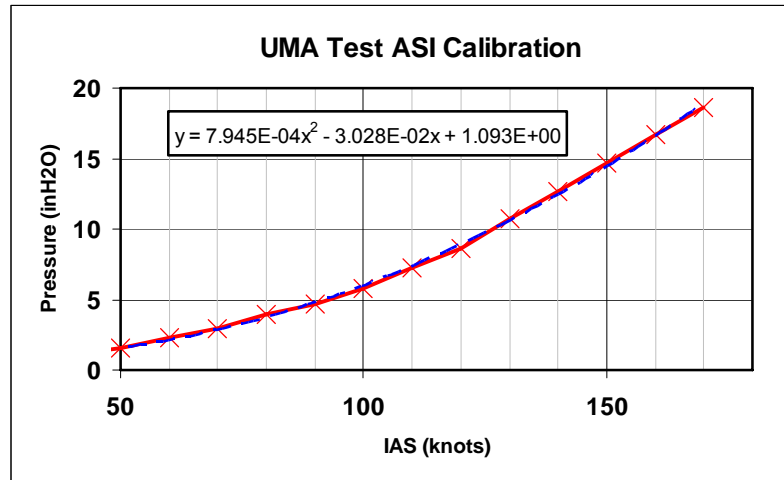
Figure 10, Test ASI Calibration

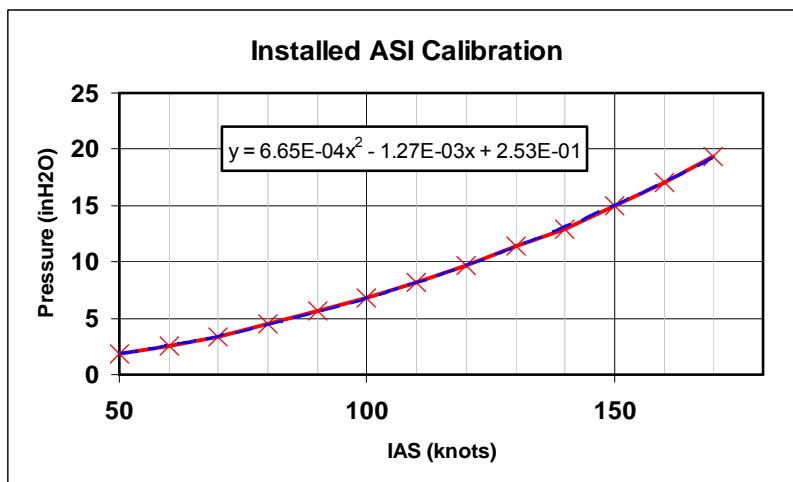
Figure 11, Aircraft ASI Calibration

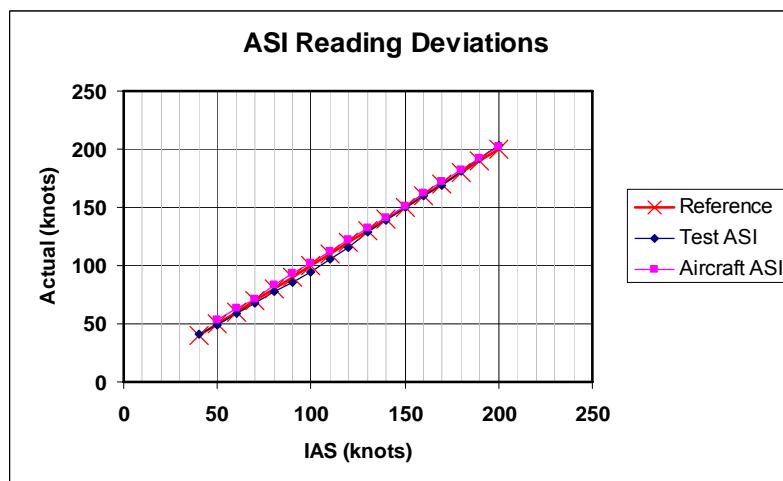
Figure 12, ASI Error

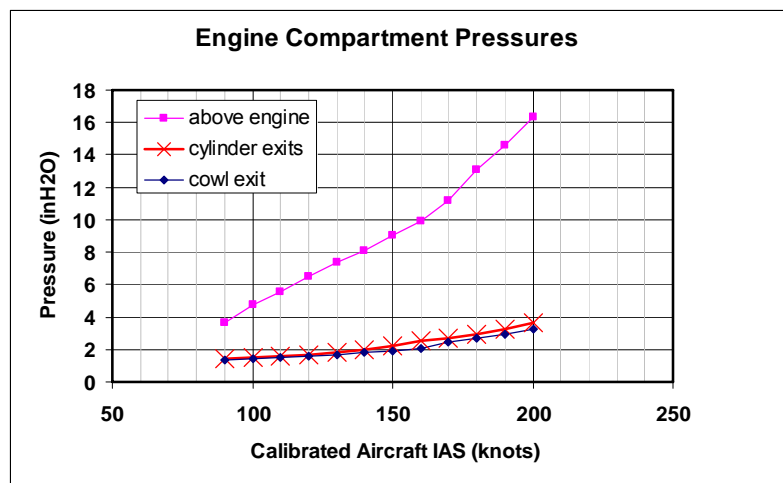
Figure 13, Engine Compartment Pressures

Static pressure measurements are shown in figure 13. The computed engine pressure drop is shown in figure 14. Lycoming chart 13245-B, (Cooling Air Requirements 0-360 & IO360 180 BHP) (Fig.15), provides pressure drop and mass flow data that define the upper operating thermal limits for the engine. As expected, based on temperature history, the engine operating points are located in a very favorable region, well clear of maximum temperature limits. (A similar chart exists for the O320/IO320 series engines. The pressure drop/mass flow curves are identical. Less air flow is required, however, due to the lower heat generation of the 320 series.)

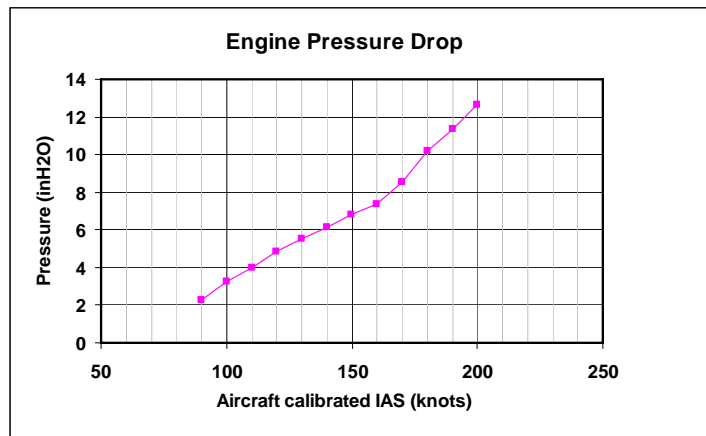
Figure 14, Engine Pressure Drop

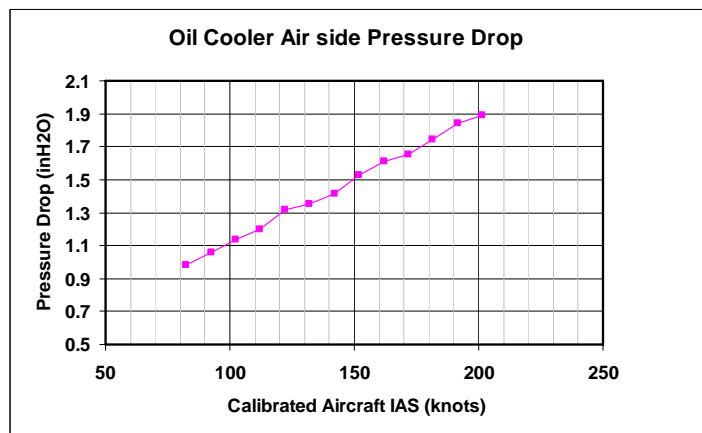
Figure 16, Oil Cooler Air Side Pressure Drop

Pressure drop across the oil cooler is shown in figure 16. Using Stewart Warner cooler performance curves the air side mass flow through the oil cooler was determined. There was relatively little pressure drop across the oil cooler. There was, however, a significant pressure drop between the oil cooler exit and the cowl exit pressure. This may be the result of the constricted exit area of the funnel attached to the bottom of the cooler. Only 5 in<sup>2</sup> is available for exit air from the cooler to enter the lower cowl area.

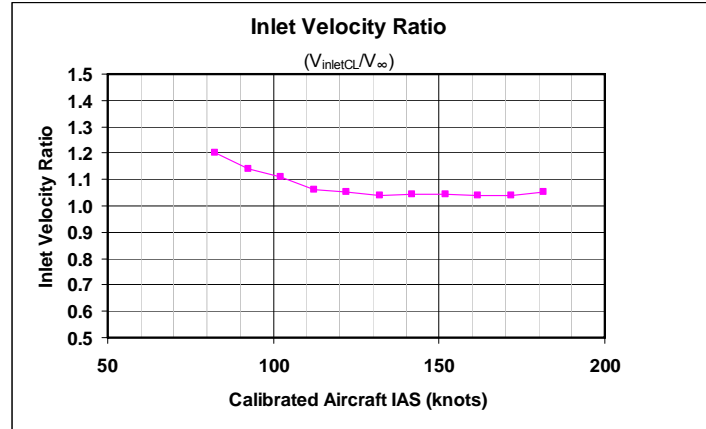
Figure 17, Inlet Velocity Ratio

A comparison of engine mass flow rates computed via pressure drops and using inlet velocity is shown in figure 18. The measured inlet velocity ratio is shown in Figure17. The inlet velocity ratio is near 1.0 across the entire speed envelope. This is not typical of cowlings inlets seen in general aviation. A more typical range is 0.3 to 0.7 where a substantial portion of the pressure recovery is done in front of the inlet. A potential downside to a high velocity ratio is the propensity for large losses during expansion of the flow past the inlet. This is typically the more difficult place to achieve good pressure recovery. With such high velocity air passing through the inlet, the need for controlled expansion behind the inlet is amplified.

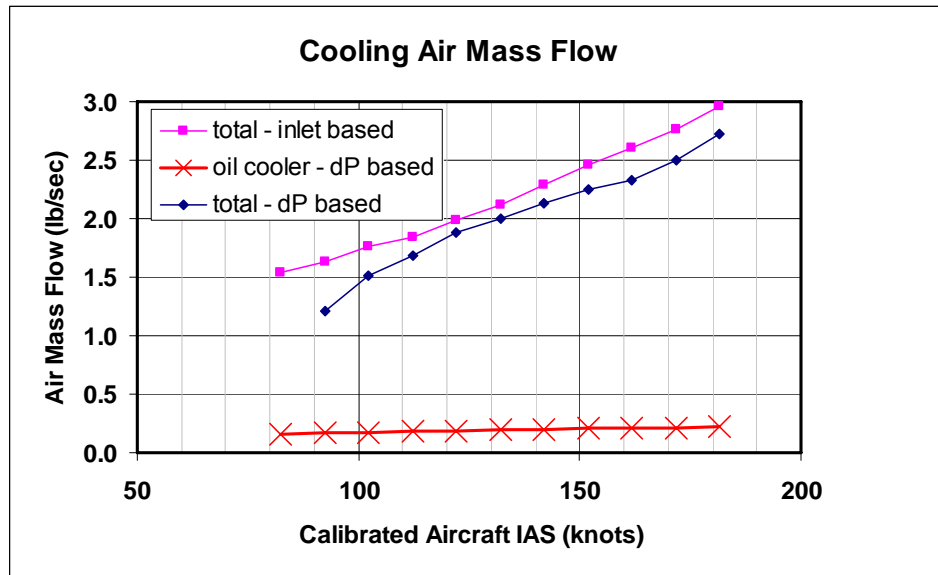
Figure 18, Cooling Air Mass Flow

The oil cooler mass flow was added to that derived from engine pressure drop to determine the total mass flow. This total was then compared to mass flow obtained via inlet velocity measurements.

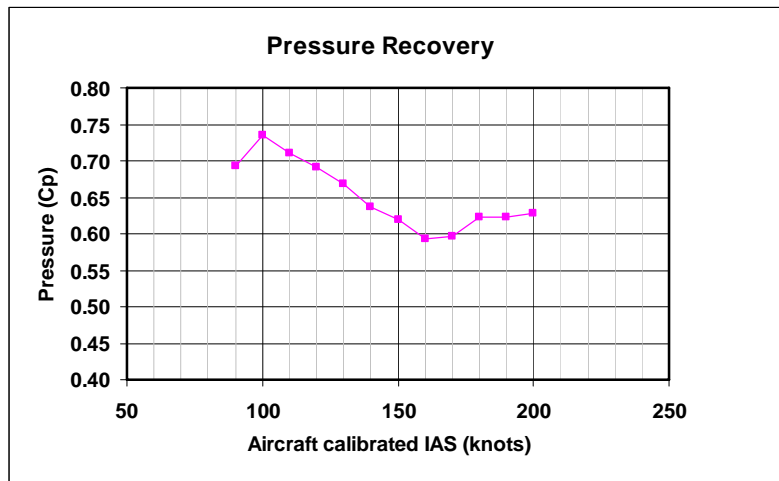
Figure 19, Plenum Pressure Recovery

Despite the very high velocity ratio, the static pressure and  $C_p$  obtained in this installation is very good. The values achieved are equivalent to those measured in the NASA report CR3045 with much lower inlet velocity ratios. Extrapolating the trend found in the NASA report indicates that the pressure recovery achieved in this test would far exceed the values measured in the NASA report. The extent to which good diffusers were design and built for the NASA test was not well documented.  $C_p$  ranges measured in the Lancair ranged from 0.60 to 0.75 for a velocity ratio near 1.0. The NASA test indicated 0.60 for an inlet ratio of only 0.6, the highest ratio tested.
